SUNRISE RESIDENCE INN

BUILDING CONDITION DUE DILIGENCE

Alachua County
Sunrise Residence Inn
Due Diligence Report
2105 & 2120 SW 14TH ST
Gainesville, FL 32608

BUILDING CONDITION DUE DILIGENCE EVALUATION

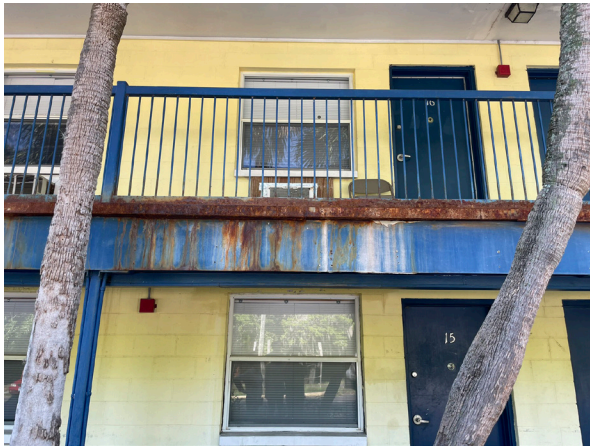
Figure 4 - Rusting Steel Structure NE Building

- 1) Condensation from A/C units on both buildings should be corrected. On the Northeast building, this has led to rusting on the steel structure, as well as cracking and movement in the concrete walkway and stairs. (See *photo/figure 4*) On the Southwest building, there appears to be cosmetic repairs to the steel structure. (Refer to the structural report for additional discussion of the walkway structure).

- 3) The condensation from the A/C units is not managed. There appears to be condensate drain piping in place that is intended to carrying the water away in a controlled fashion, however this seems to have mostly been abandoned, and currently the condensation is being collected in a bus pan under each AC unit. Many of the bus pans were full and overflowing during our visit. This creates a breeding environment for mosquitoes, algae, etc., and the pans overflow water onto the concrete walkways, which pools and runs over the edge of the second level walkways. On the second floor of this building, this has led to rusting on the steel structure of the walkway (*Figures 4, 5, 6, & 7*). See the structural report below for additional discussion of the second level walkways.

- 2) The soffit, ceilings inside the units, and the floors in the units all need minor maintenance.
- 3) The condensation of the A/C units needs to be addressed with proper drainage, currently the condensation is not managed well.

- 4) The concrete walkway and stairs have cracking and rust on the supporting structure.
- 5) The SW building has part of the foundation exposed, this needs to be buried and proper water runoff through gutters and downspouts will prevent this in the future.

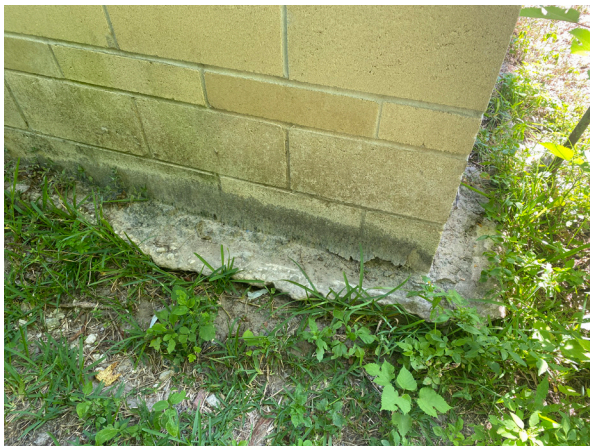
Figure 6 - Exposed Footing SW Building

- 3) The Southwest building exhibits a significant amount of erosion at grade on the southwest corner, and the west side, due to water falling from the roof. At the southwest corner of the building, the footing appears to be exposed. (See *photo/figure 6*) The recommendation would be to provide gutters and downspouts at both buildings. (See structural report for additional discussion of the southeast building foundation.)

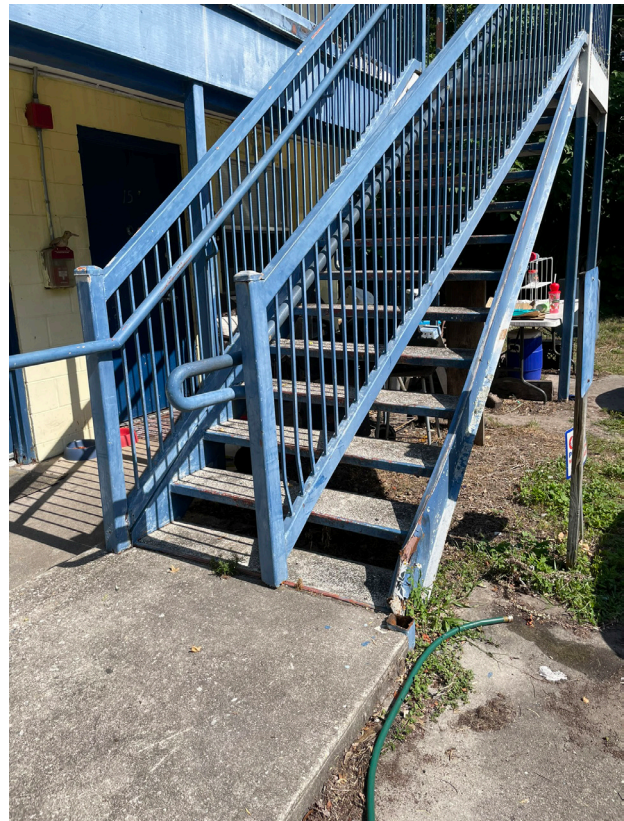
Figure 5 - Guard Rail SW Building

- 2) At the southwest building, the handrail/guardrail on the north stair is broken. It appears to have been hit by a vehicle, and is sheared off at the base. This is a significant hazard to life safety and should be corrected as soon as possible. (See *photo/figure 5*).

- 1) One of the guard rails on the North staircase is broken and loose. Our hypothesis is a combination of the steel structure rusting and possibly being hit by a vehicle from the parking lot. (See photo/figure 5)
- 2) The Southwest corner of the building possibly has an exposed part of the foundation. We believe erosion on this corner is from water falling from the roof. (See photo/figure 6) This should be corrected - see structural report for additional discussion of this item.
- 3) Each unit in this building has one single hung window and one exterior hollow metal door located on the same wall. Both the windows and doors are generally in good condition. (See photo/figure 16)
- 4) Apartments are heated and cooled by a single through-wall mounted AC unit located below the windows. (See photo/figure 17)

- 6) One of the stairs on the SW building has a broken guard rail that is a safety concern and needs to be replaced.
- 7) While repairs have been made to previous water staining on the interior ceilings, we recommend having these areas addressed by a professional contractor.

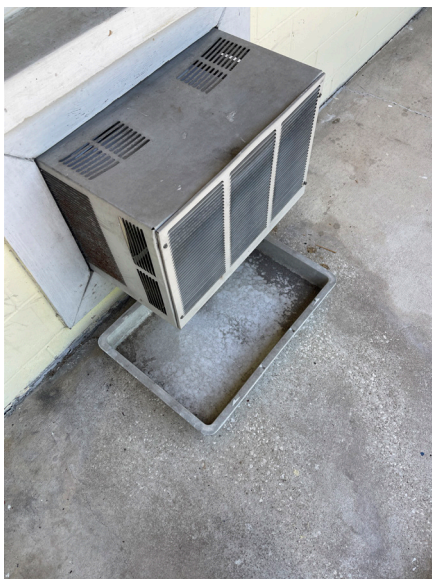
Figure 9 - Typical AC Unit

- 1) Each unit has one single hung window and one exterior hollow metal door located on the same wall facing the exterior walkways. Both the windows and doors are generally in good condition. (See *photo/figures 7 & 8*)
- 2) Each unit is heated and cooled by a single wall mounted AC unit located below the windows. (See *photo/figure 9*)

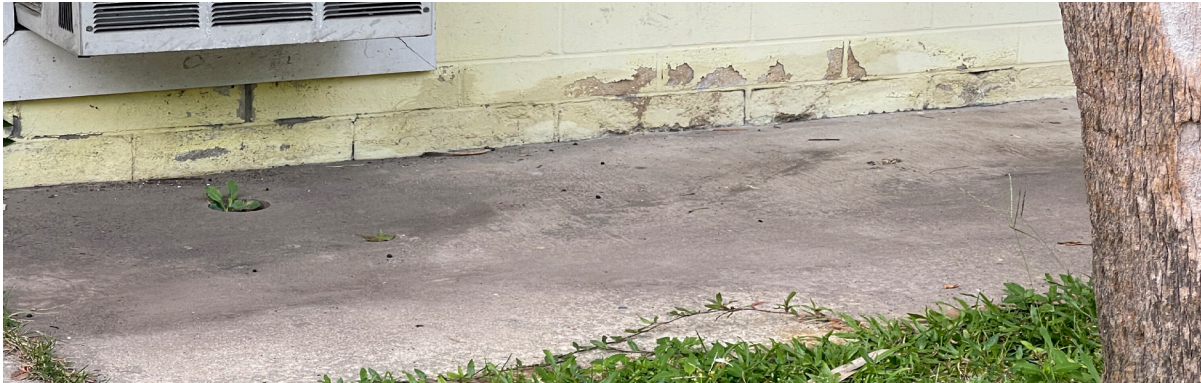
Figure 10 - Flood Damage in NE Building

- 7) It was noted that several units in the Northeast building have flooded. We observed repairs on these ground floor units, and were told that the water resulted from the stormwater system on the neighboring property. Water damage appears to have been corrected, although there is evidence of peeling exterior paint on the walls facing walkway specifically in front of these units.

- 4) It was reported that three units (Units 13, 15, & 17) on the ground floor flooded recently from a retention pond on the adjacent property. There are signs of this in paint discoloration at the base of the building. (See photo/figure 10). The interior of these units has been repaired and the flooring has been replaced, there is currently no remaining indication of water intrusion inside these units. One of the units was still partially demoed, and the floor/ceiling assembly was visible. This unit was being used as storage.

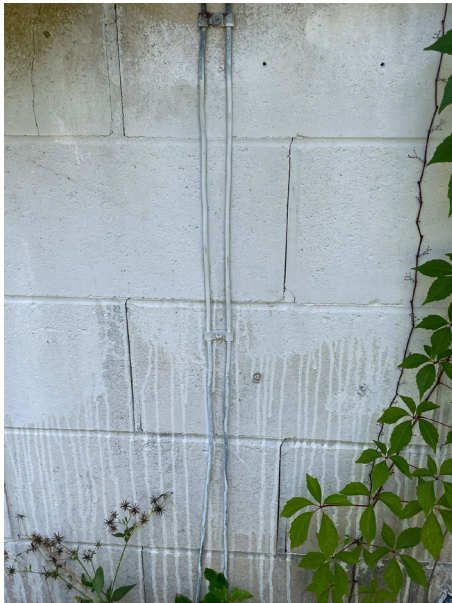
Figure 11 - Stair stepping in CMU walls

- 5) CMU walls are in generally good condition. Minor "stair step" cracking was observed but is generally within or below the expected range for a building this age. (See photo/figure 11) Minor remediation may include providing sealant at small cracks the next time the building is painted. See the structural report for additional comments on the CMU condition.
- 6) According to the Owner's representative, the roof on this building is approximately 3 years old. The property appraiser's website indicates a roof permit was pulled in 2016. Our observation is that the roof is in "good" to "very good" condition. Estimate this roof has another 12 to 15 years of service remaining. (See photo/figure 12 & 13)

- 1) The structure of both building is generally good, including CMU bearing walls, roof, and the walls separating the units. Only minor cosmetic repairs for stair step cracks is needed.

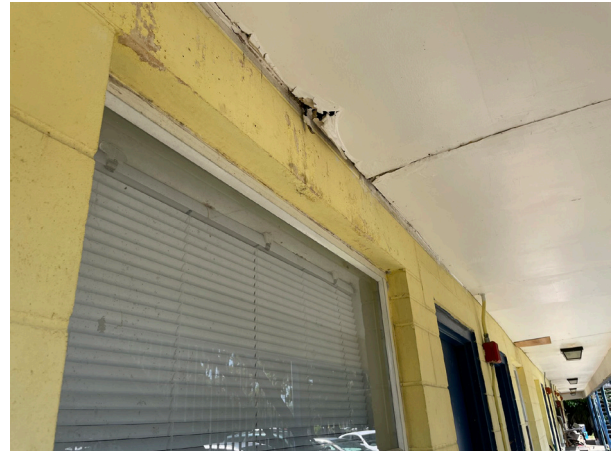
Figure 14 - Damaged soffit NE Building

- 7) Some maintenance is required on parts of the soffit. (See photo/figure 14)
- 8) Paint is peeling on the lintels above the windows on the first floor, but the lintels on the second floor do not have this occurring. We believe that that moisture is causing the paint to peel in these locations, due to the condensation from the A/C units on the second floor. (See photo/figure 15)

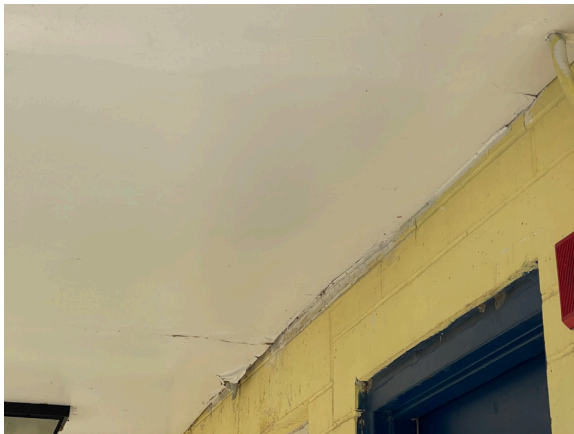
Figure 18 - Paint peeling on lintels above windows

- 7) The roof on this building is in “below average” condition. We estimate this roof has another 5 to 7 years of service remaining. (See photo/figure 20)
- 8) Some maintenance is required on parts of the soffit. (See photo/figure 21)
- 9) Paint is peeling on the lintels above the windows on the first floor, but the lintels on the second floor do not have this occurring. We believe that condensation moisture from the A/C units on the second floor is causing the paint to peel in these locations. (See photo/figure 18)

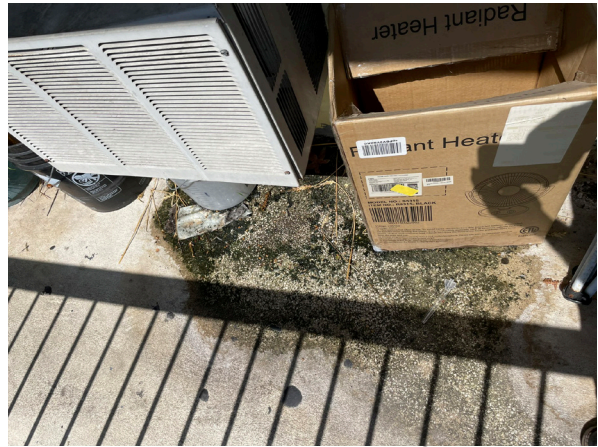
Figure 19 - AC unit condensation overflow SW building

- 5) The condensation from the A/C units is not managed. Condensate drains are in place, but seem to have been abandoned over the years, and currently the condensation is being collected in a bus pan under each window. When these are not emptied, they overflow, and the water runs out across the walkway. (See photos/figures 18 & 19) On this building, the rusting on the exterior walkway is not as prominent, but it also appears that there has been attempts to repair and clean the steel have been undertaken. As we did not perform any destructive observations on these areas, we cannot describe the full extent of potential structural issues with the walkway. See structural report for additional discussion.

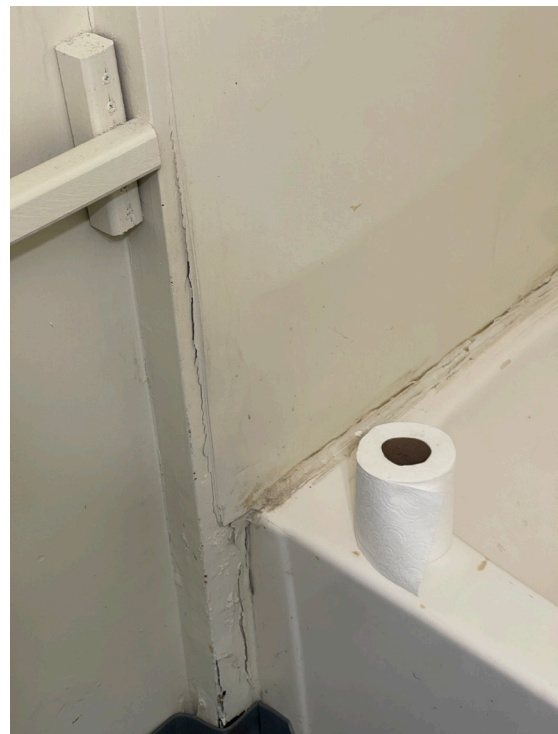
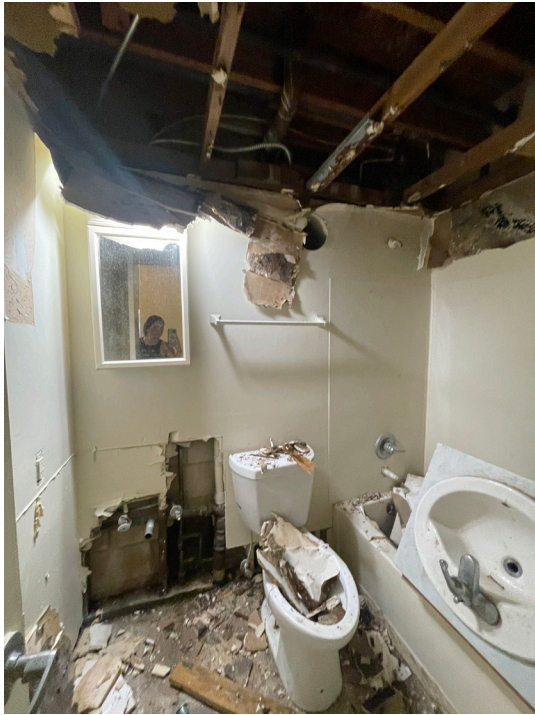
- 13) The bathroom and tub/shower: some are in good condition, and some need maintenance. Primarily in the sealant around the tub/shower. *(See photo/figure 29 & 30)*

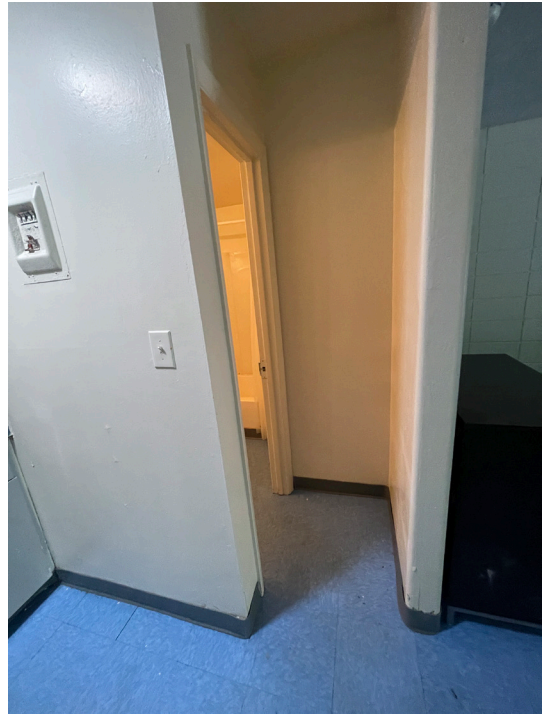
Figure 31 - Narrow bathroom door

- 2) Interior layout of the units includes doorways into the bathroom and kitchen that are very narrow, at 24" (*see typical unit plan.*) While the code minimum door width of 32" does not apply to Group R2 Residential units (*FBC-B Section 1010.1.1*), 24" is very narrow, and it would be advisable to enlarge these openings.

- 14) Bathroom door (24") and the other thresholds in the units are small. *(See photo/figure 31)*
- 15) There is a vent fan in both the kitchen and the bathroom. These exhaust through the wall to the rear of the building.

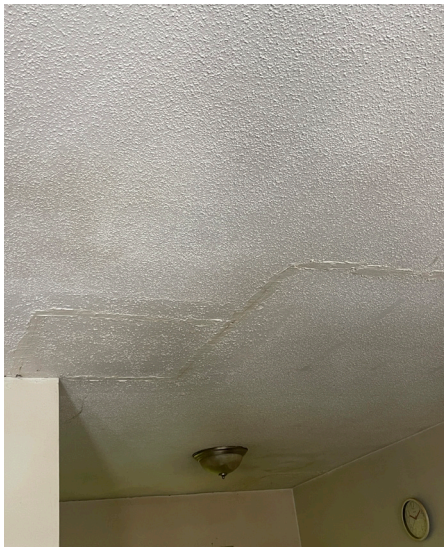
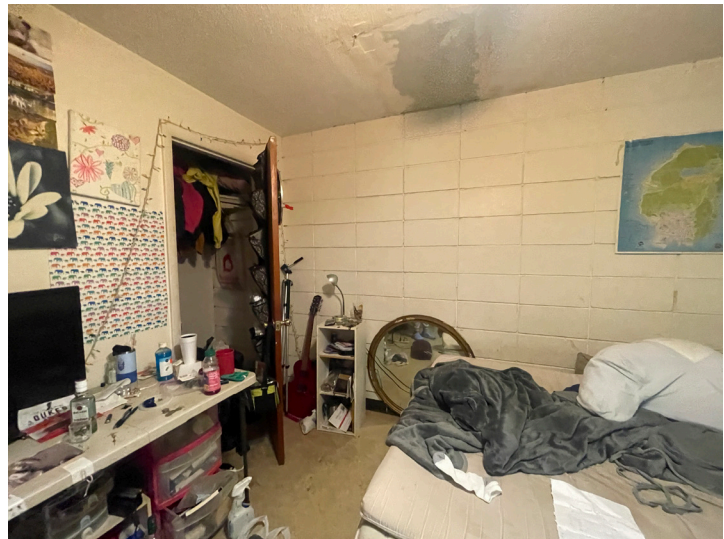
- 1) The 2nd floor in this building has one 2-bedroom unit that occupies the area of two regular units. This apartment includes windows on the rear of the building provide emergency escape and rescue from the second bedroom. There is evidence of repair to water damage in the ceiling. According to the owner's representative, there was a pipe that broke in the attic over this unit, but this was repaired. (See photos/figures 32 & 33)

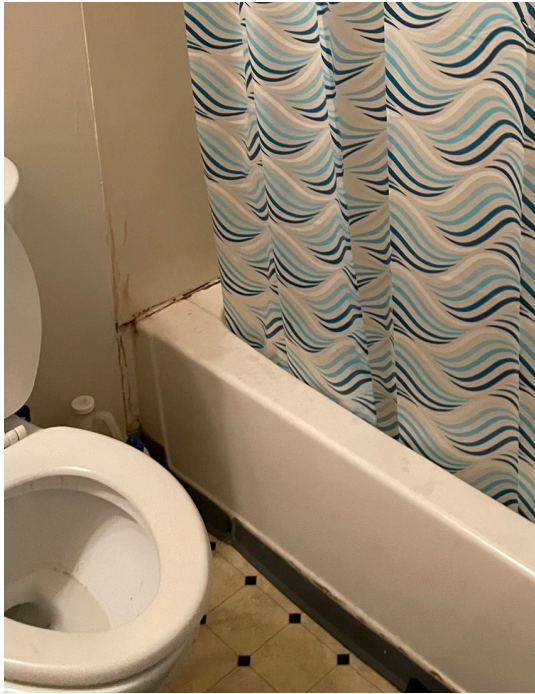
Figure 36 - Typical tub condition

- 5) Ceilings are in generally fair condition. We observed signs of repairs and patches, but no active water issues were observed.
- 6) Some bathroom tub/showers are in good condition, and some need maintenance. Primarily in the sealant around the tub/shower. (See photo/figure 36)
