ALACHUA COUNTY PUBLIC WORKS 2020 STORMWATER

Contents

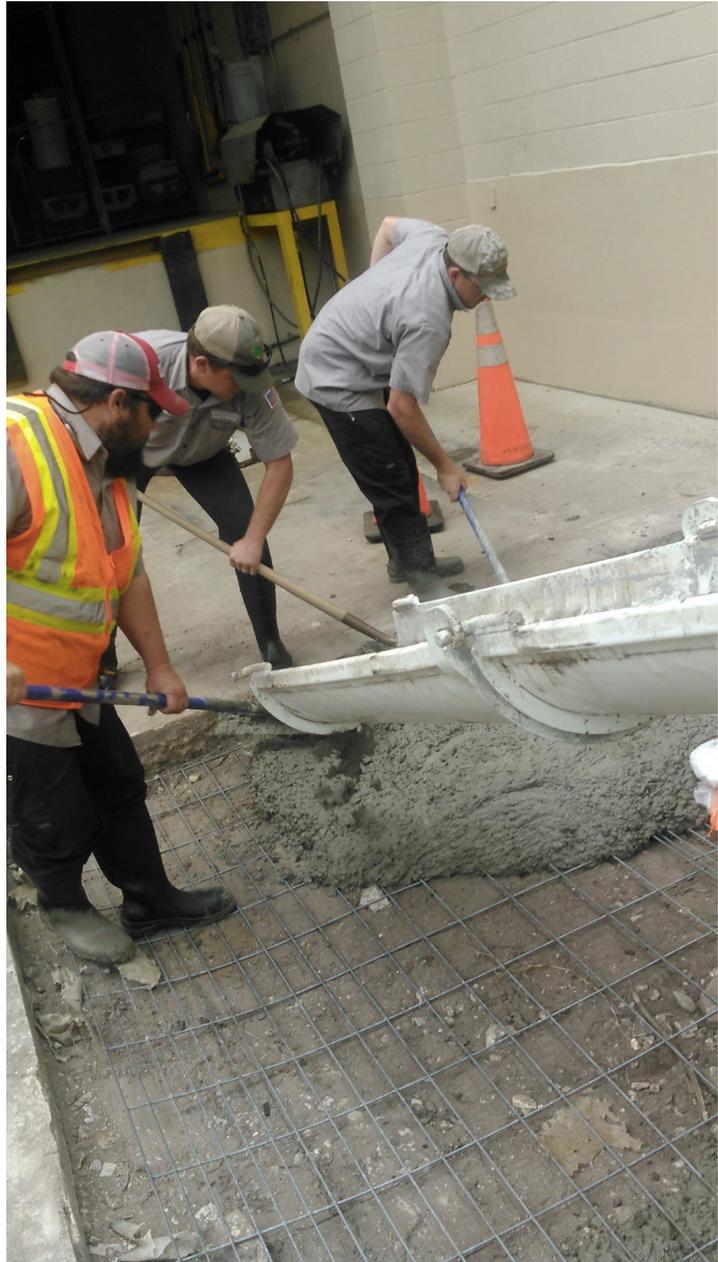
Achua County Jail Spillway Replaced

The Stormwater Crew completed a drainage system repair which required demolition and replacement of concrete slabs.

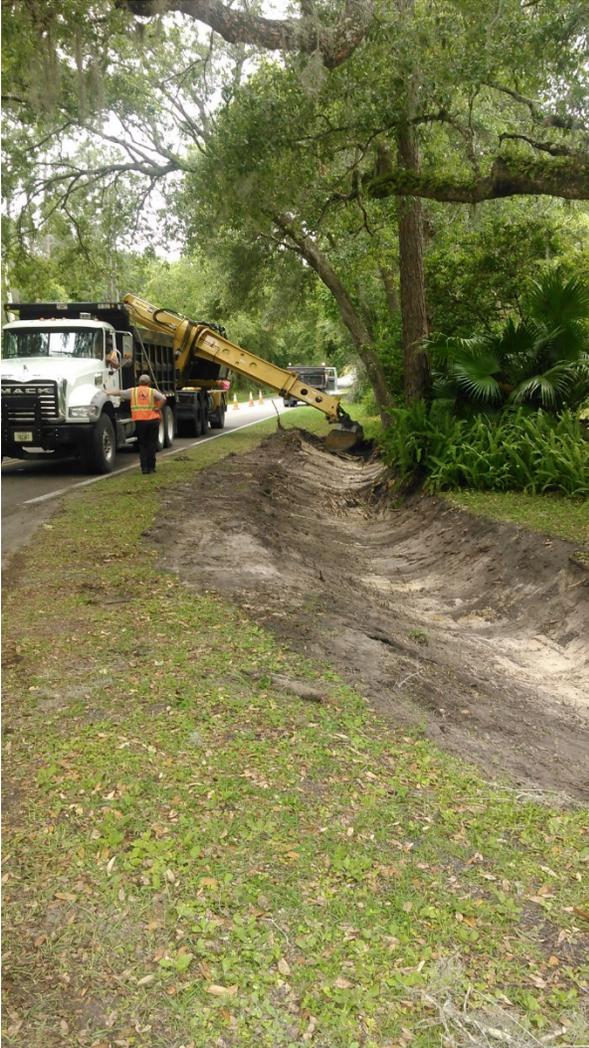
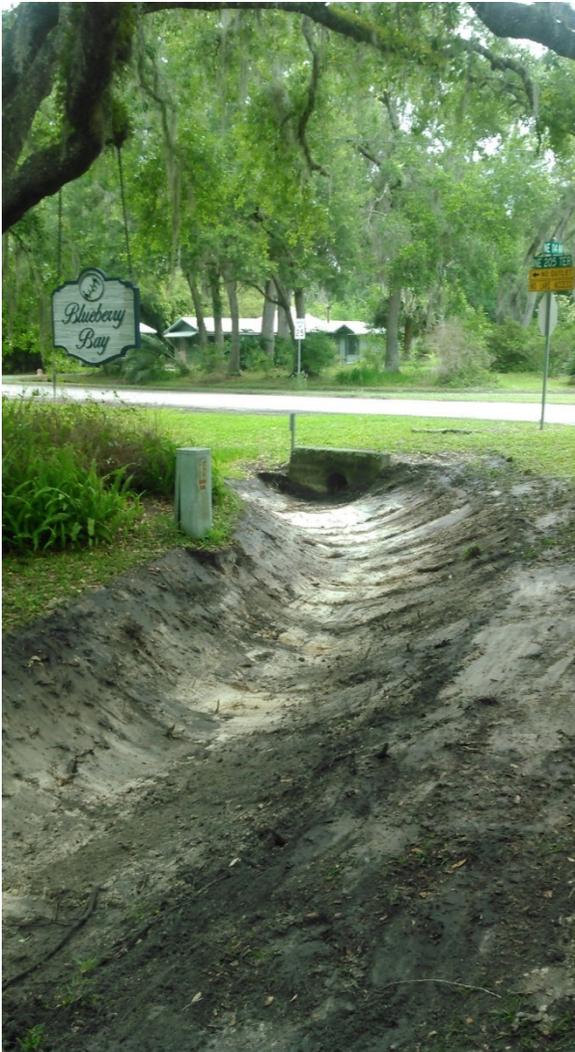
Blueberry Bay Ditch Excavation

Restoration of roadside drainage system on NE 114th Avenue near Santa Fe Lake. This work was requested because the deterioration of the roadside drainage was beginning to affect the adjacent residences. The drainage pattern was restored by removing accumulated sediment. Impact to trees in the right-of-way is minimized.

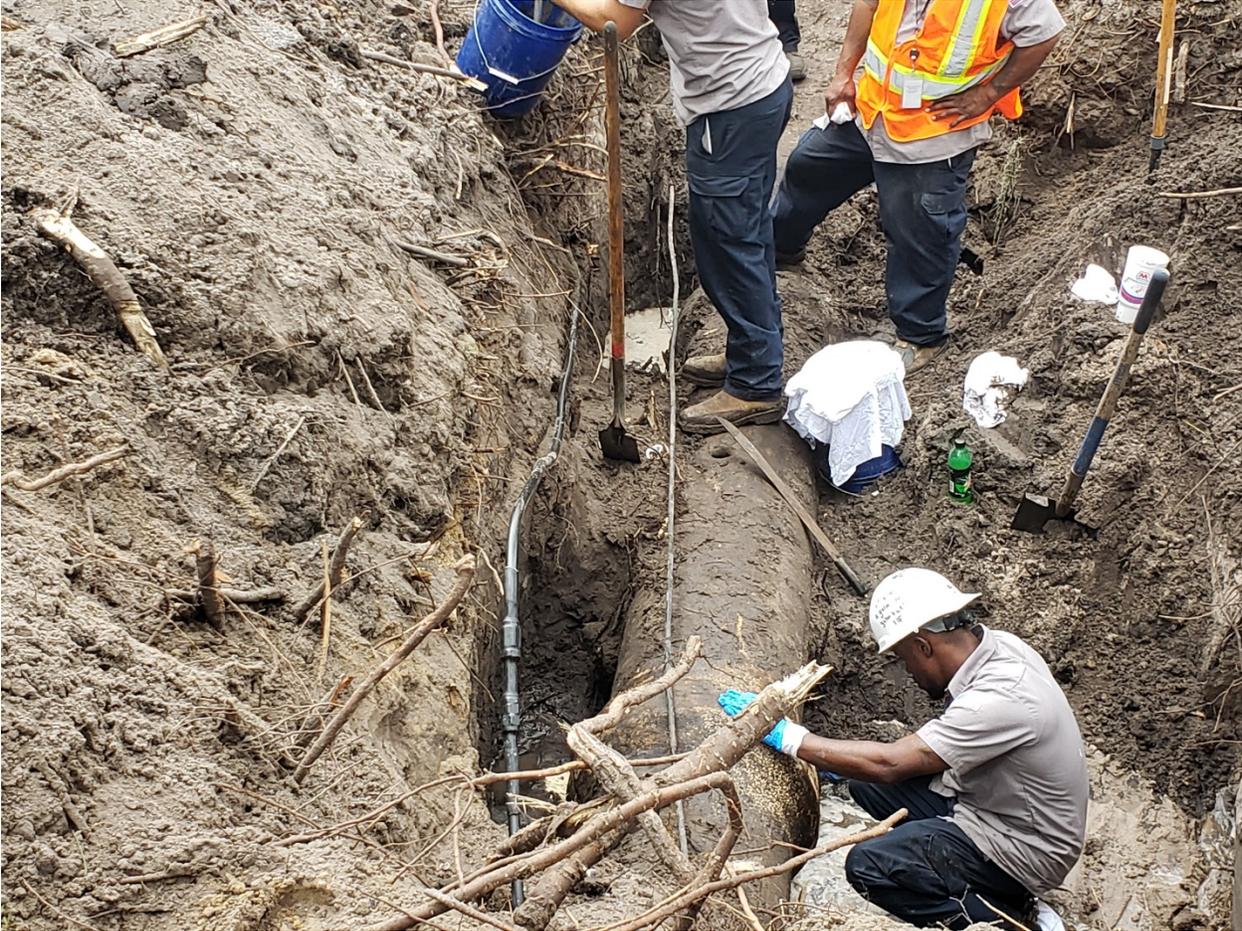
Blues Creek Damaged Culvert Repair

The storm sewer providing drainage for the NW 52nd Terrace became completely clogged with tree roots. Crews worked to remove the root ball from the concrete pipe and flush accumulated debris from the pipe.

Storm sewer impacted by roots

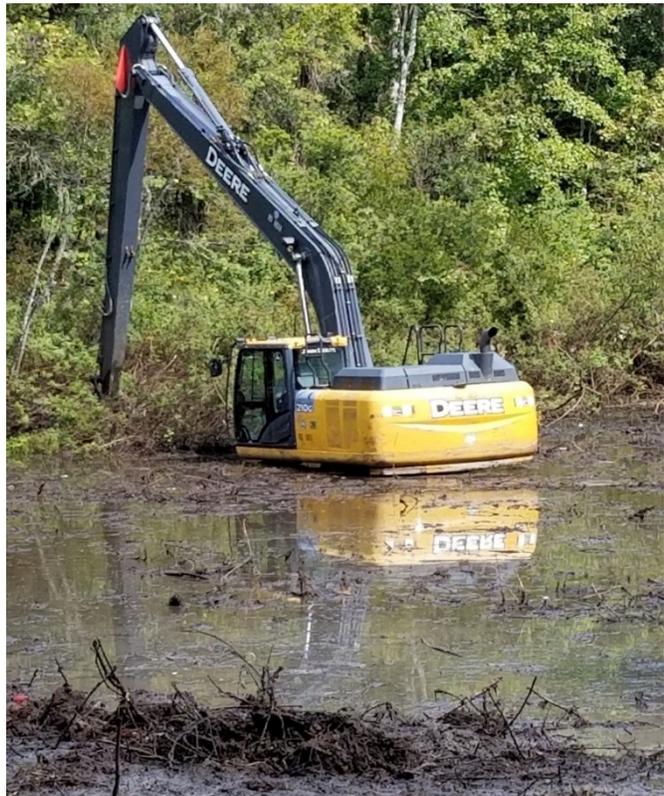
Crews are restoring a stormwater basin that serves the roadways in the northern portion of Deer Run. This is a wet detention pond that became overgrown with vegetation and full of muck. The basin's water quality treatment volume was greatly diminished by the volume of vegetation and muck. This basin discharges to Blues Creek. Operations were conducted to prevent water quality impacts to Blues Creek. Residents were reporting this area as an eyesore and appeared to welcome the work.

Overgrowth and muck removal

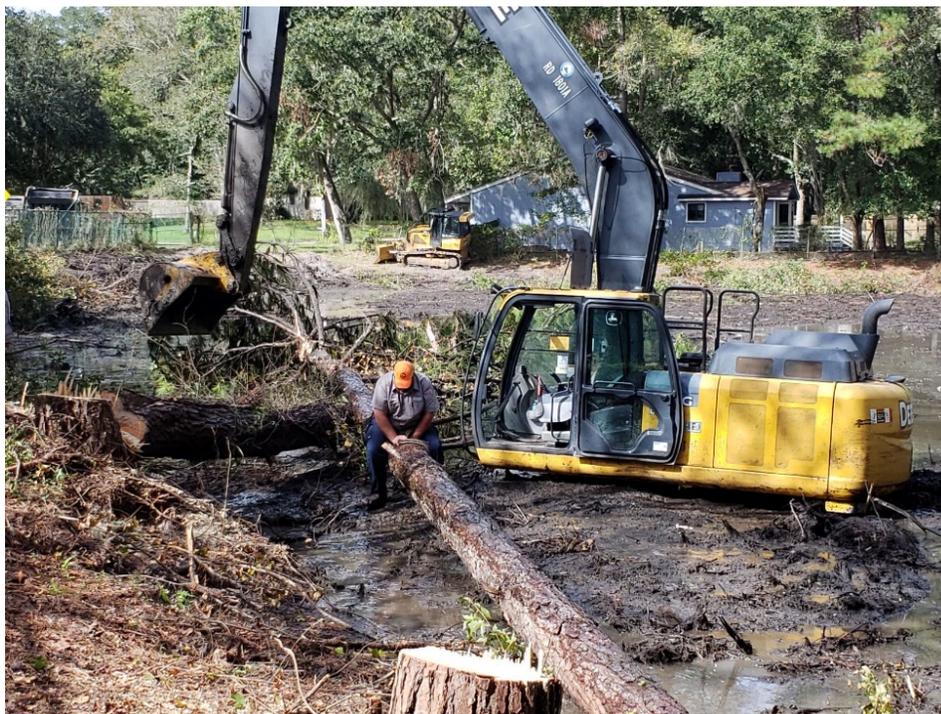
Access clearing and muck removal

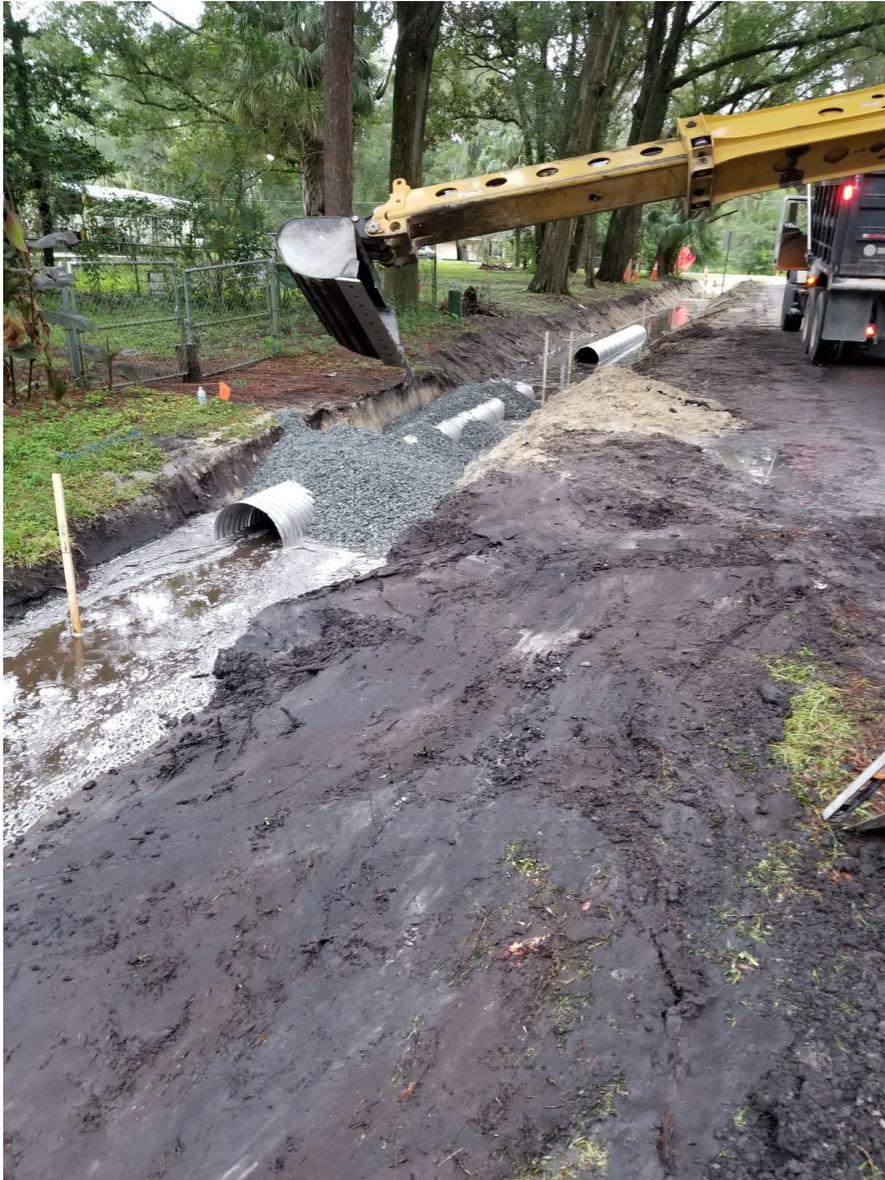
Fairbanks Culverts Replaced

Heavy rainfall and wet season water tables caused roadway and yard flooding Along NE 76th Avenue and NE 52nd Terrace. Improvements to the roadside ditches provided relieve to residents who were having issues accessing their property.

Ditch grading and driveway culvert repair

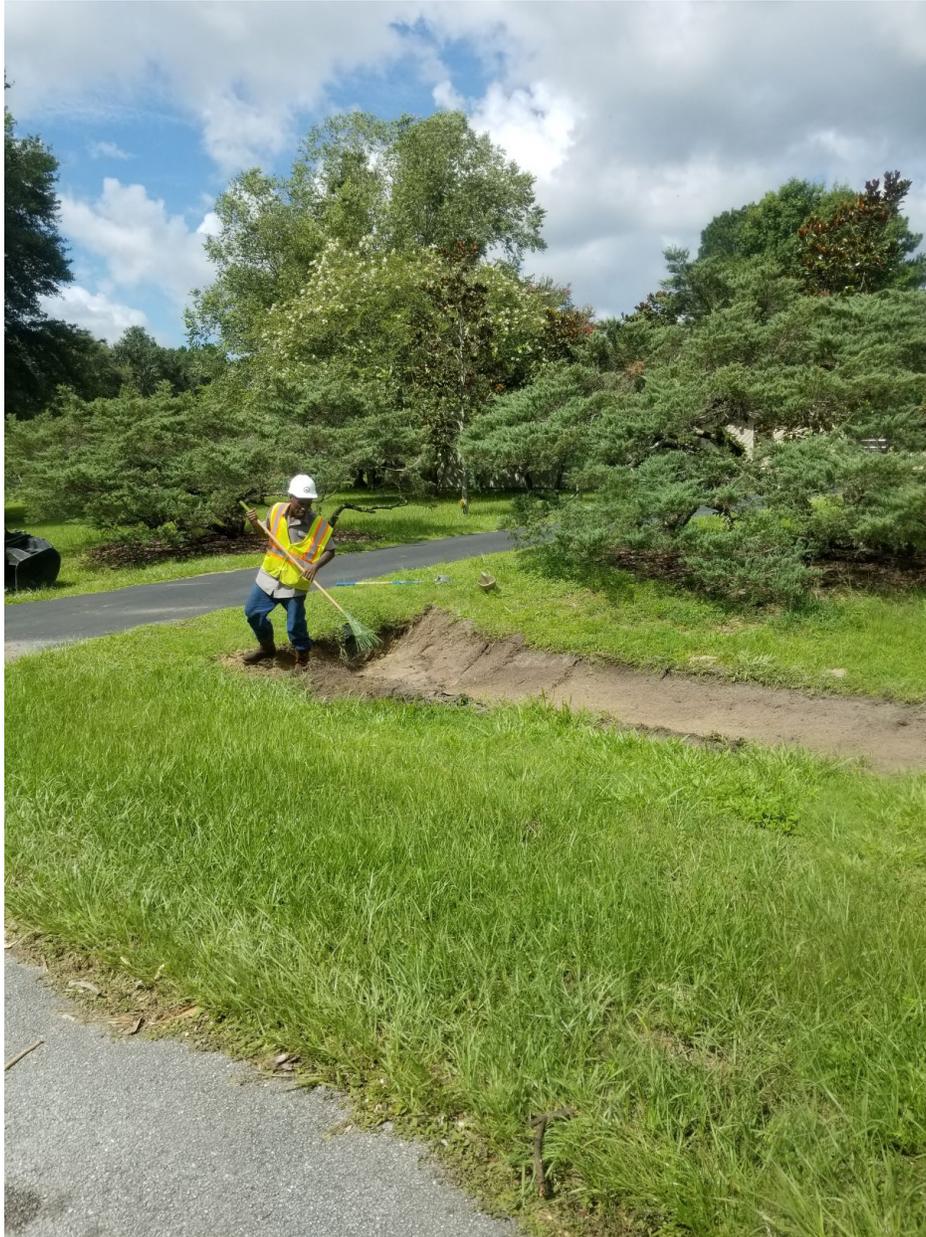
Edgecliff Subdivision Ditch Excavation and Seeding

This work restored the flowline of existing swales along the roadways in the subdivision. Some properties depend on these swales for the drainage of their yards.

Ditch grading

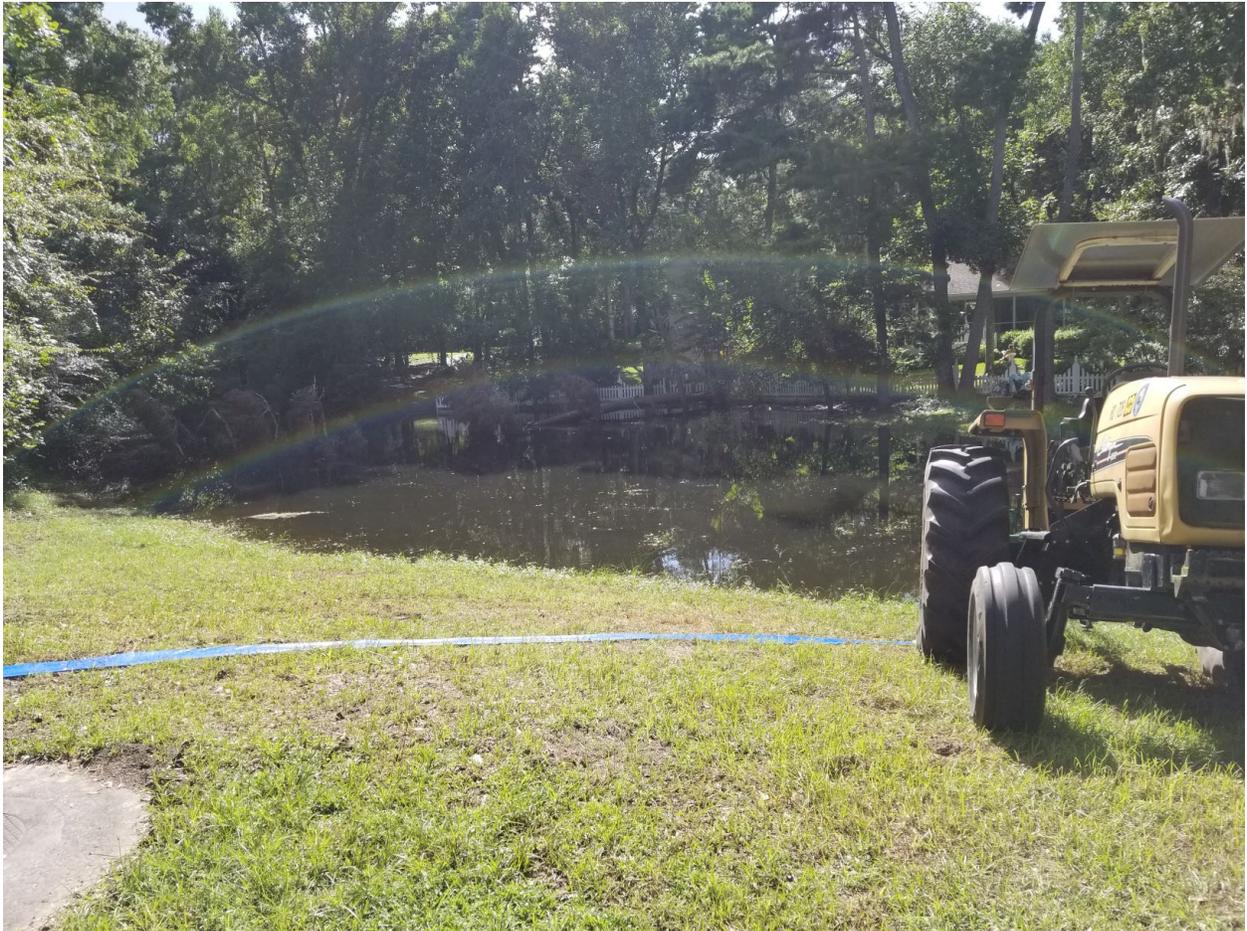
Emerald Woods Water Removal with Gator Pump

This work was done to draw down the water level of a basin that had filled up and remained outside of its boundaries. Public Works is planning to improve the soils in the bottom of the basin to provide faster infiltration of stormwater.

Basin pumping with PTO powered "Gator" pump

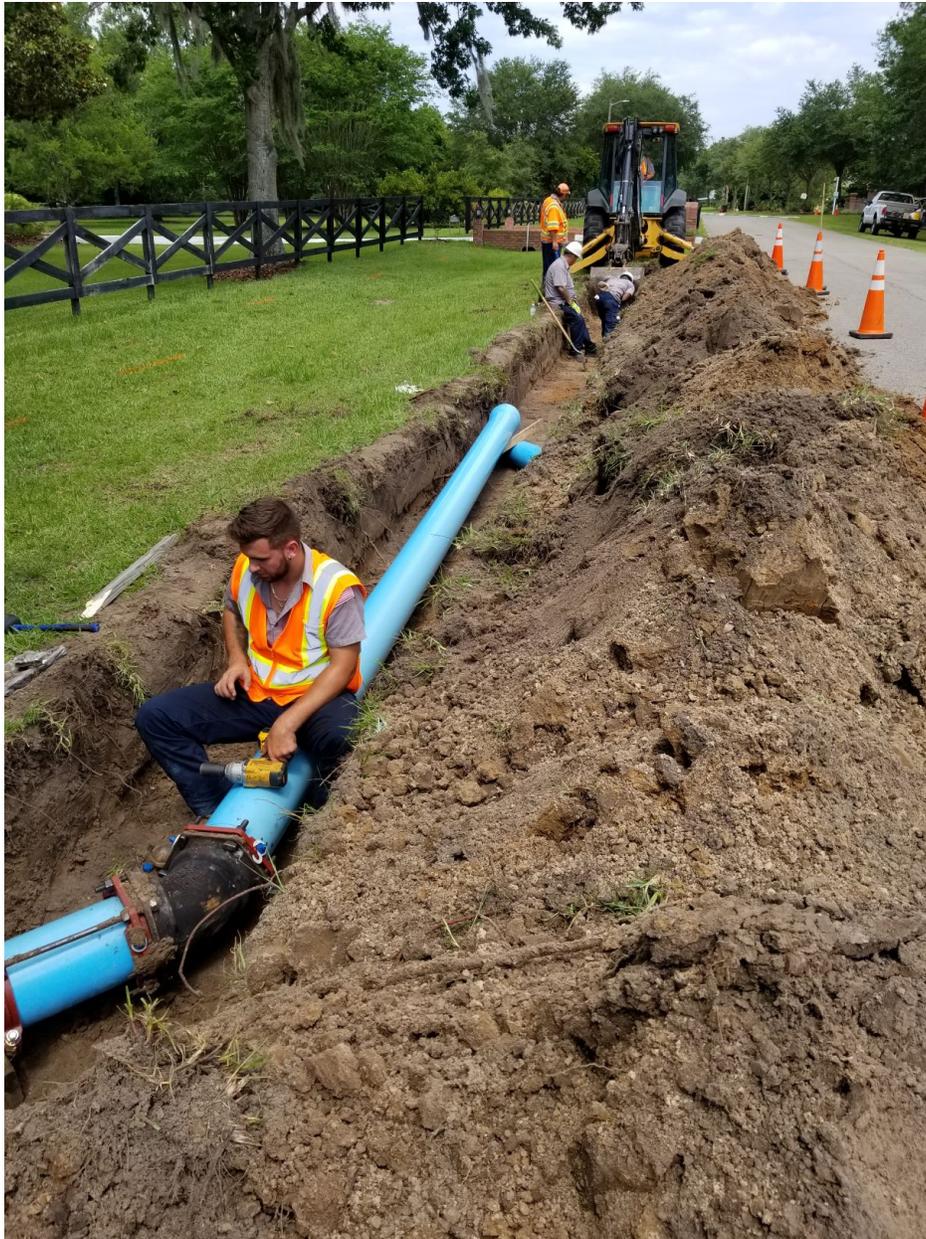
Hayes Glen Pipe Permanent Piping

Crews installed PVC piping from a flood plain in Hayes Glen to a drainage easement in the adjacent Cheney Walk Estates subdivision. This location has a history of roadway and property flooding. The permanent piping will allow us to rapidly deploy pumps after flood events, as well as focus manpower on other recovery efforts.

Permanent piping installation

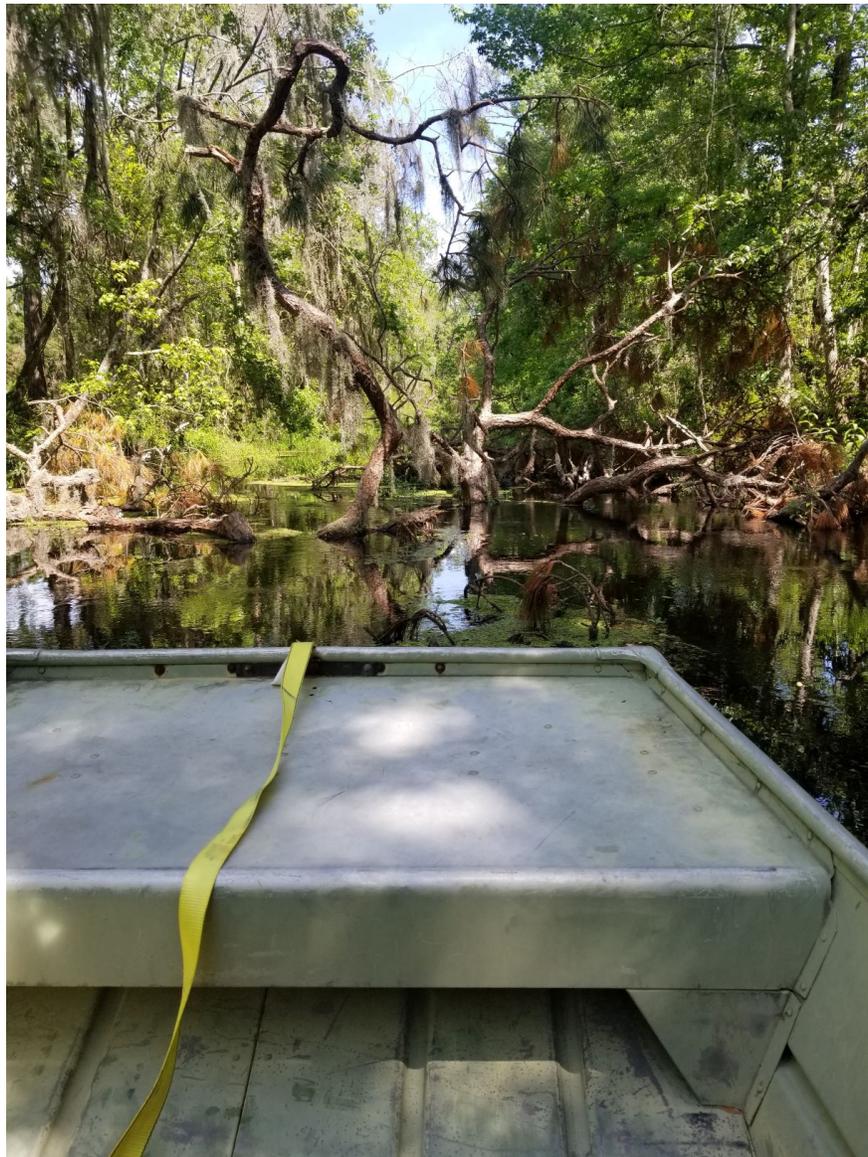
Old Steam Boat Canal from Lake Alto to Little Lake Santa Fe Debris Removal

The debris removal was to address citizen concerns about the interaction of the water levels in Lake Alto and Little Lake Santa Fe through the canal. In addition to removing debris, survey crews established monitoring locations for both lakes to observe the relationship of the water levels.

Canal obstruction

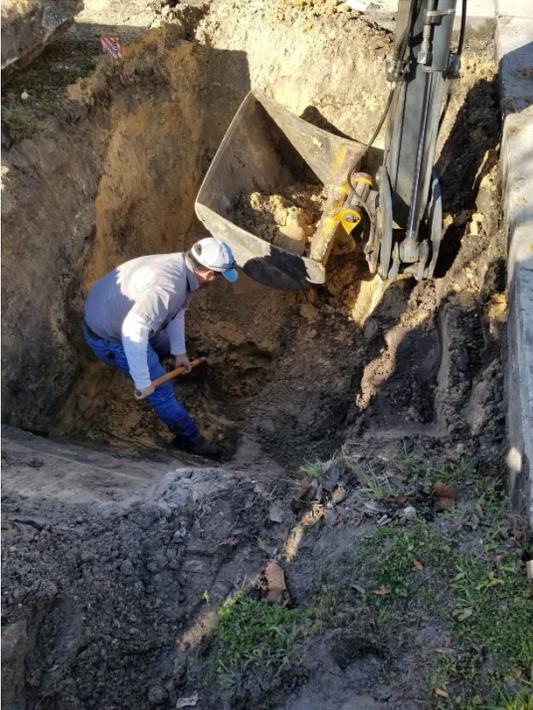
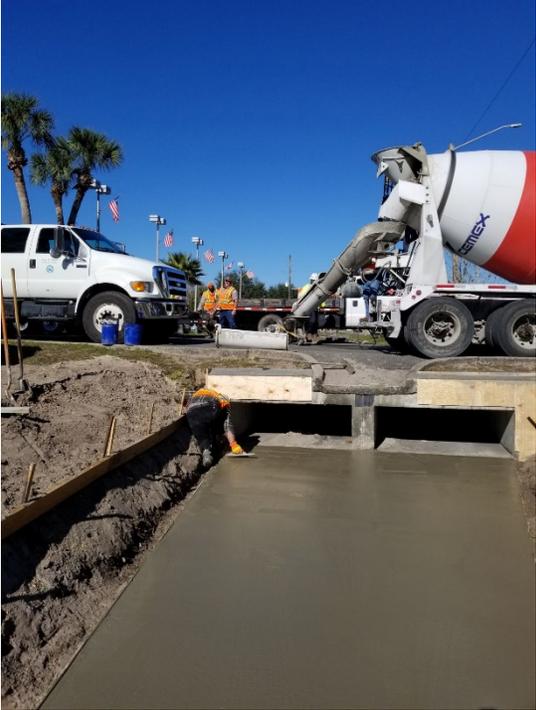
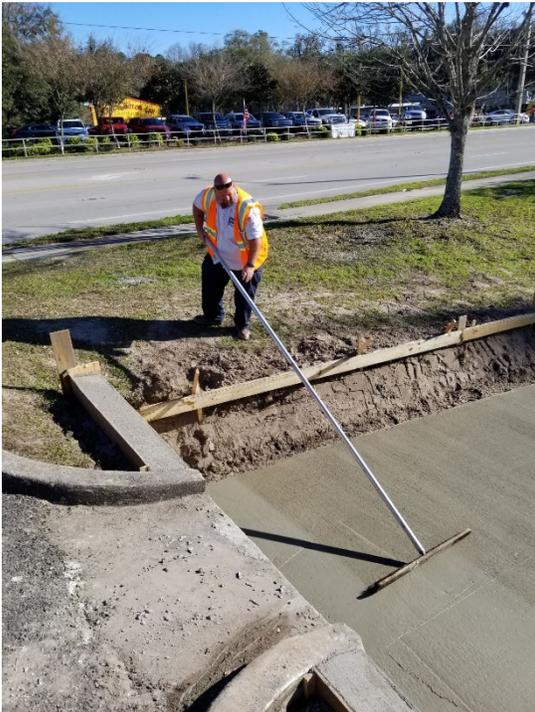
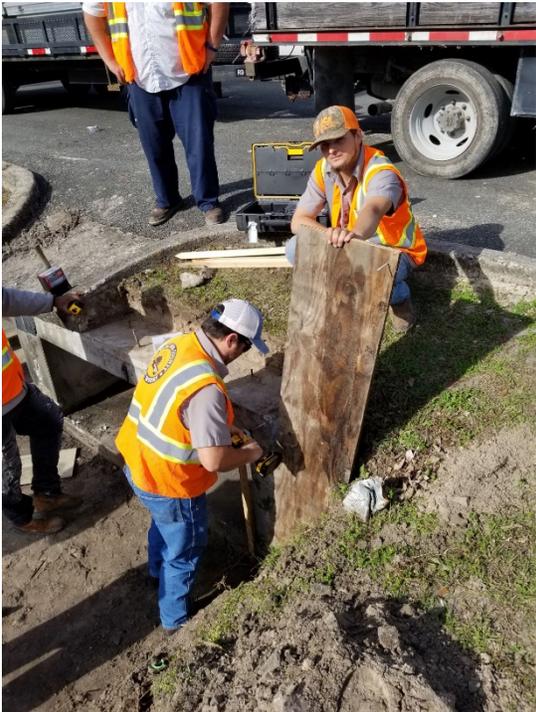
North Main Street Paved Ditch Repair

Undermining of the concrete ditch paving necessitated repairs to a portion of this drainage ditch near NW 23rd Avenue on N. Main street.

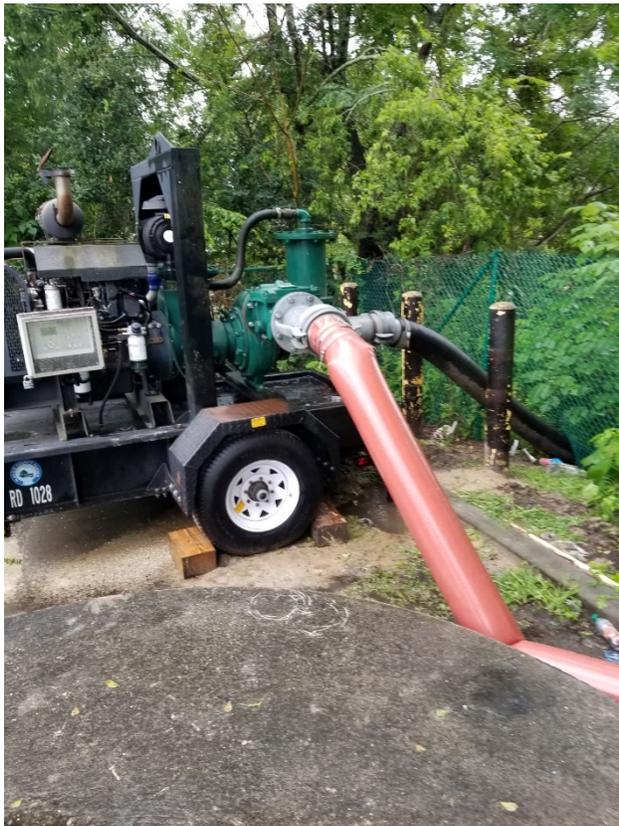
Portable pump connected to permanent piping with high pressure hose

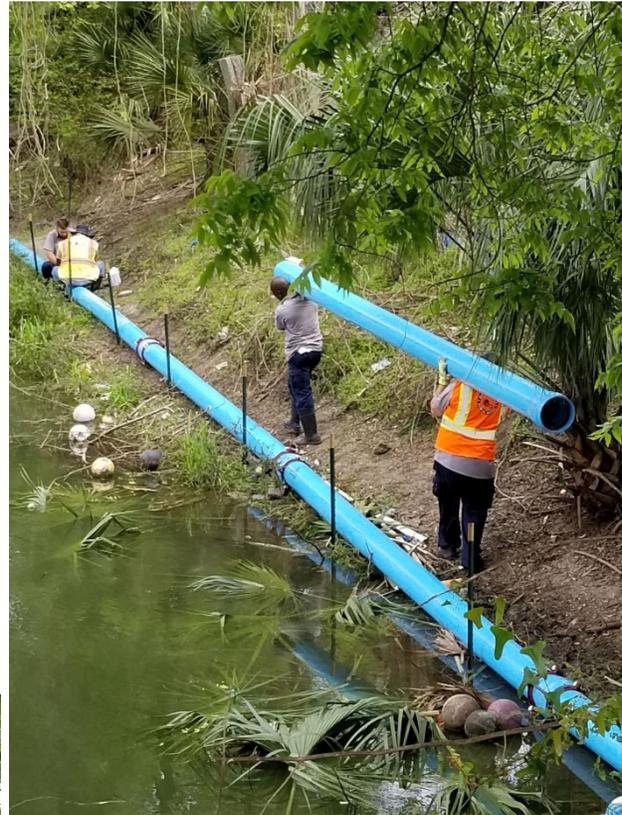
Assembling permanent piping

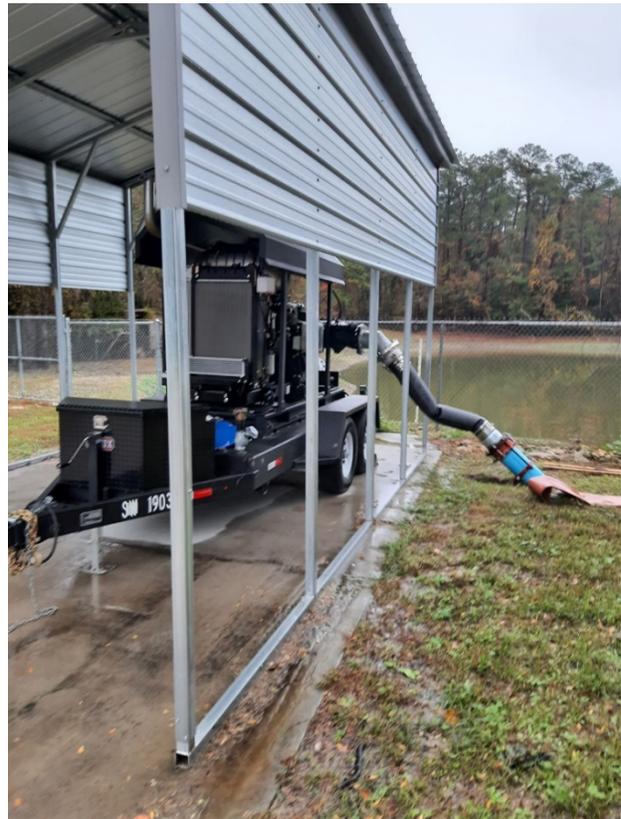
New pump primarily for Robin Lane

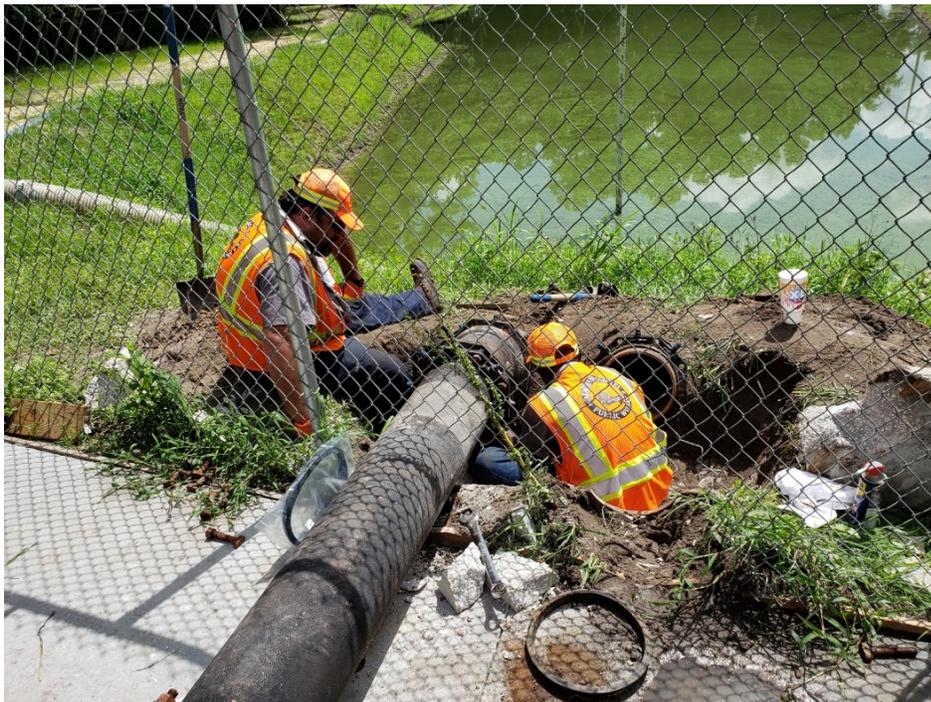
Dual intake pipes being installed

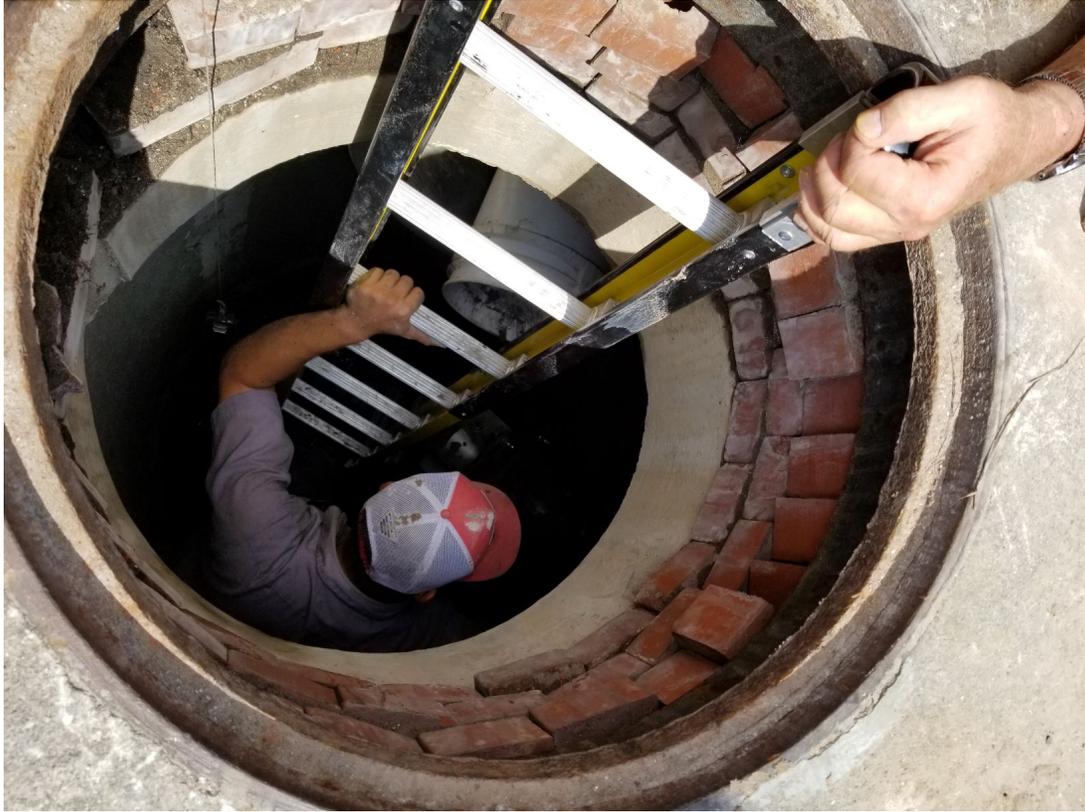
Connecting permanent piping from Robin

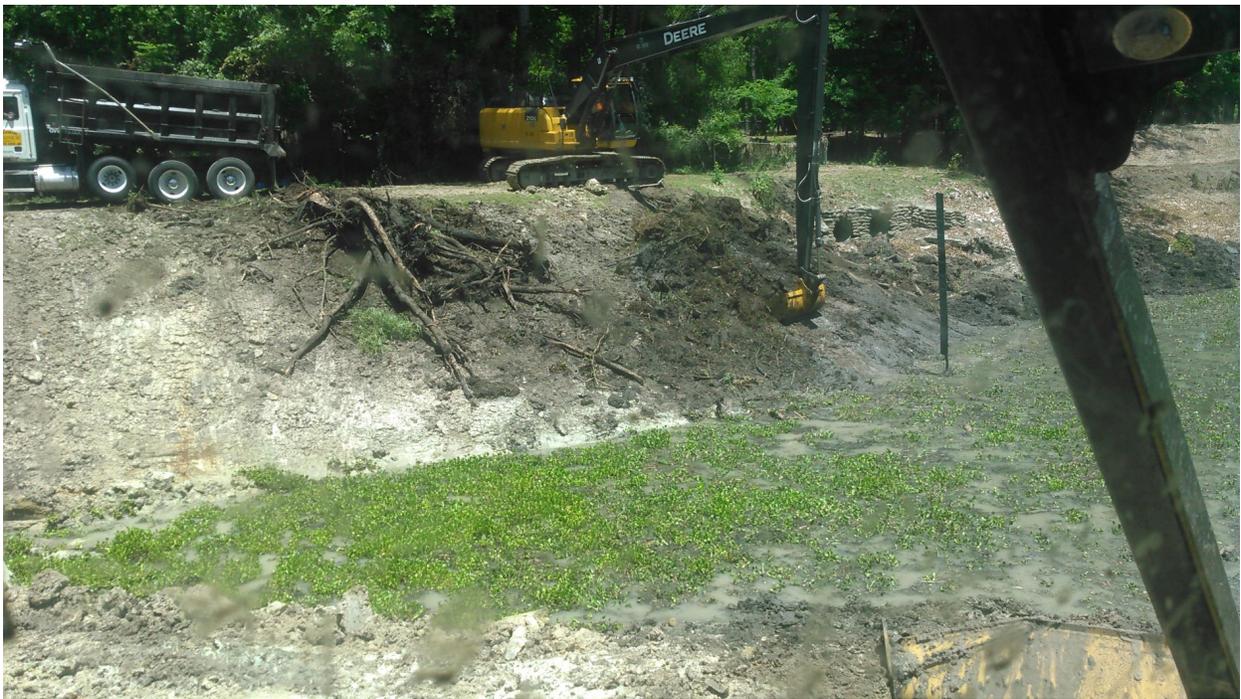
Dredging Robin Lane basin bottom

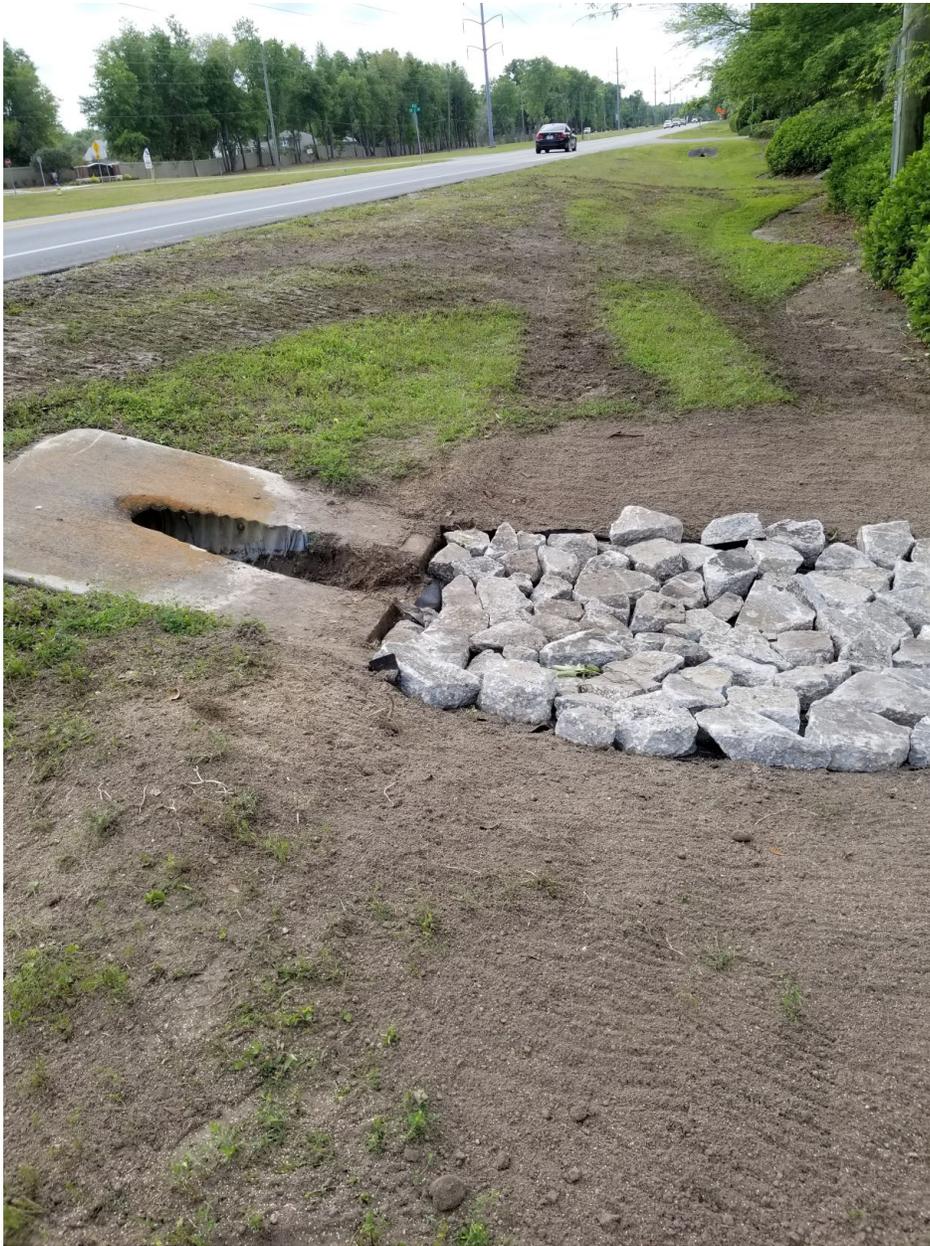
Parker Road Cross Drain Washout Repair with Rip-Rap

The flow out of this cross-drain caused erosion within the right-of-way and on the side slope of an adjacent receiving basin. Due to the severity of the erosion, rip-rap was utilized to stabilize the area rather than seeding/sodding.

Cross-drain outfall stabilization

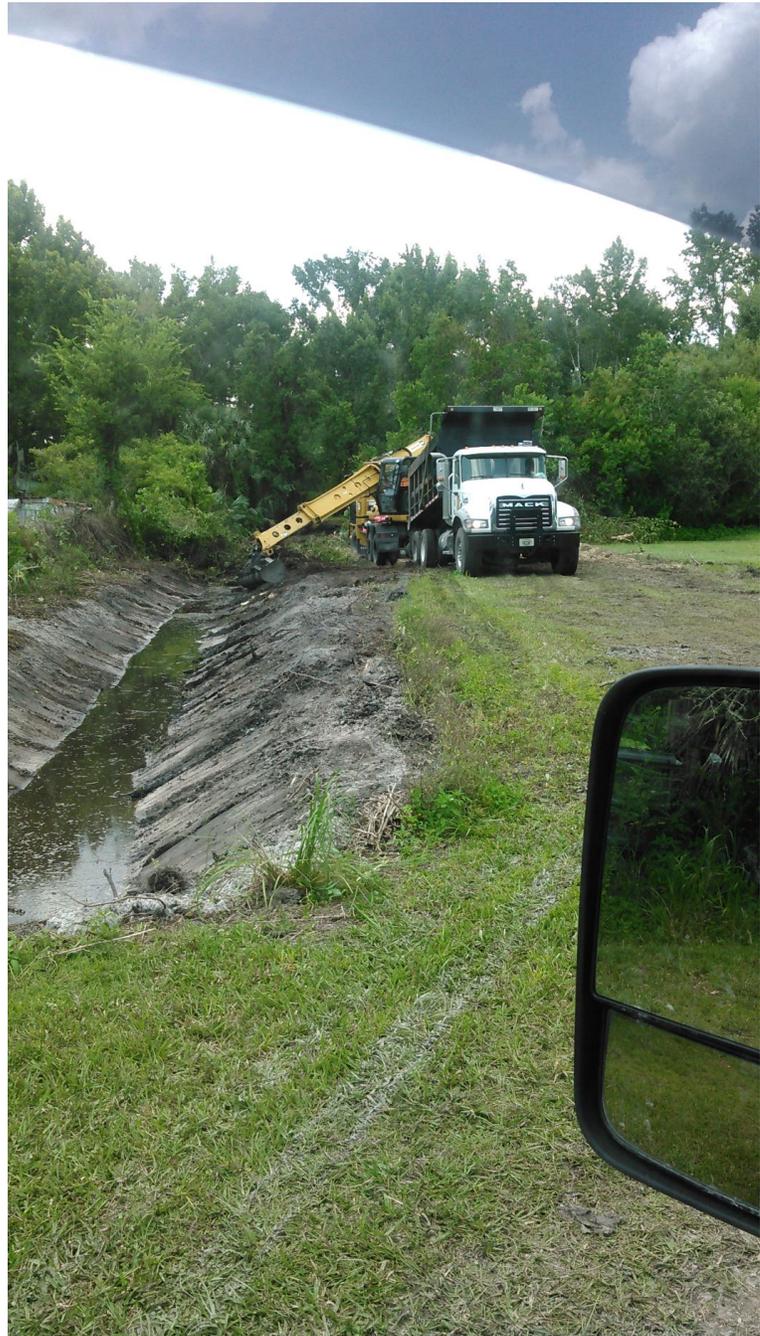
Lochloosa Ditch off US 301 Sediment and Vegetation Removal

This work is typical of work done to conveyance ditches around the County. The County has drainage easements like this that serve subdivisions and rights-of-way where routine removal of sediment and vegetation is needed to allow the movement of water.

Gradall and dump truck cleaning a ditch

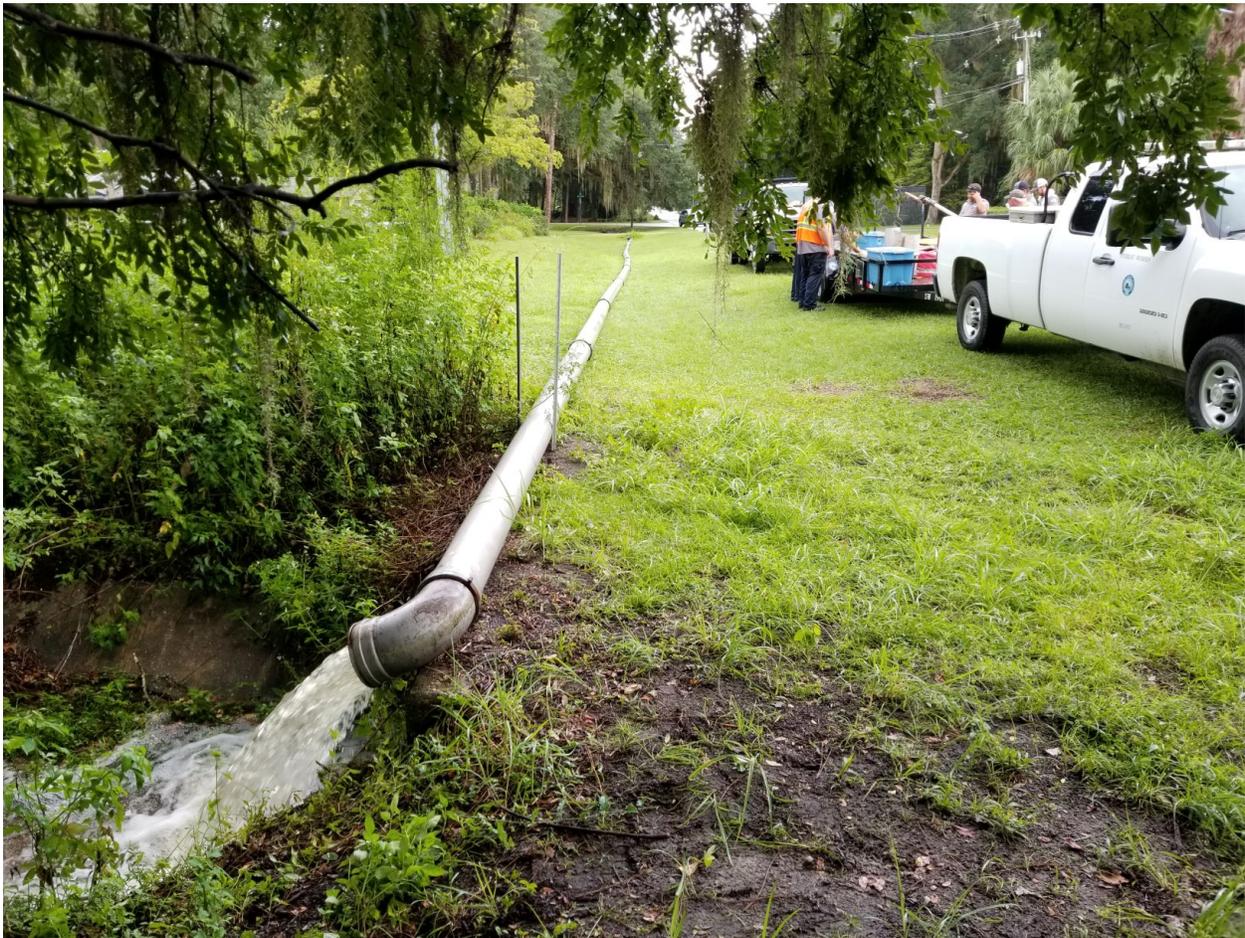
Sunningdale Basin Permanent Piping

Permanent piping was installed underground to improve the maintenance and emergency operations that have been conducted at the basin located along SW 1st Place at SW 80th Drive. The wet detention basin has no outfall and has required pumping for both maintenance and emergency purposes. The installation of the permanent piping allows these operations to be conducted much more quickly and efficiently than was previously possible utilizing hoses/pipes that had to be set up and removed for each instance.

Above ground piping used previously

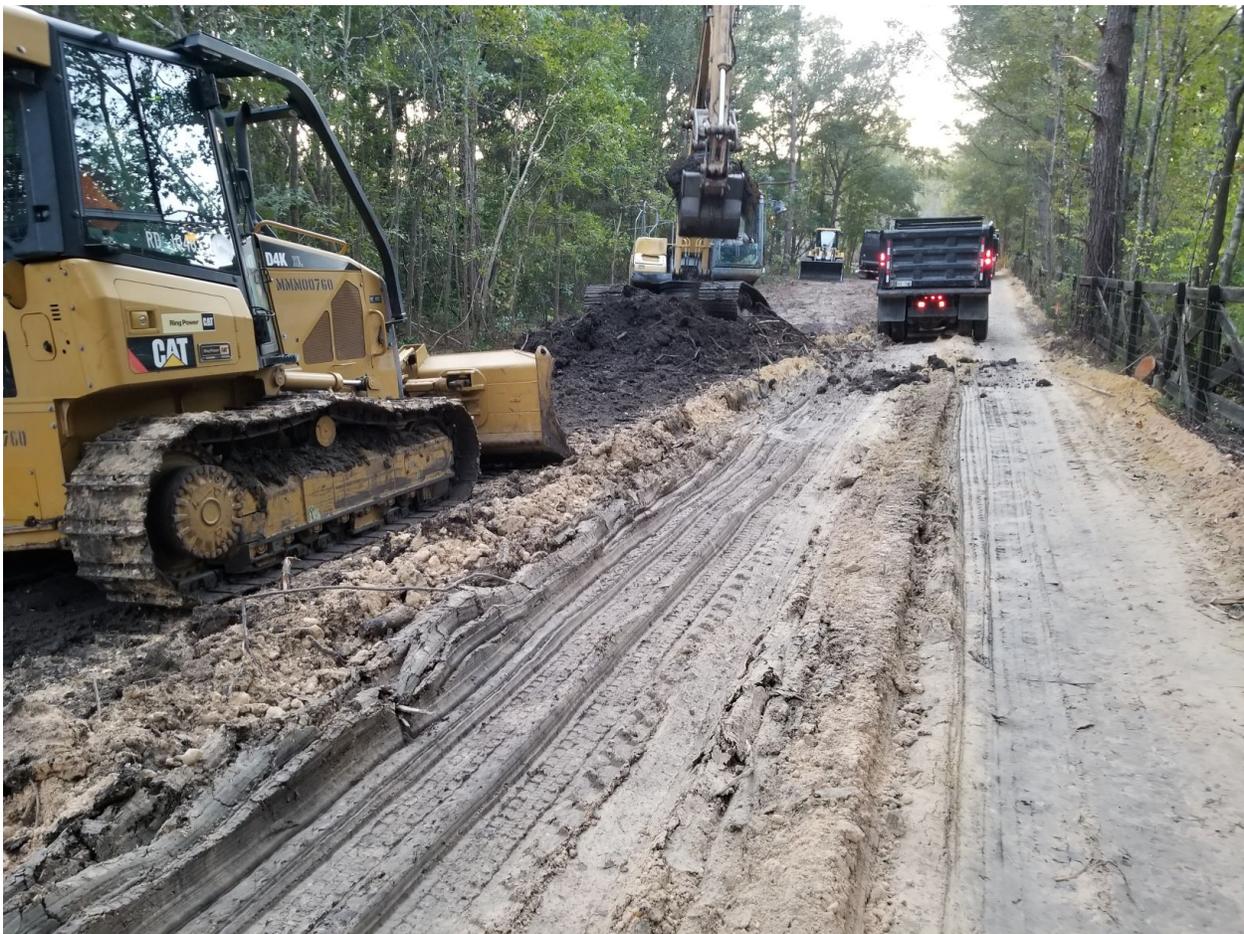
Tomoca Hills Basin Restoration

This work was undertaken to restore the stormwater basin located in a drainage easement in Tomoca Hills. Flooding occurred downstream south of 8th Avenue after Hurricane Irma and the Board directed staff to locate areas where work could be done to reduce flooding. The basin bottom was cleared and was to be planned to be leveled and have sediment removed. Work was stopped due to potential litigation but may resume depending on the outcome of discussion with the property owners or there representative.

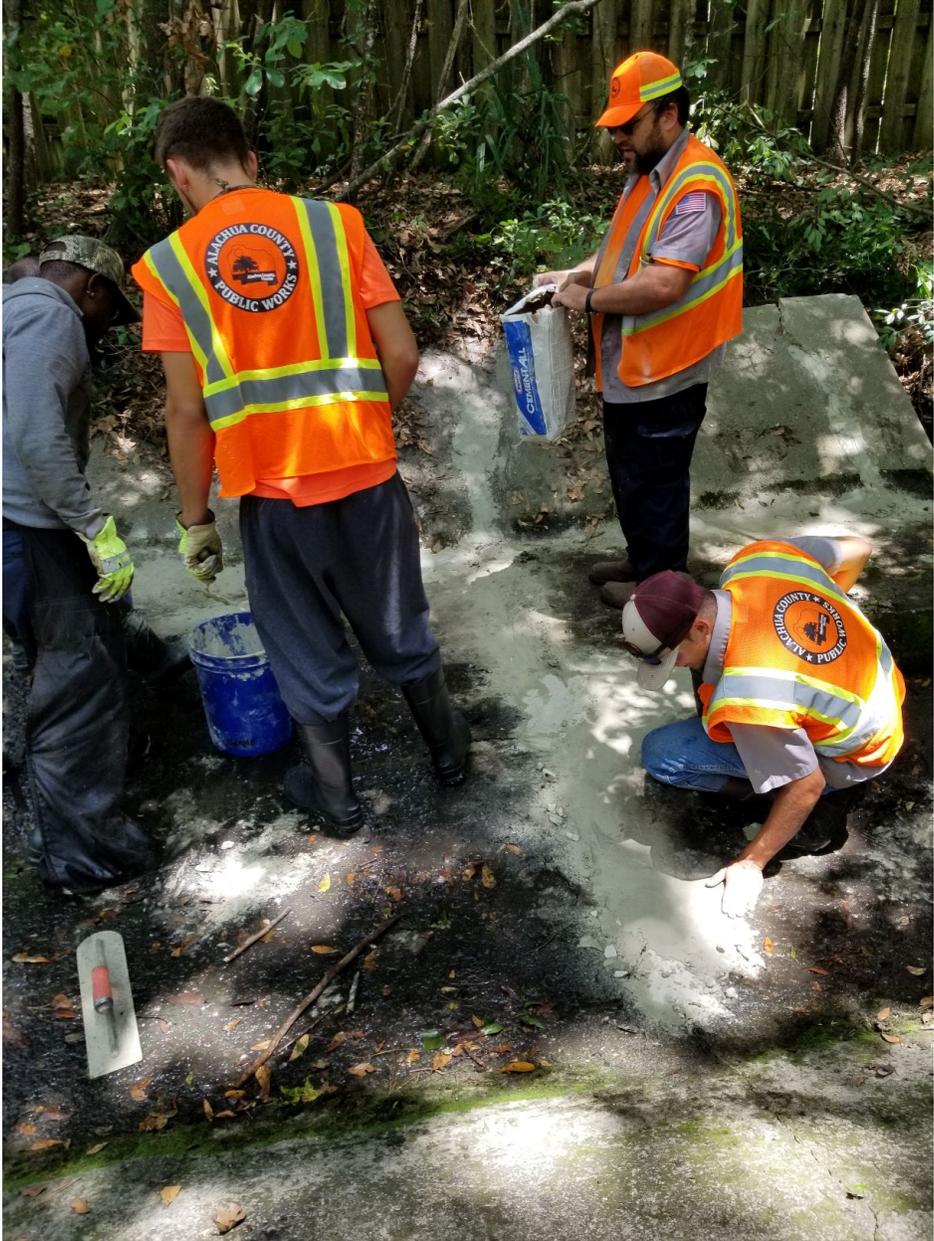
NW 41st Street Drainage Cement Spillway Repair

A concrete lined spillway associated with the NW 16th Blvd drainage system needed repairs due to erosion. The crew worked to repair eroded portions of the spillway and so seal cracks to prevent further deterioration.
