ALACHUA COUNTY PUBLIC WORKS 2020 STORMWATER

Contents

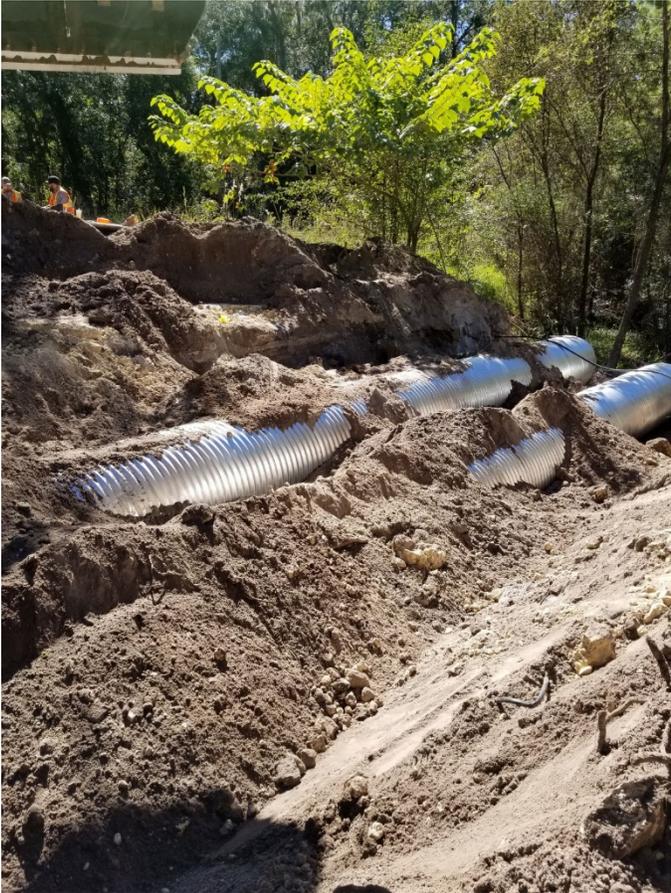
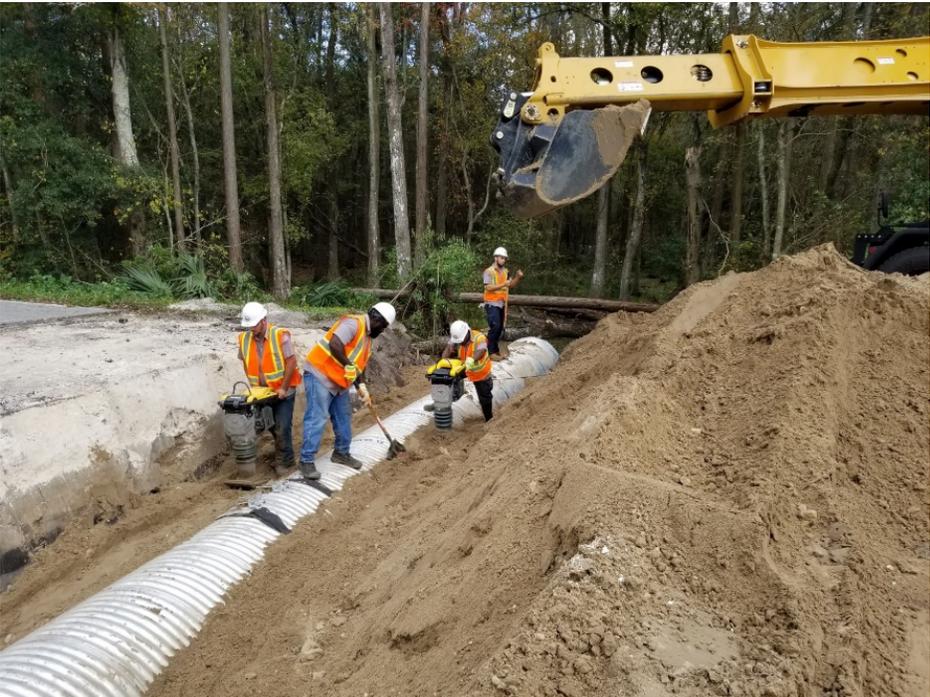
NW 59th Drive Cross Culverts Replacement

The existing pipes under NW 59th Drive were failing due to age of the materials. The two-lane roadway was temporarily closed in order to remove and replace the pipes and restore the roadway.

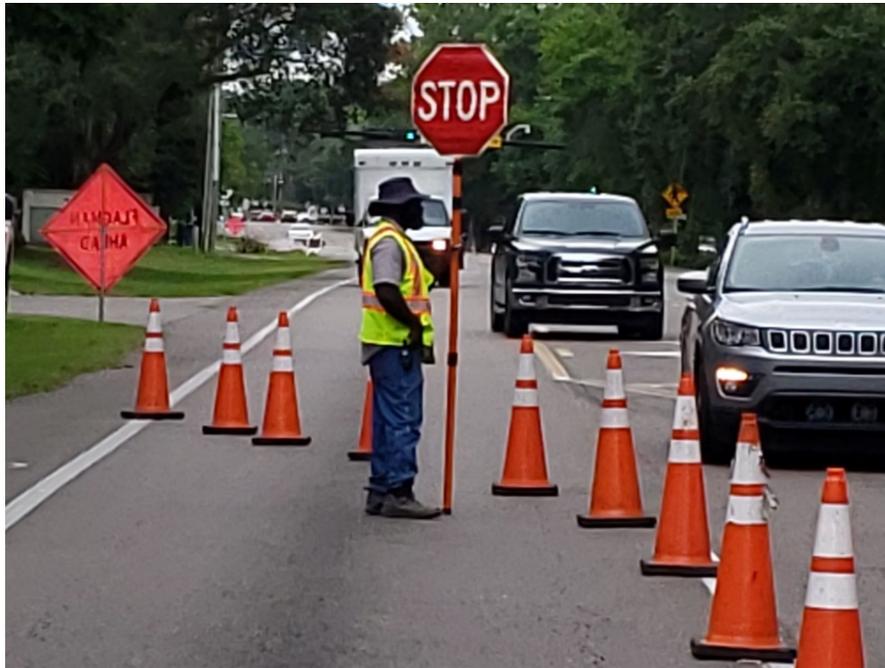
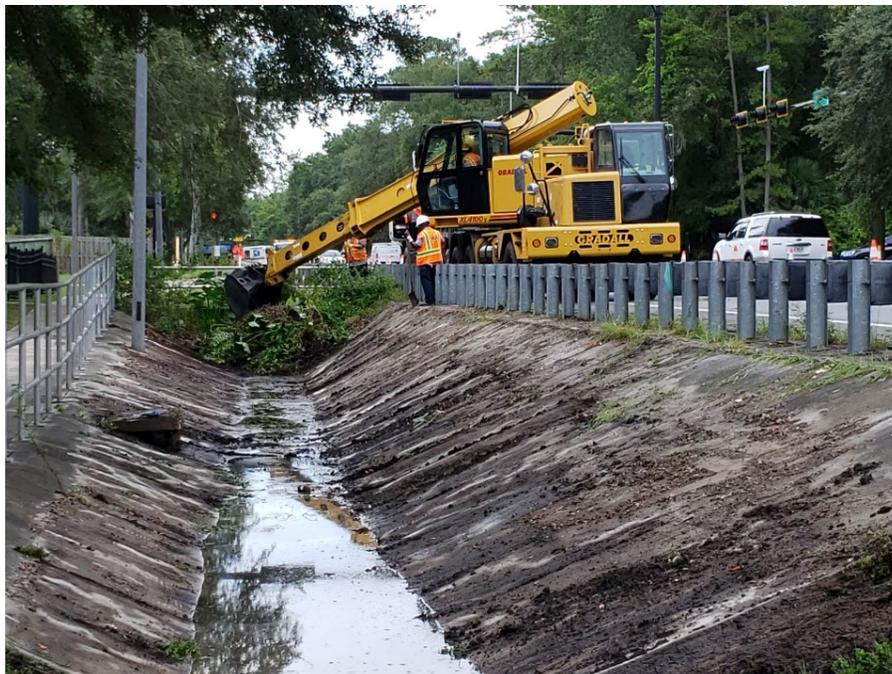
SW 20th Avenue Traffic Control and Sediment Removal

Crews worked to remove sediment and vegetation from the concrete ditch located on SW 20th Avenue at SW 38th Terrace. This type of work requires crews to implement a maintenance of traffic plan that complies with FDOT standards. It is critical that the standards are followed to provide safety for the public and for the workers.

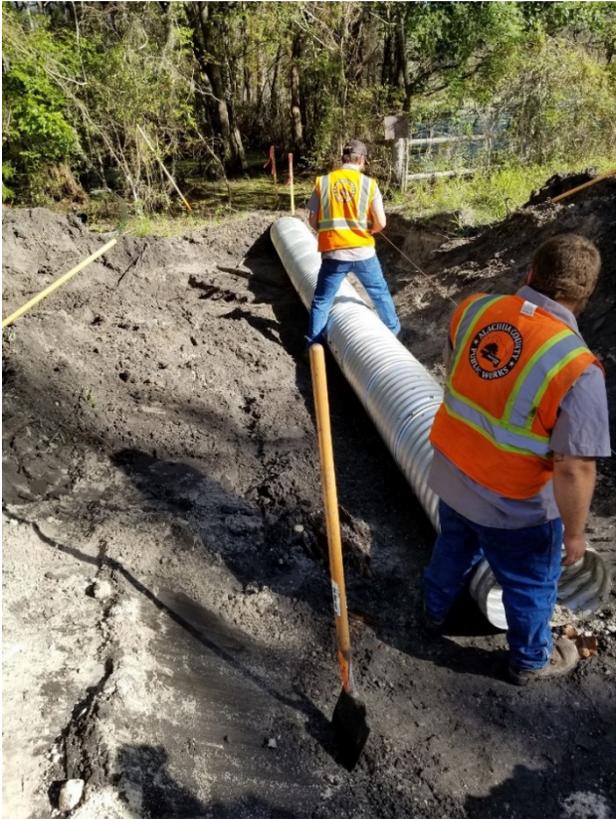
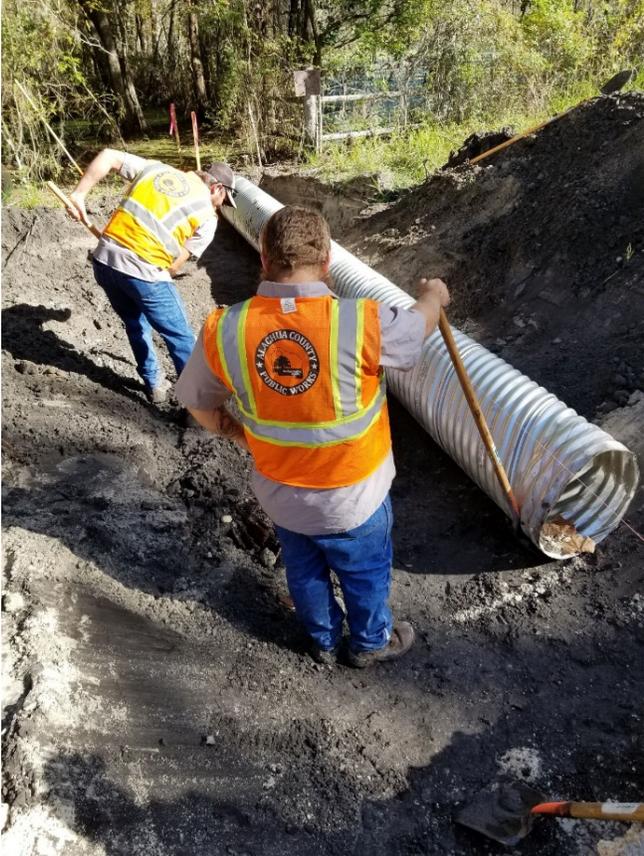
NE 73rd Avenue Cross Culvert Installation

This pipe was installed to restore drainage across NE 73rd Avenue along CR 225 (Race Track Road). Prior to the work runoff from CR 225 and adjacent lands was flowing over NE 73rd Avenue, no existing pipe could be located and engineering staff worked with field crews to determine the best location for constructability and to avoid existing utilities.

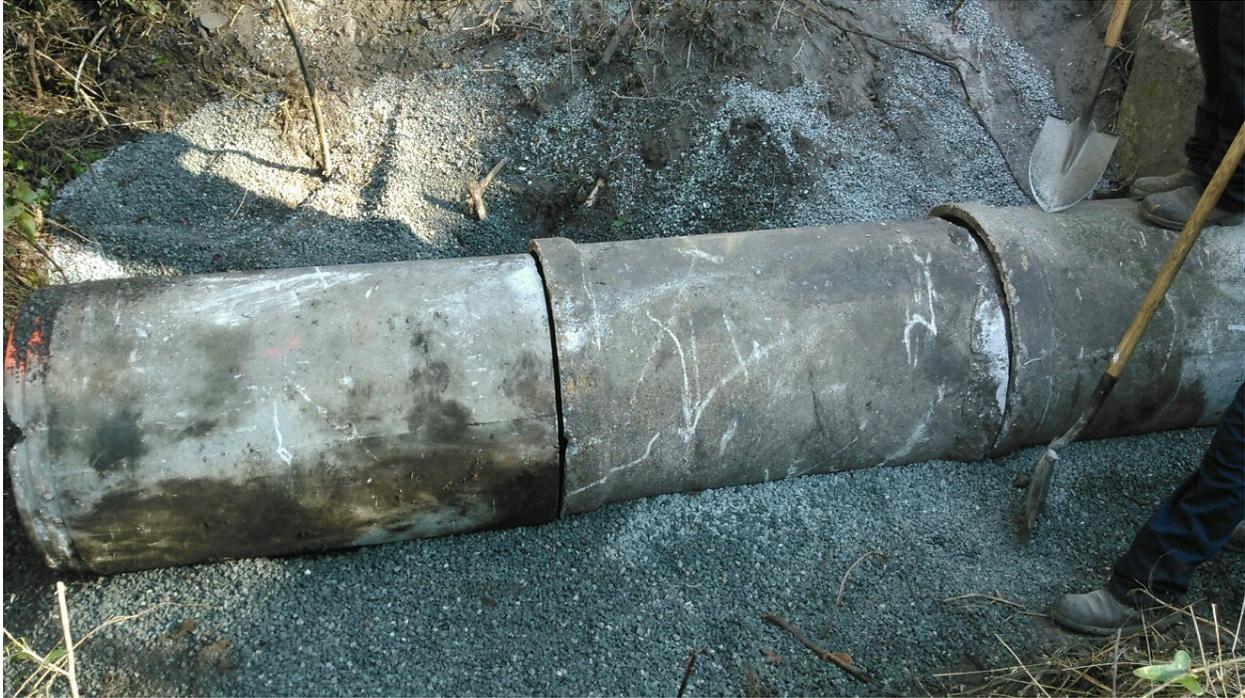
NE CR 231 Concrete Cross Culvert Repair

This roadway was constructed by FDOT and was later given to the County. Erosion around a pipe headwall resulted in a dangerous drop-off along the roadway. Crews extended the cross-drain to allow for a flatter slope which will be less prone to erosion in the future.

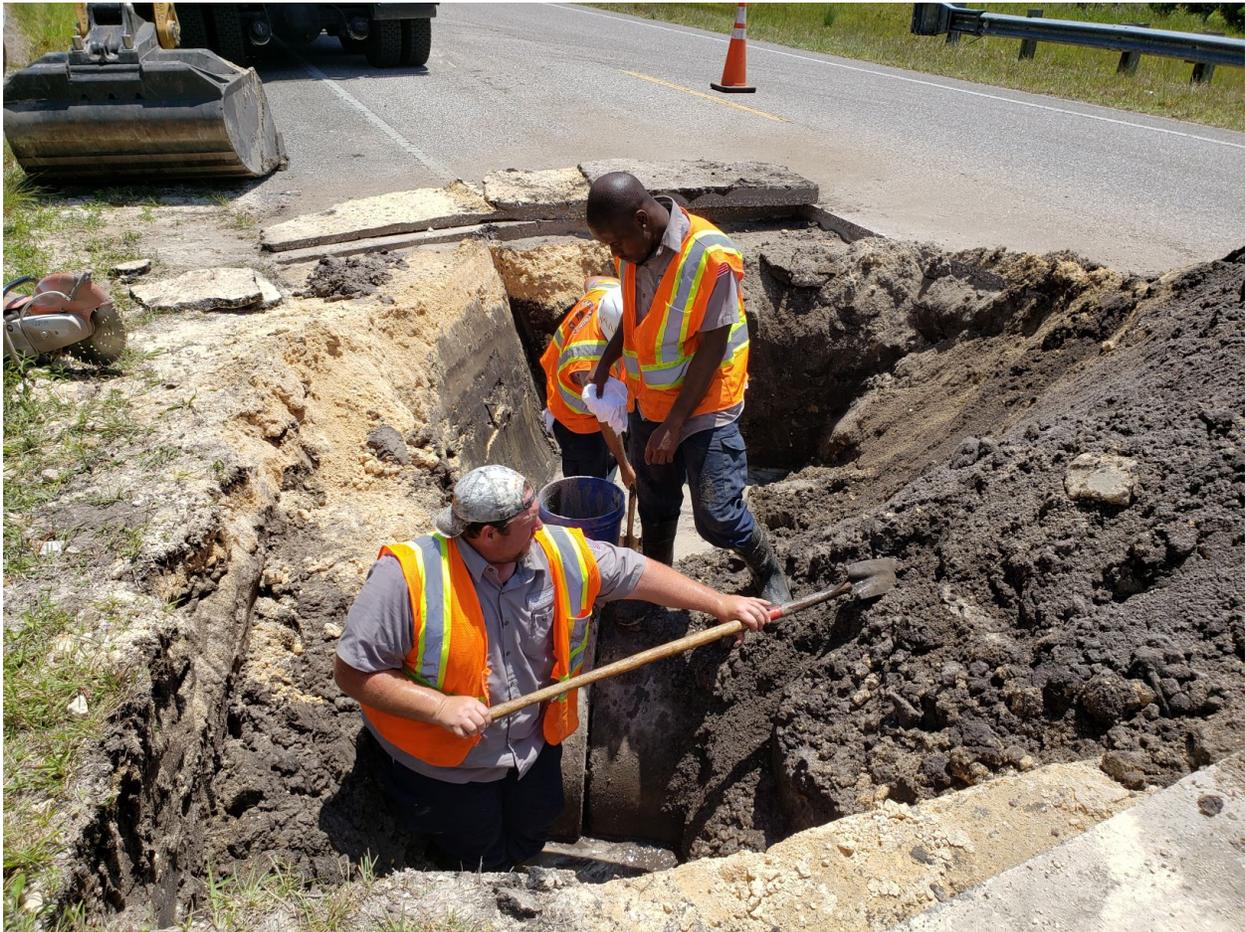
E CR 225 Concrete Culvert Repair

Like many County roadways, this road was turned over to the County by FDOT. The work at this location the concrete pipe under the roadway had an opening in a joint which allowed soil to migrate into the pipe and ultimately led to a collapse in the roadway surface. The stormwater crew uncovered the pipe and repaired the joint before restoring the roadway.

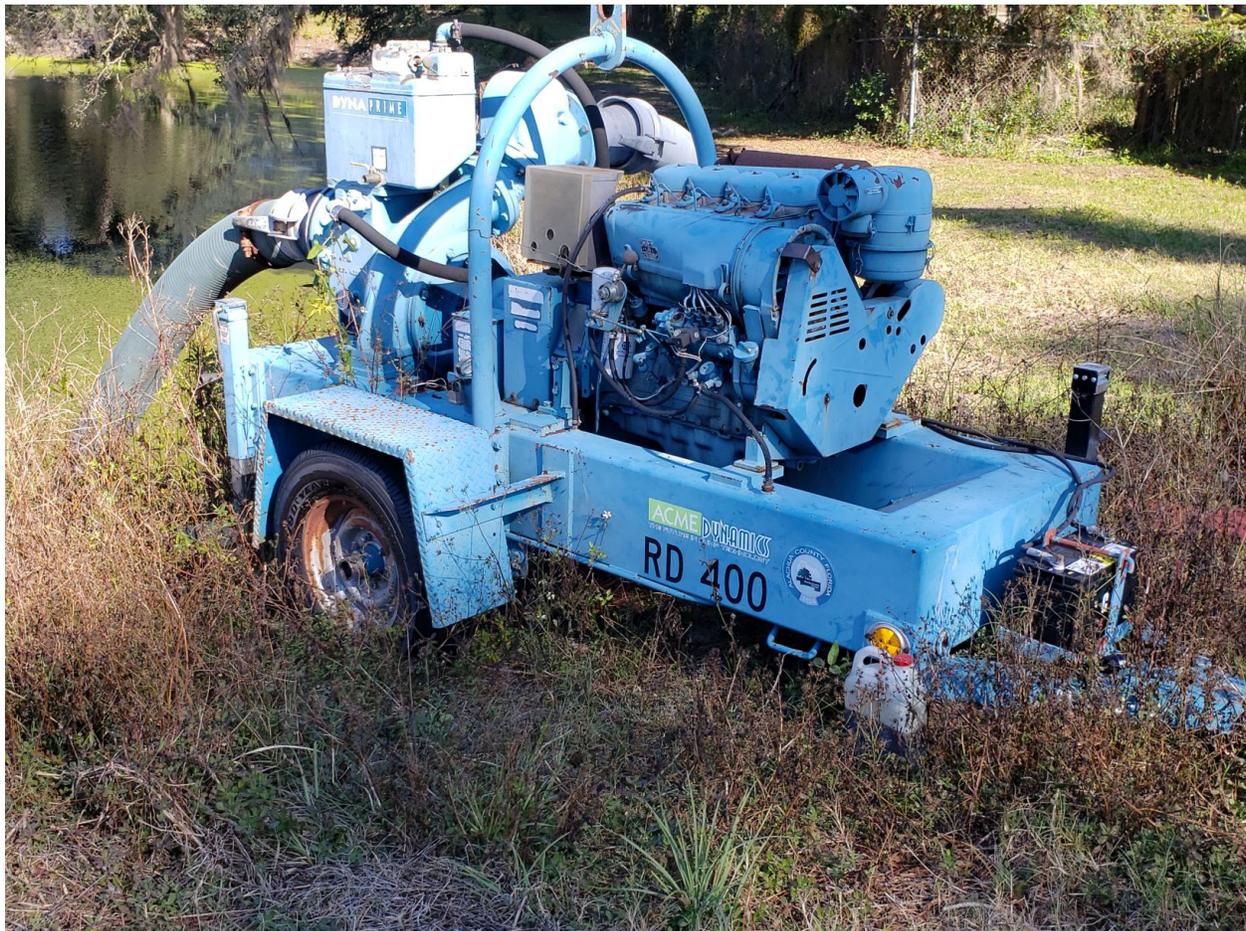
SE 35th Street Basin Permanent Piping

Permanent piping was installed to assist in the maintenance operations conducted on a basin located at SE 35th Street and SE 17th Avenue. Previous pumping operations interfered with the citizens access to their homes due to the layout of discharge hose. Underground piping was installed to eliminate conflicts with the citizens and greatly reduces staff time to conduct pumping. In the past many hours and days were spent repairing leaks in the hose due to damage from vehicles.

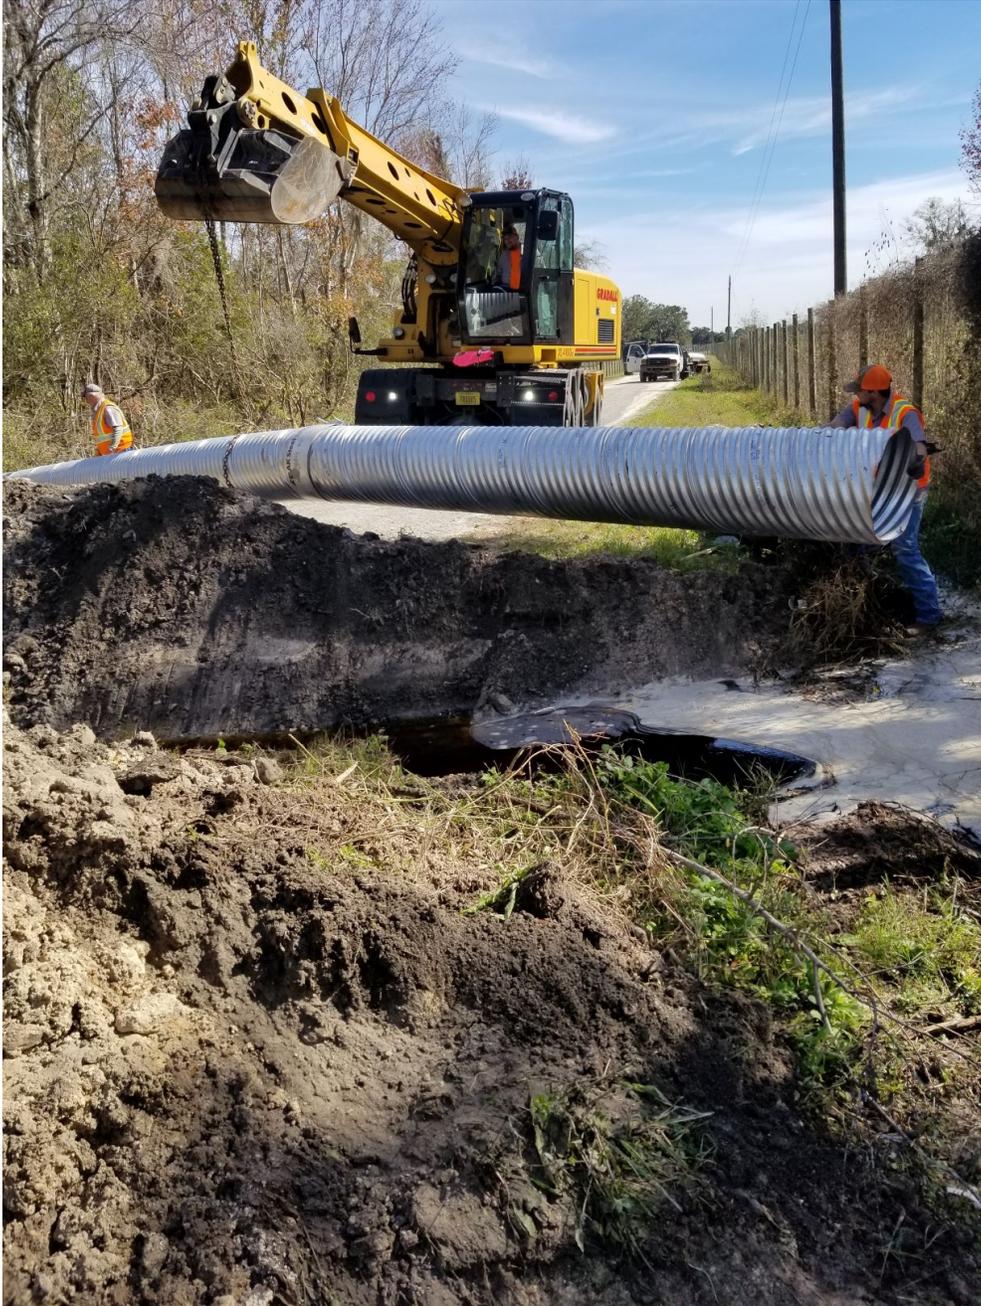
SE 177th Avenue Culvert Replaced

Aging culverts being replaced by the stormwater crew.

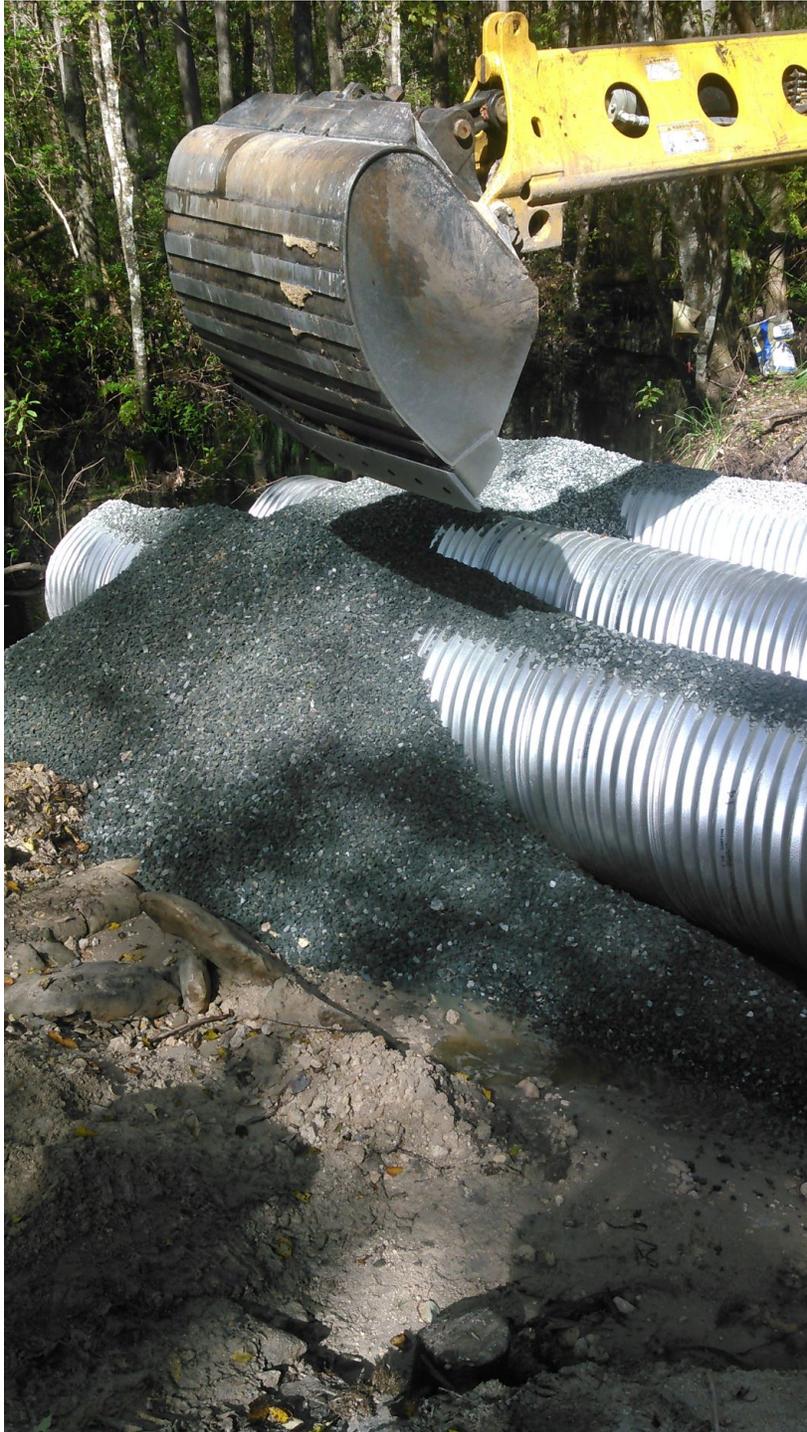
SE 225th Drive Three Culvert Replacement

Aging culverts being replaced by the stormwater crew.

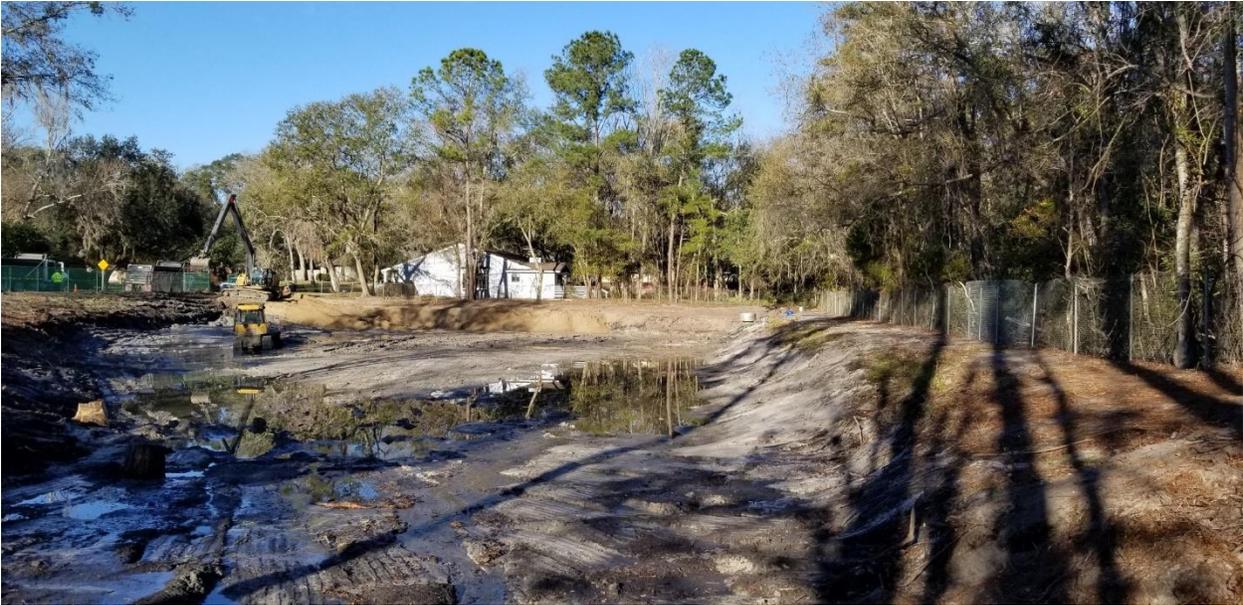
Deer Creek Basin Maintenance

Crews removed organic debris and vegetation that had completely filled the basin and diminished its capacity.

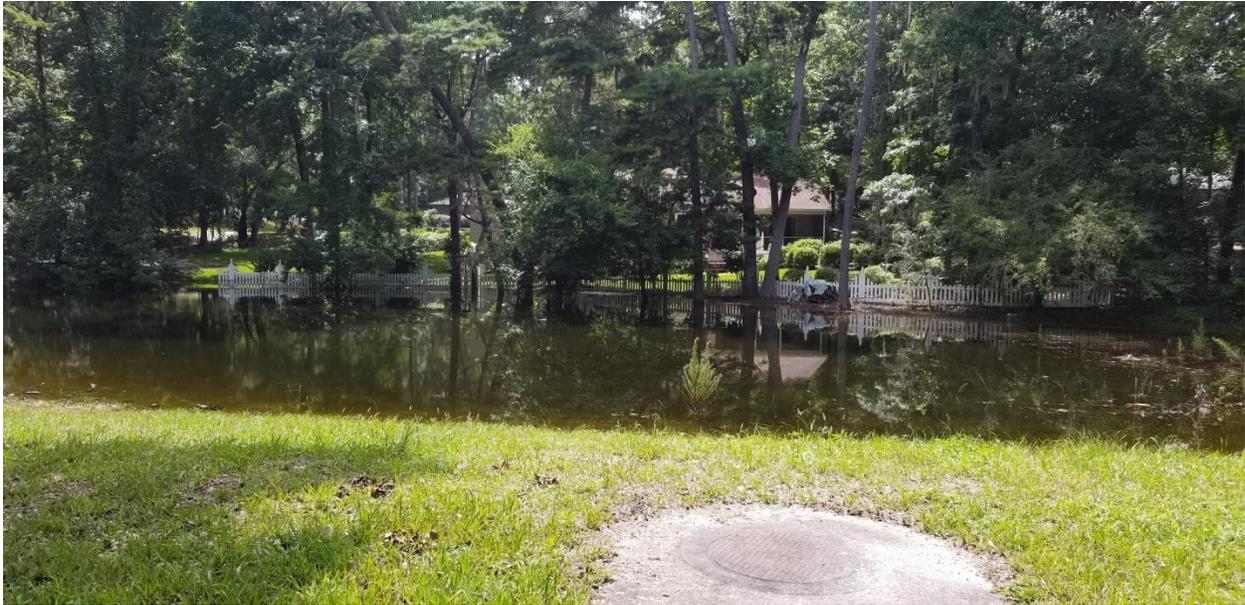
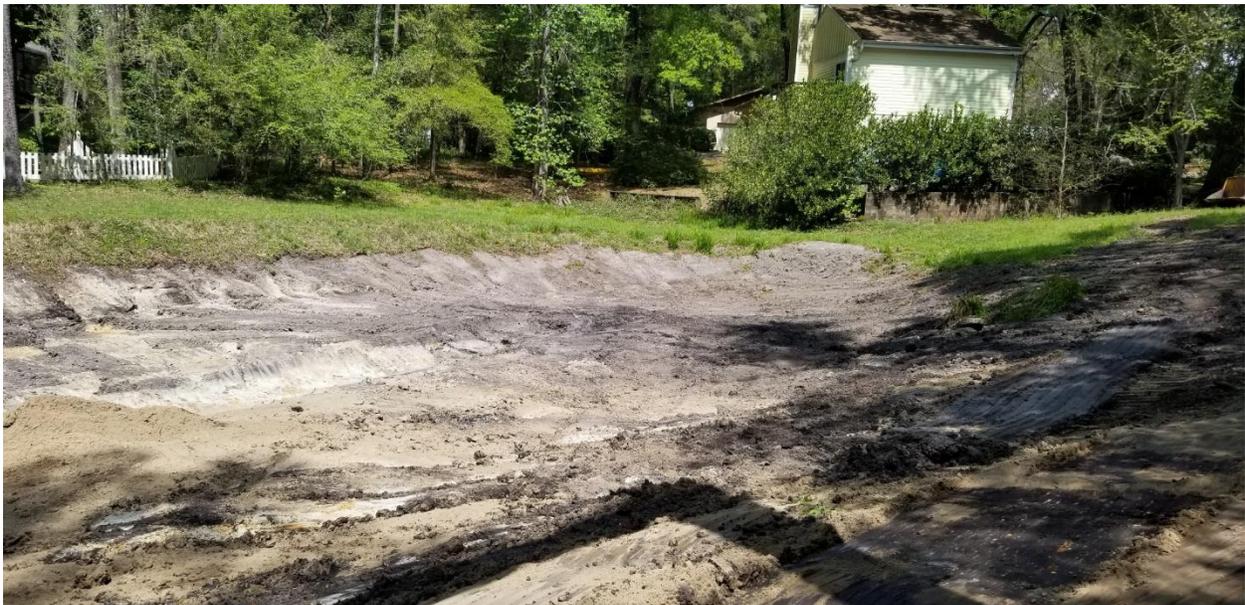
Emerald Woods Basin Maintenance

Crews removed organic and clay layer from basin bottom and replaced said material with clean sand to allow infiltration through existing areas of sandy bottom.

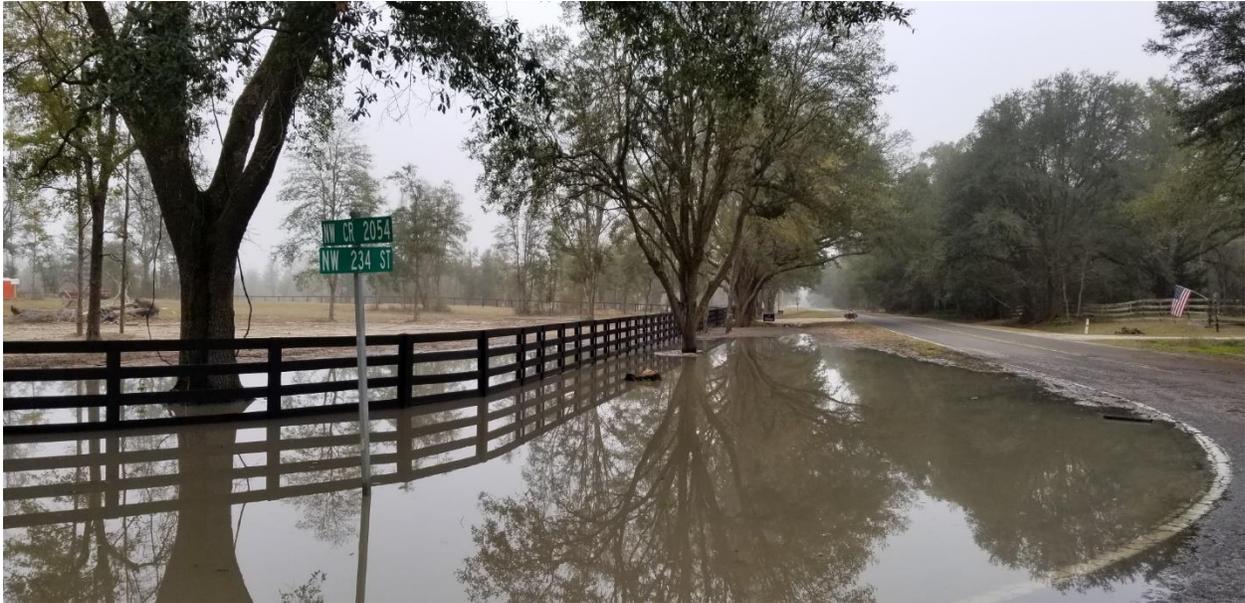
CR2054/NW 234 Street Intersection Drainage Improvements

Modify the roadside swale to convey runoff from the intersection back onto adjacent development, with the Developer's cooperation.
