4.1 Introduction

4.2 Watershed Description

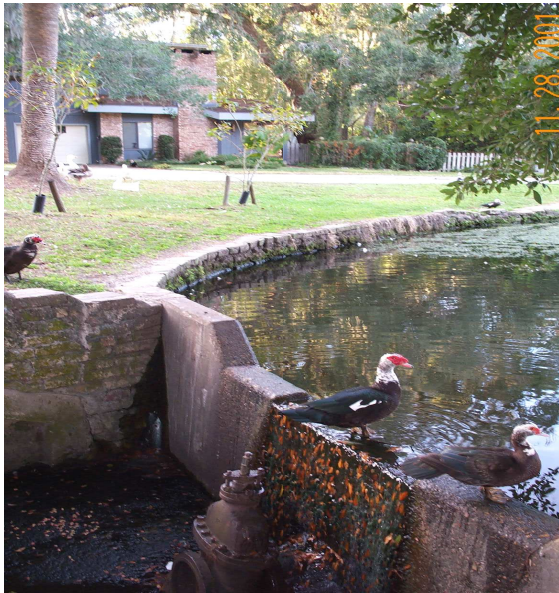
Muscovy ducks on Sweetwater Branch at the Duck Pond weir at SE 5th Avenue (before recent restoration)

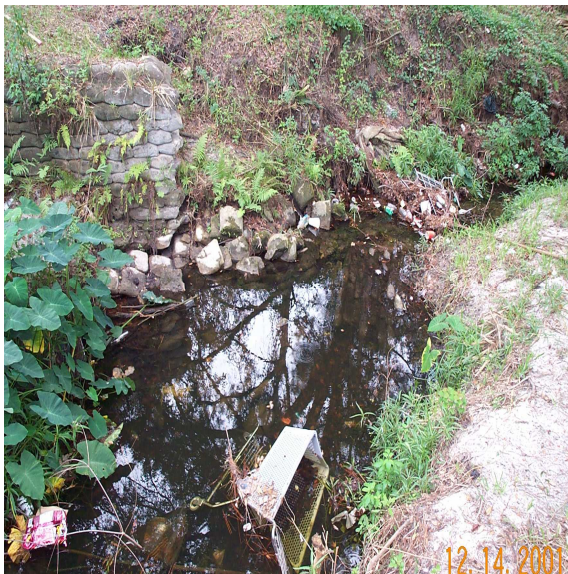
Rosewood Branch running through a residential area along NE 11th Street

vert at NE 3rd Avenue, banks are moderately unstable due to erosion, and the streambed is covered with sand.

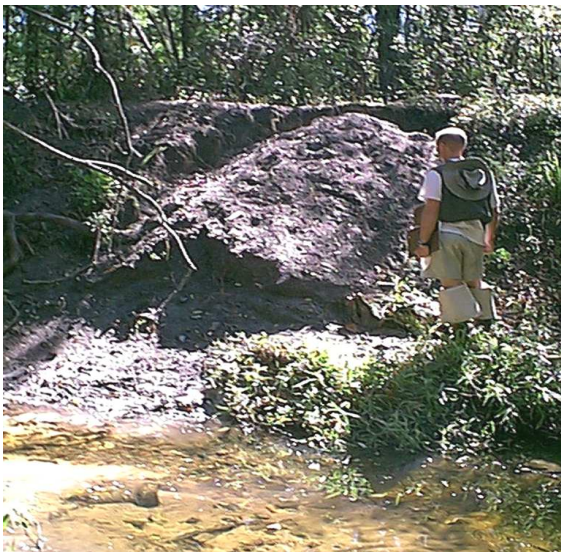
This segment of stream is characterized by severe bank failure in places and a streambed littered with debris from an old

landfill site located in the vicinity of SE 9th Street and SE 9th Avenue. Trenches and pits along the riparian zone indicate bottle looter activity. At several places along this segment, a natural vegetative buffer is absent. Rosewood Branch joins Sweetwater Branch in this area.

Former landfill site at the confluence of Rosewood Branch and Sweetwater Branch

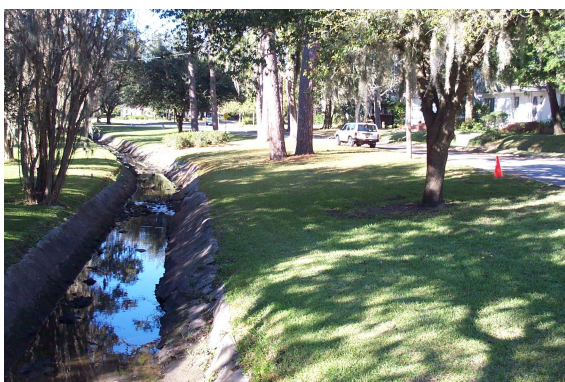
Urban area north of the Duck Pond weir on Sweetwater Branch

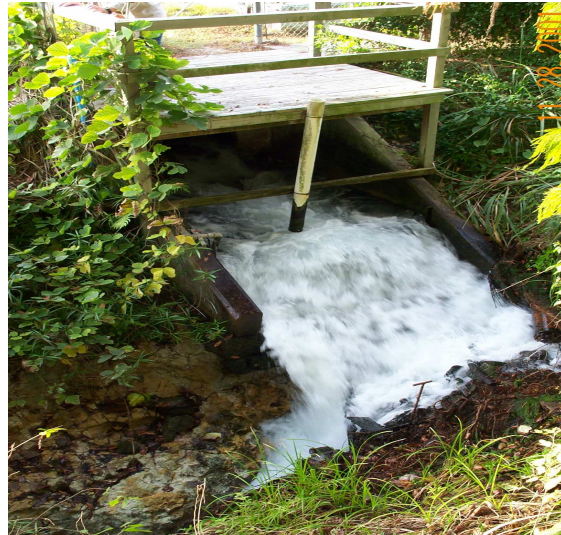
Discharge from the GRU Main Street WRF into Sweetwater Branch

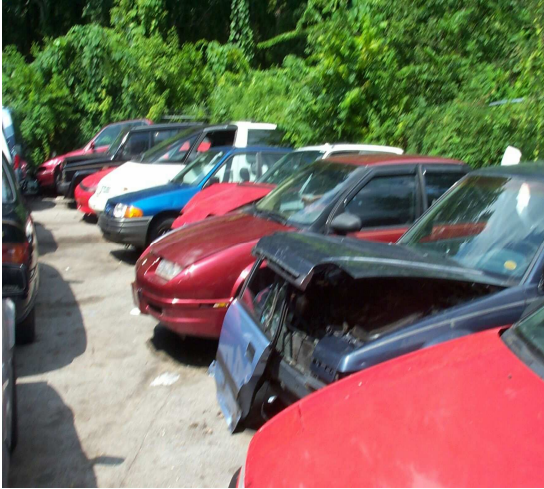
Auto storage and repair shop adjacent to Sweetwater Branch

Sweetwater Branch. Machine and auto repair shops are common throughout the watershed and several are located adjacent to the stream channel. Many of these businesses repair and store machine parts on unsheltered, impervious areas that are stained with paint, oil, and grease. Without adequate riparian buffers in these areas, concerns arise with regard to potential leaks or spills of hazardous materials such as fuel, oil, and antifreeze that could enter the creek.

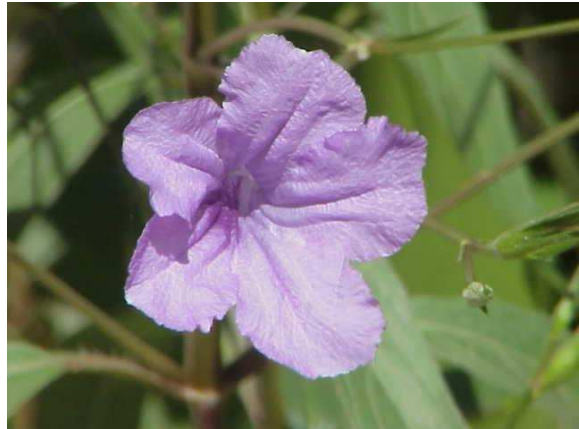
Mexican Petunia (*Ruellia brittoniana*). An exotic and highly invasive plant found along Sweetwater Branch

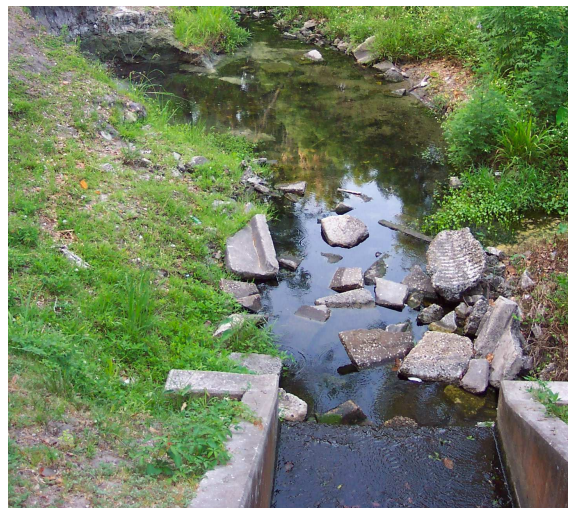
Sweetwater Branch at a culvert at SE 3rd

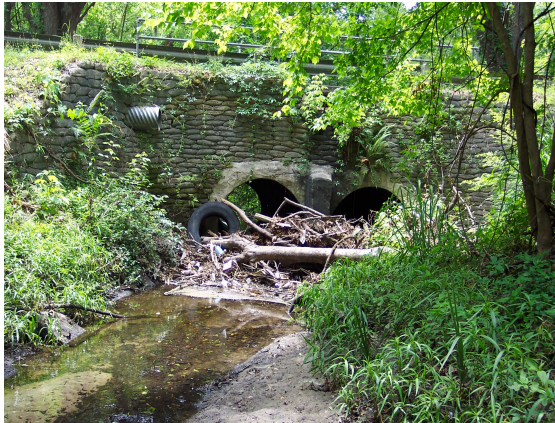
Sweetwater Branch at SE 4th Street.

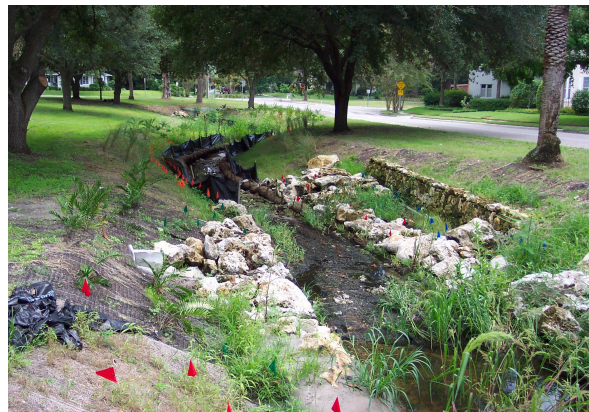
Restoration area on Sweetwater Branch upstream of the Duck Pond
