# Bivens Arm

## Fact Sheet

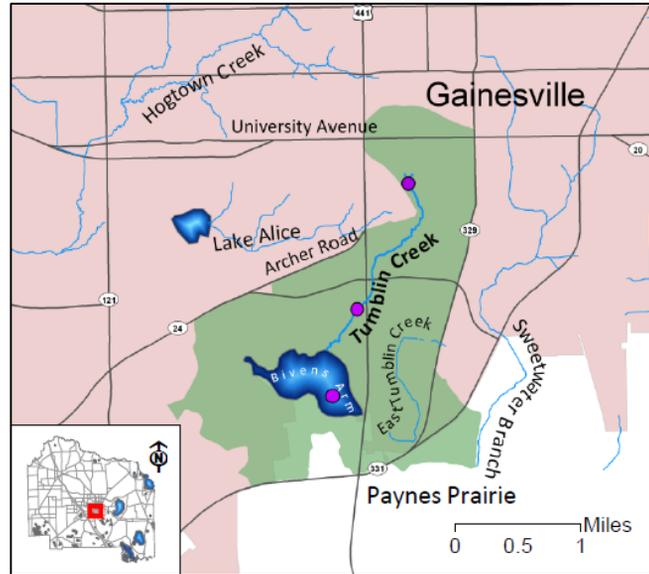
Map of Bivens Arm watershed (green).

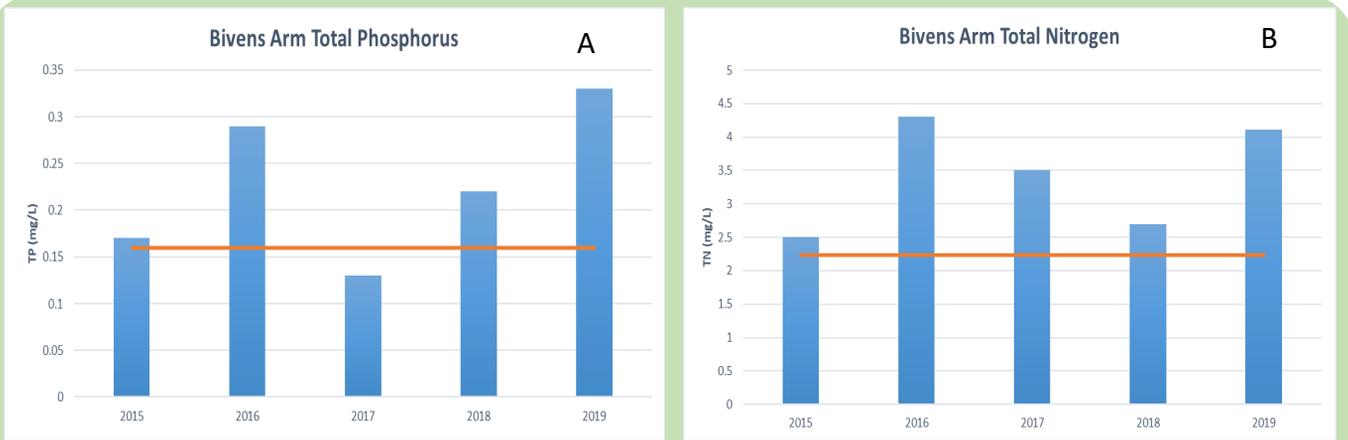
Figure 1. Annual geometric mean of A) total phosphorus (TP) and B) total nitrogen (TN). Numeric Nutrient Criteria (NNC) for each analyte denoted by orange line.

**Nutrients:** The current FDEP water quality rule on nutrient standards went into effect February 2016. A potential phosphorus source is the erosion of phosphorus rich soils that compose the Hawthorn clays which underlie some of the stream beds in the watershed. Nitrogen is likely entering the lake through surrounding septic systems of private residences. The major source of pollutants is most likely from Tumblin Creek, a basin composed of 60% impervious surfaces, which contributes stormwater and other urban products from southern Gainesville into Bivens Arm.

Algal abundance is commonly measured in the amount of chlorophyll- $\alpha$  in water. The high nutrient concentrations have led to the elevated chlorophyll- $\alpha$  concentrations. The chlorophyll- $\alpha$  patterns closely reflect the TN results shown in Figure 1B. Rainfall also influences the chlorophyll- $\alpha$  abundance.

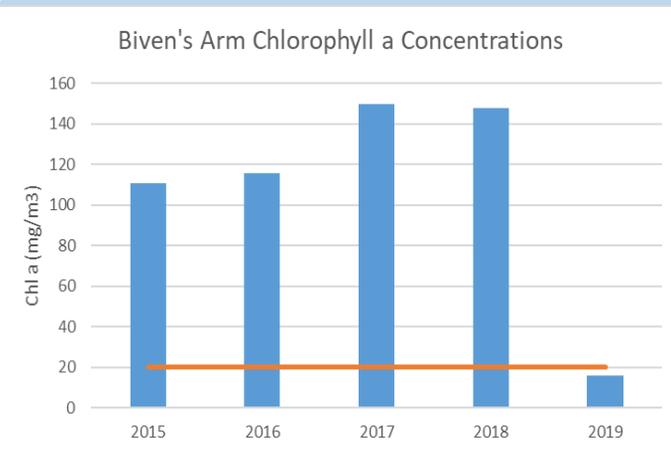
Figure 2. Annual geometric mean of Chlorophyll- $\alpha$  (corrected).
