Blues Creek Fact Sheet

The Watershed

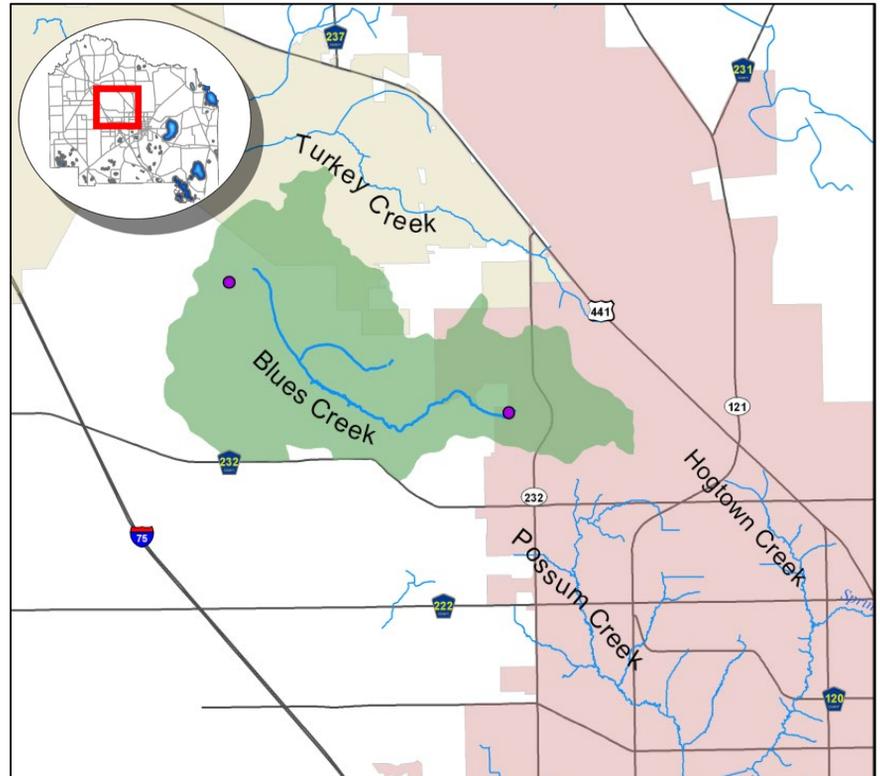
Map of Blues Creek watershed (green) with sampling sites (purple circles).

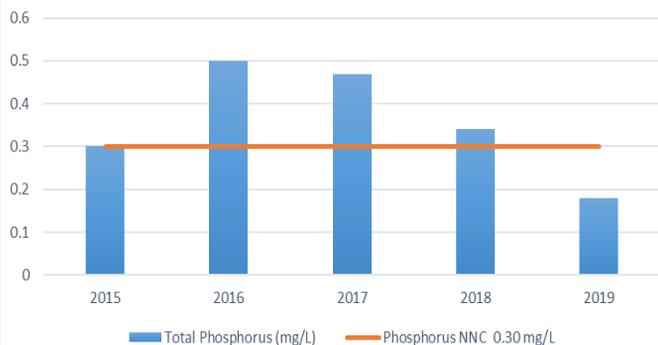
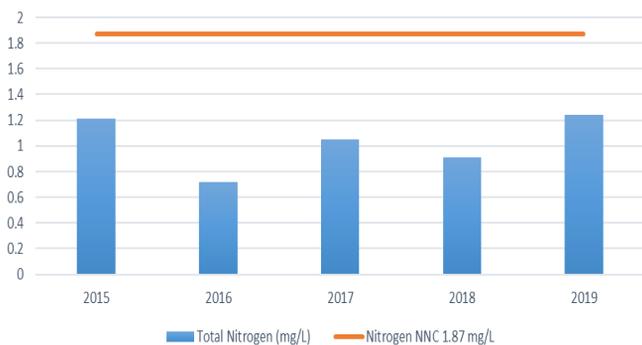
Blues Creek Total Phosphorus A

Figure 1. Annual geometric mean of A) total phosphorus (TP) and B) total nitrogen (TN) with NNC denoted by orange line.

Nutrients: The current FDEP water quality rule on nutrient standards went into effect February 2016. As a result, Blues Creek has been above the Numeric Nutrient Criteria (NNC) threshold for total phosphorus (TP) and not for total nitrogen (TN). Potential phosphorus sources are the erosion of phosphorus rich soils that compose the Hawthorn clays which underlay the stream bed, and agricultural inputs of fertilizer and manure. It does not appear that the elevated TP concentrations are influencing the stream biota. If another SCI results in a “healthy” score, this stream will be meeting the NNC.

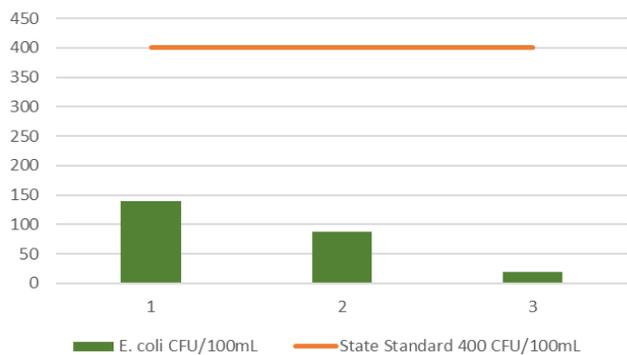
Blues Creek *E. coli* Concentration

Figure 2. Annual geometric mean fecal coliform colony forming units (CFU)/100mL.

Bacteria: Blues Creek rarely exceeds the state standard for *E. coli* coliform of a single sample having no more than 400 colony forming units (CFU)/100 mL. Fecal Coliform bacteria are an indicator of the possible presence of pathogens. The source of this bacteria is most likely domestic and wild animals. Other potential sources are leaky sanitary line, sewer connections, and failing septic tanks. Decreased abundance in fecal coliform in 2013-2015 may be attributed to dilution from increased stream flow. Blues Creek is listed by FDEP to be impaired for fecal coliform.
