Mill Creek Fact Sheet

The Watershed

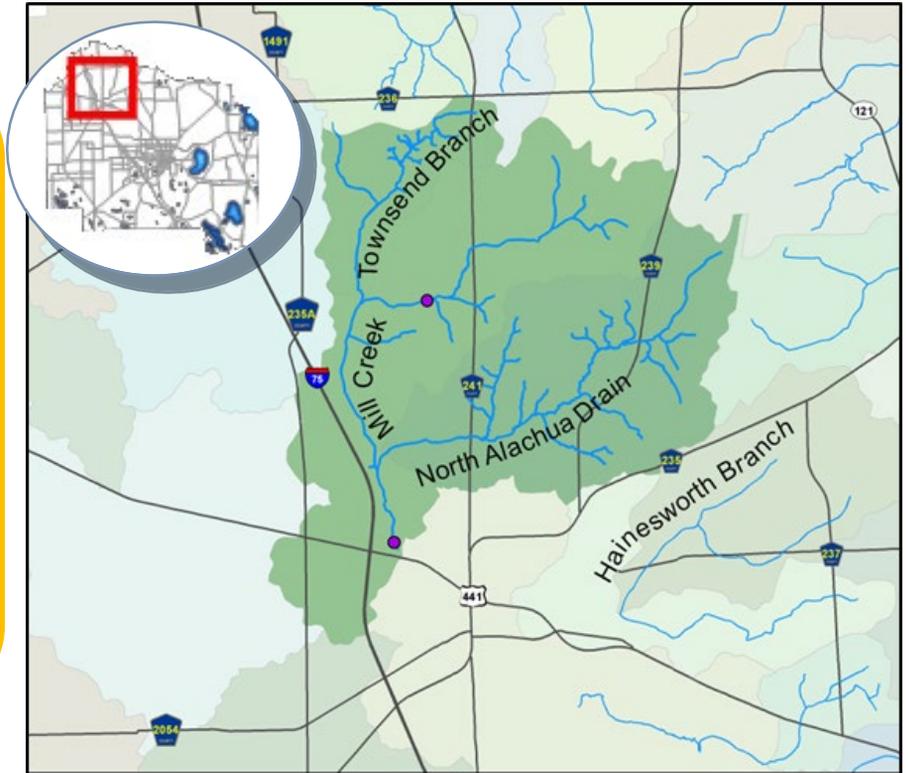
Map of Mill Creek watershed (green) with sampling sites (purple circles).

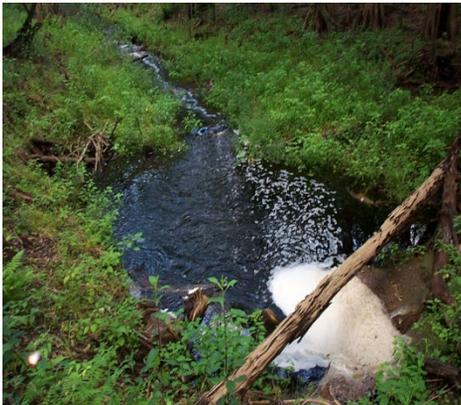
Swallet near Mill Creek Sink.

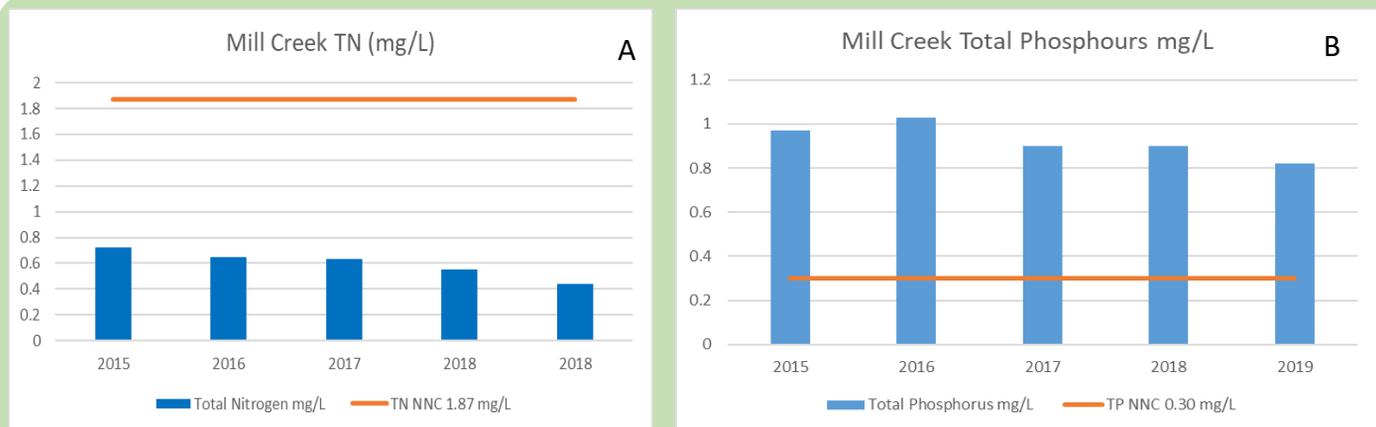
Figure 1. Annual geometric mean of A) total phosphorus (TP) and B) total nitrogen (TN).

Nutrients The current FDEP water quality rule on nutrient standards went into effect February 2016. As a result, Mill Creek is above the Numeric Nutrient Criteria (NNC) threshold for total phosphorus (TP) but not for total nitrogen (TN). Potential phosphorus sources are the erosion of phosphorus rich soils that compose the Hawthorn clays which underlay the stream bed and agricultural inputs of fertilizer and manure. It does not appear that the elevated TP concentrations are influencing the stream biota. If another SCI results in a “healthy” score, this stream will be meeting the NNC. Mill Creek Sink is classified as impaired for dissolved oxygen (DO), which is attributed to nutrient concentrations.

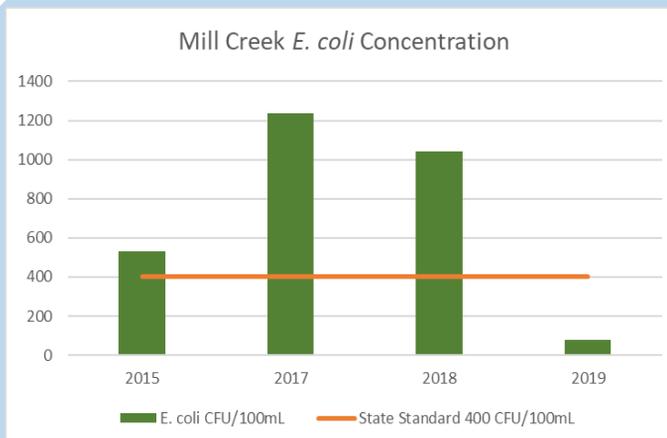
Figure 2. Annual geometric mean fecal coliform colony forming units (CFU)/100mL.

Bacteria: Mill Creek has high abundance of *E. coli* bacteria. State standards for a single sample are 400 colony forming units (CFU)/ 100 mL. Mill Creek Sink frequently exceeds this standard, classifying it as impaired. Possible sources of bacteria include domestic and wild animal waste, leakage from sanitary sewer lines, faulty private sewer connections and overflows, persistence and regrowth of bacteria in creek sediments, and failing septic systems.

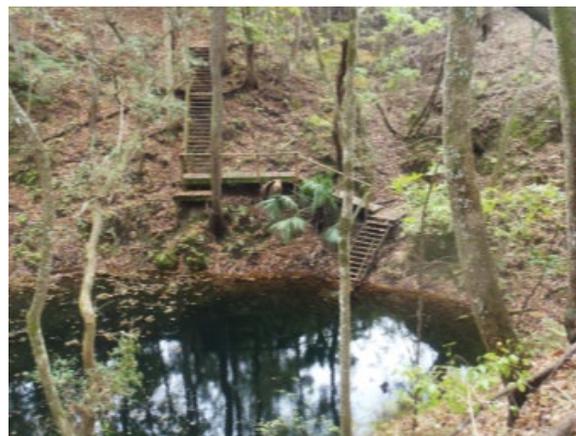
Mill Sink is connected to springs of the Santa Fe River.
