Tumblin Creek

Fact Sheet

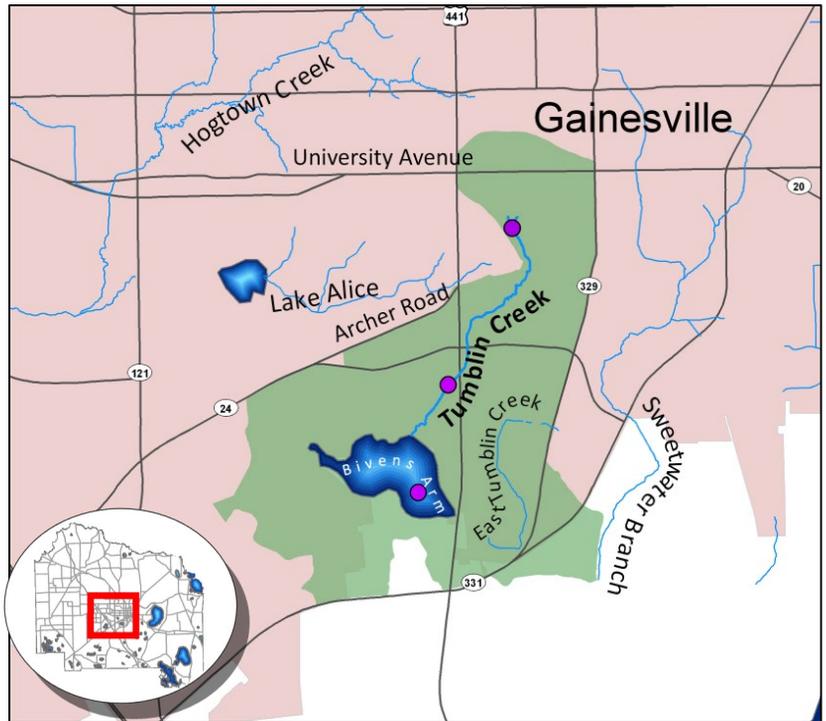
Map of Tumblin Creek watershed (green) with sampling sites (purple circles).

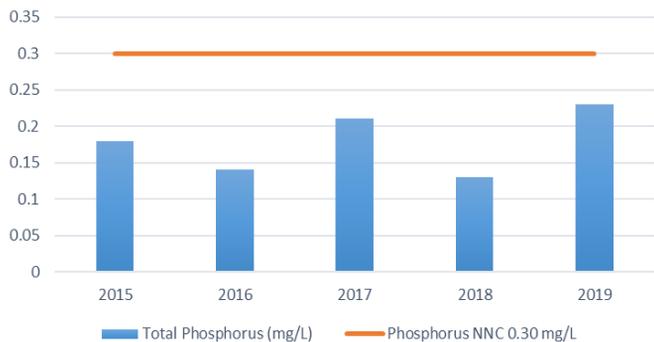
A

Tumblin Creek Total Phosphorus

Figure 1. Annual geometric mean of A) total phosphorus (TP) and B) total nitrogen (TN).

Nutrients: The current FDEP water quality rule on nutrient standards went into effect February 2016. As a result, Tumblin Creek does not exceed the Numeric Nutrient Criteria (NNC) threshold for total phosphorus (TP) or for total nitrogen (TN). The stormwater pond constructed in the headwaters of the creek may have helped reduce the phosphorus loading to Tumblin Creek by reducing the peak velocity of stormwater flows.

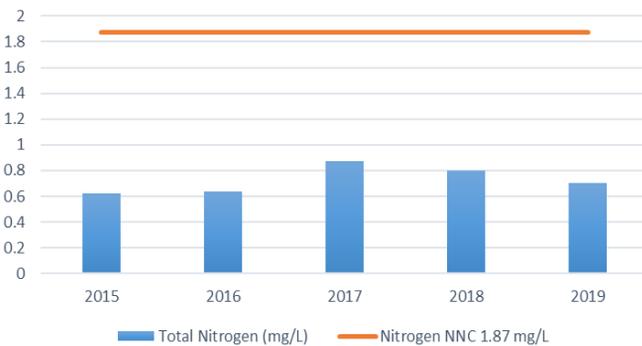
B

Tumblin Creek Total Nitrogen

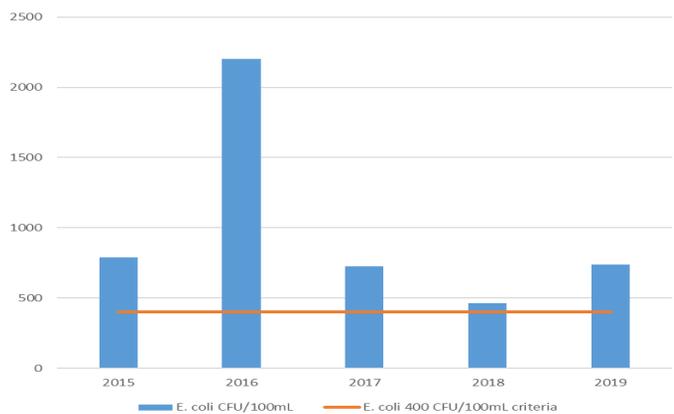
Tumblin Creek *E. coli* Concentration

Figure 2. Annual geometric mean *E. coli* coliform colony forming units (CFU)/100 mL.

Bacteria: Measuring *Escherichia coli* is the more accurate method for determining fecal coliform contamination in streams. State standards for a single sample are 400 colony forming units (CFU)/100 mL. Tumblin Creek is listed as impaired for fecal coliform. Possible sources of this bacteria include urban campers, domestic and wild animal waste, leakage from sanitary sewer lines, faulty private sewer connections and overflows, persistence and regrowth of bacteria in creek sediments, and failing septic systems.
