# An Evaluation of Nutrient Sources and Potential Nutrient Reduction Projects for Santa Fe Lake

September 30, 2021

Alachua County Environmental Protection Department  
Work Order 002D-20-171

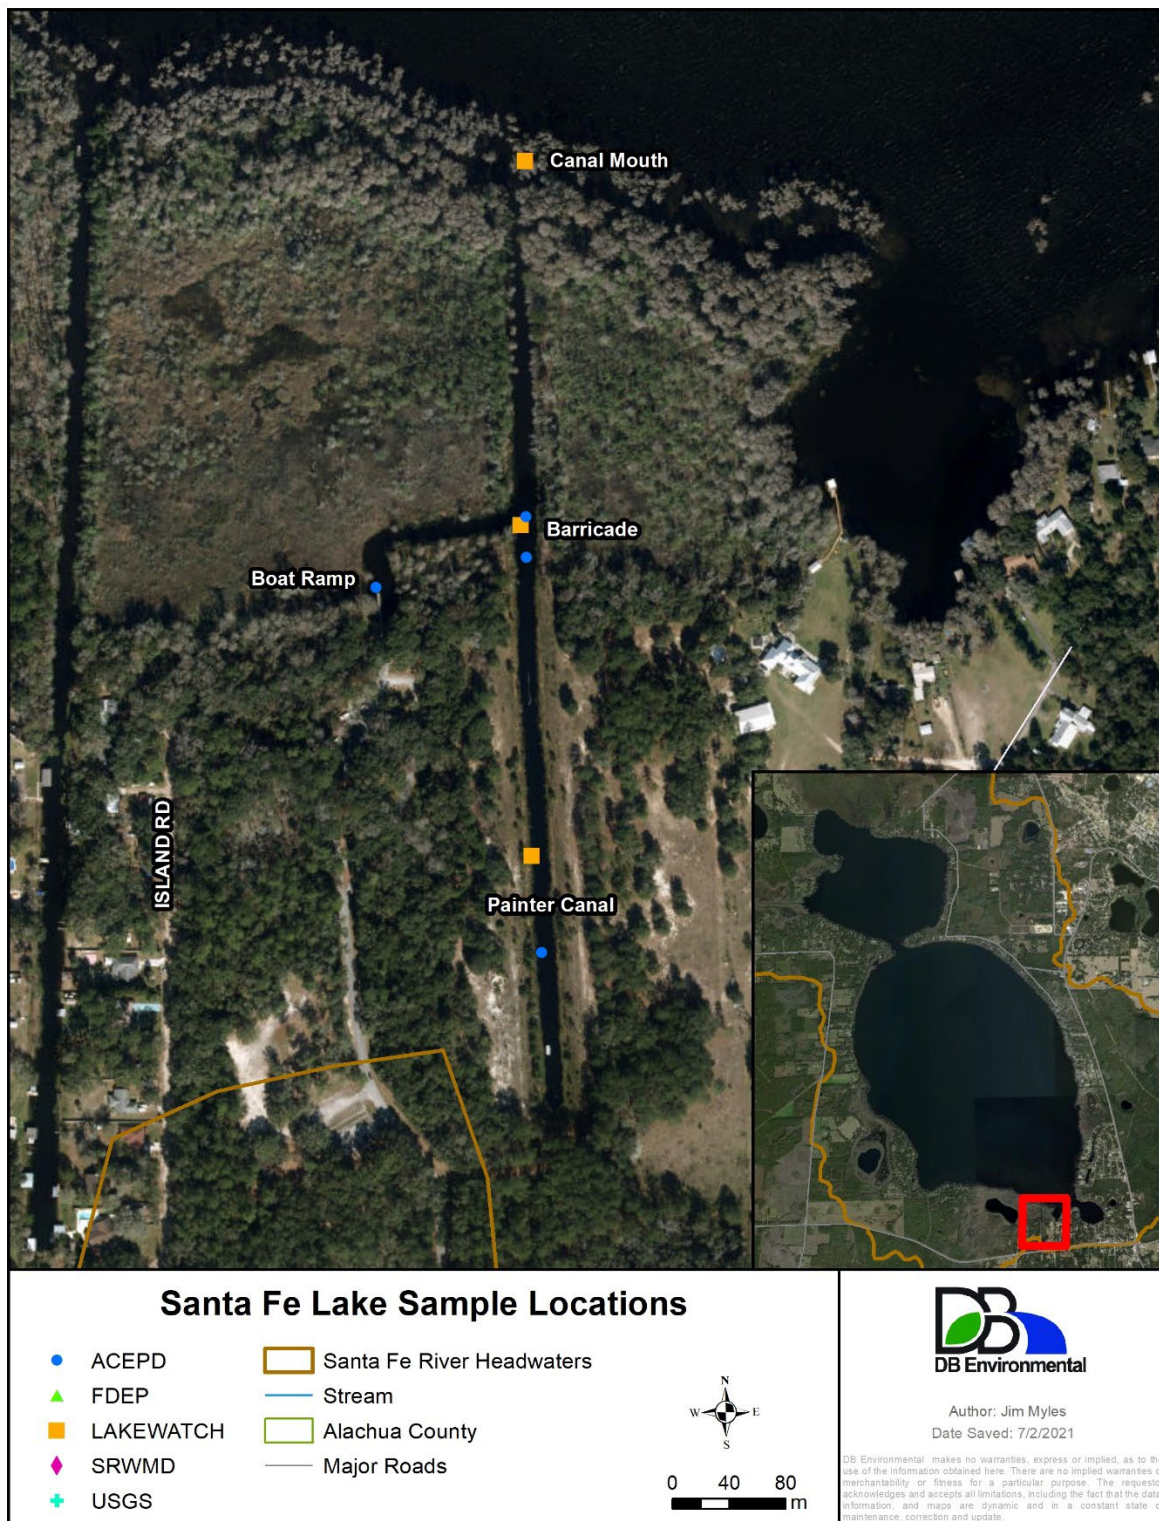
**Figure 29.** Sampling locations in the Painter Canal on the south side of Santa Fe Lake.

At times, the data demonstrate relatively high nutrient and chlorophyll *a* concentrations (Figures 15 through 17). After looking into the location of the some of these higher concentrations it became evident that many of these samples were collected from a canal on the south side of the lake (Figure 29). Unpermitted dredging to deepen this canal (Painter Canal) occurred in the winter of 2000 to 2001. In response to the high turbidity levels observed from the dredging activities, ACEPD completed a monitoring effort from February to September 2001. During this period of elevated turbidity, extremely high concentrations of TP were observed in the canal (Figure 30). Increased TN and chlorophyll concentrations in 2001 were not observed (Figures 31 and 32), suggesting a discreet source of P to the water column, that had not become accompanied by N or stimulated phytoplankton and chlorophyll *a* concentrations.

**Figure 33.** Annual average total phosphorus and total nitrogen concentrations in the canal on south end of Santa Fe Lake (measured and reported by LAKEWATCH 2020). See Figure 29 for sampling locations.

**Figure 34.** Annual average chlorophyll *a* concentration and Secchi depth in the canal on south end of Santa Fe Lake (measured and reported by LAKEWATCH 2020). See Figure 29 for sampling locations.

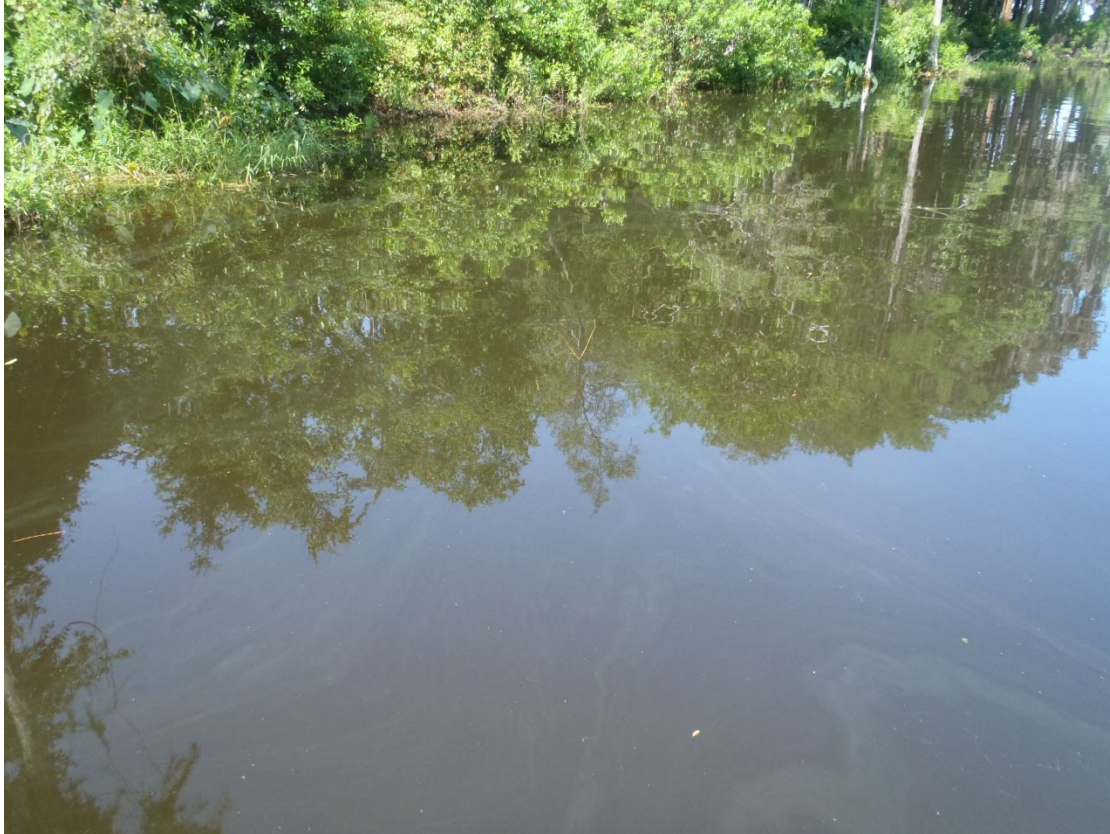
**Figure 46.** Algal bloom in Little Santa Fe Lake on May 29, 2014.

FDEP and ACEPD have responded to citizen reports of algal blooms in the Santa Fe Lake system. On May 29, 2014, ACEPD collected samples from Little Santa Fe Lake in response to an observed algal bloom (Figure 46). The dominant species of algae or cyanobacteria (blue-green algae) were not identified; however, the samples were analyzed for the cyanotoxins cylindrospermopsin and anatoxin-a which are produced by cyanobacteria blooms. Neither toxin was detected in the sample collected from Little Santa Fe Lake. The chlorophyll *a* concentration was 19 µg/L, which is considerably higher than the mean concentration of 8 µg/L and indicative of an algae bloom.

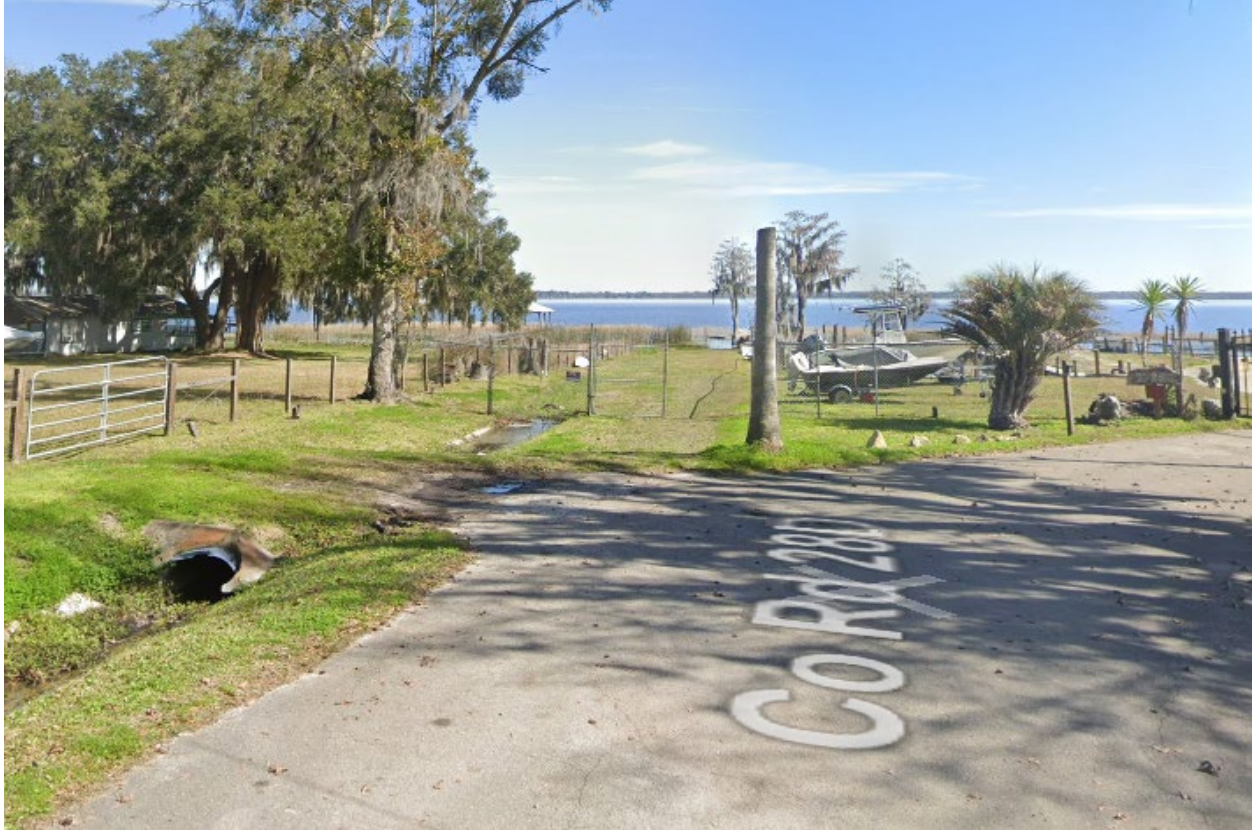
**Figure 49.** Google street view facing east from the end of NE 100<sup>th</sup> Avenue, Earleton, FL.

While reviewing the stormwater geodatabase, a collector pipe was observed near the corner of CR 1469 and NE 100<sup>th</sup> Avenue (Figure 48). Based on the topography and imagery available through Google Street view it appears stormwater runoff from NE 100<sup>th</sup> Avenue (C.R. NE 28-D) and the residences is flowing east toward Santa Fe Lake (Figures 49 and 50). At the end of the road there is a small parcel where it appears the concrete swale discharges. Additional investigations would need to be completed to determine if runoff is directly entering the lake and if there are opportunities for nutrient reduction projects. This parcel is privately owned and would need to be accounted for when ranking potential projects. Possible solutions include partnership with the landowners to implement a stormwater improvement project. Other options would include acquisition or lease from the owner (Parcel ID - 18478-000-000, Prop Id - 100208, Owner - BIVINS & BIVINS & DAVIS & GREEN, Acres - 0.1) (Figure 51). Further investigations are necessary to determine if this parcel could be utilized for a stormwater treatment swale, pond or bioretention garden.

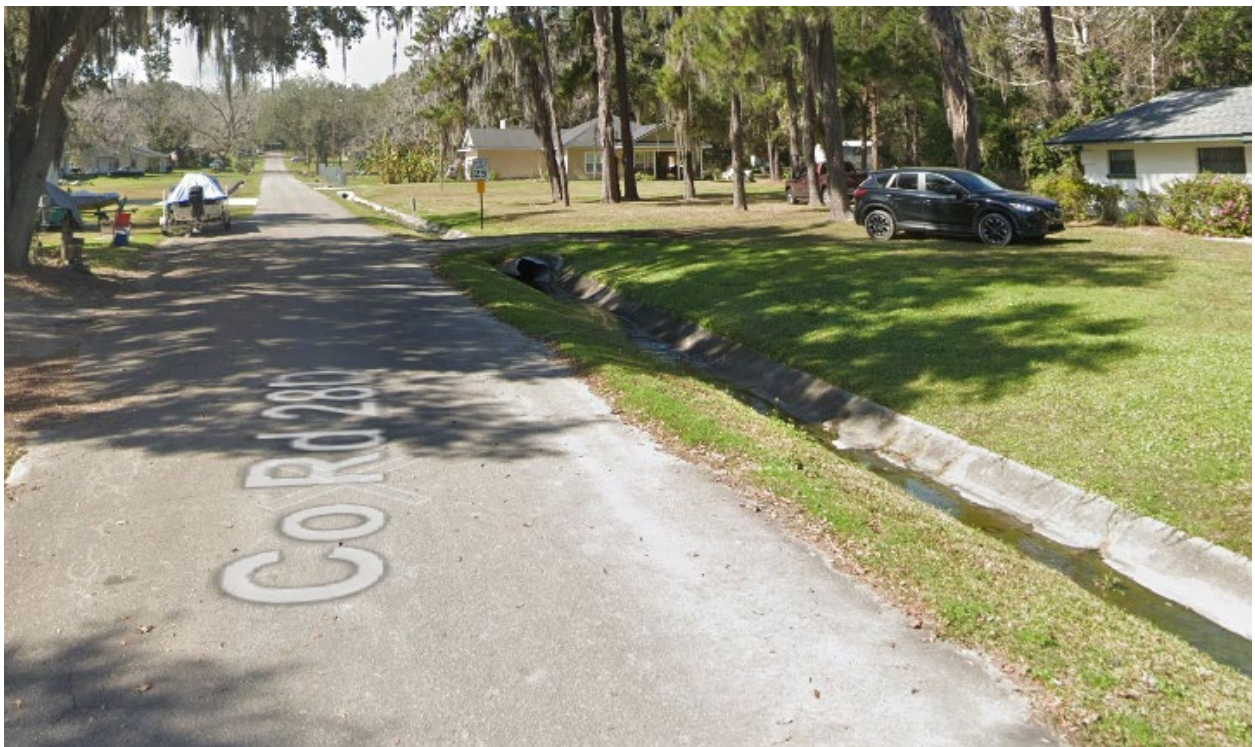
**Figure 50.** Google street view facing west from the end of NE 100<sup>th</sup> Avenue, Earleton, FL.

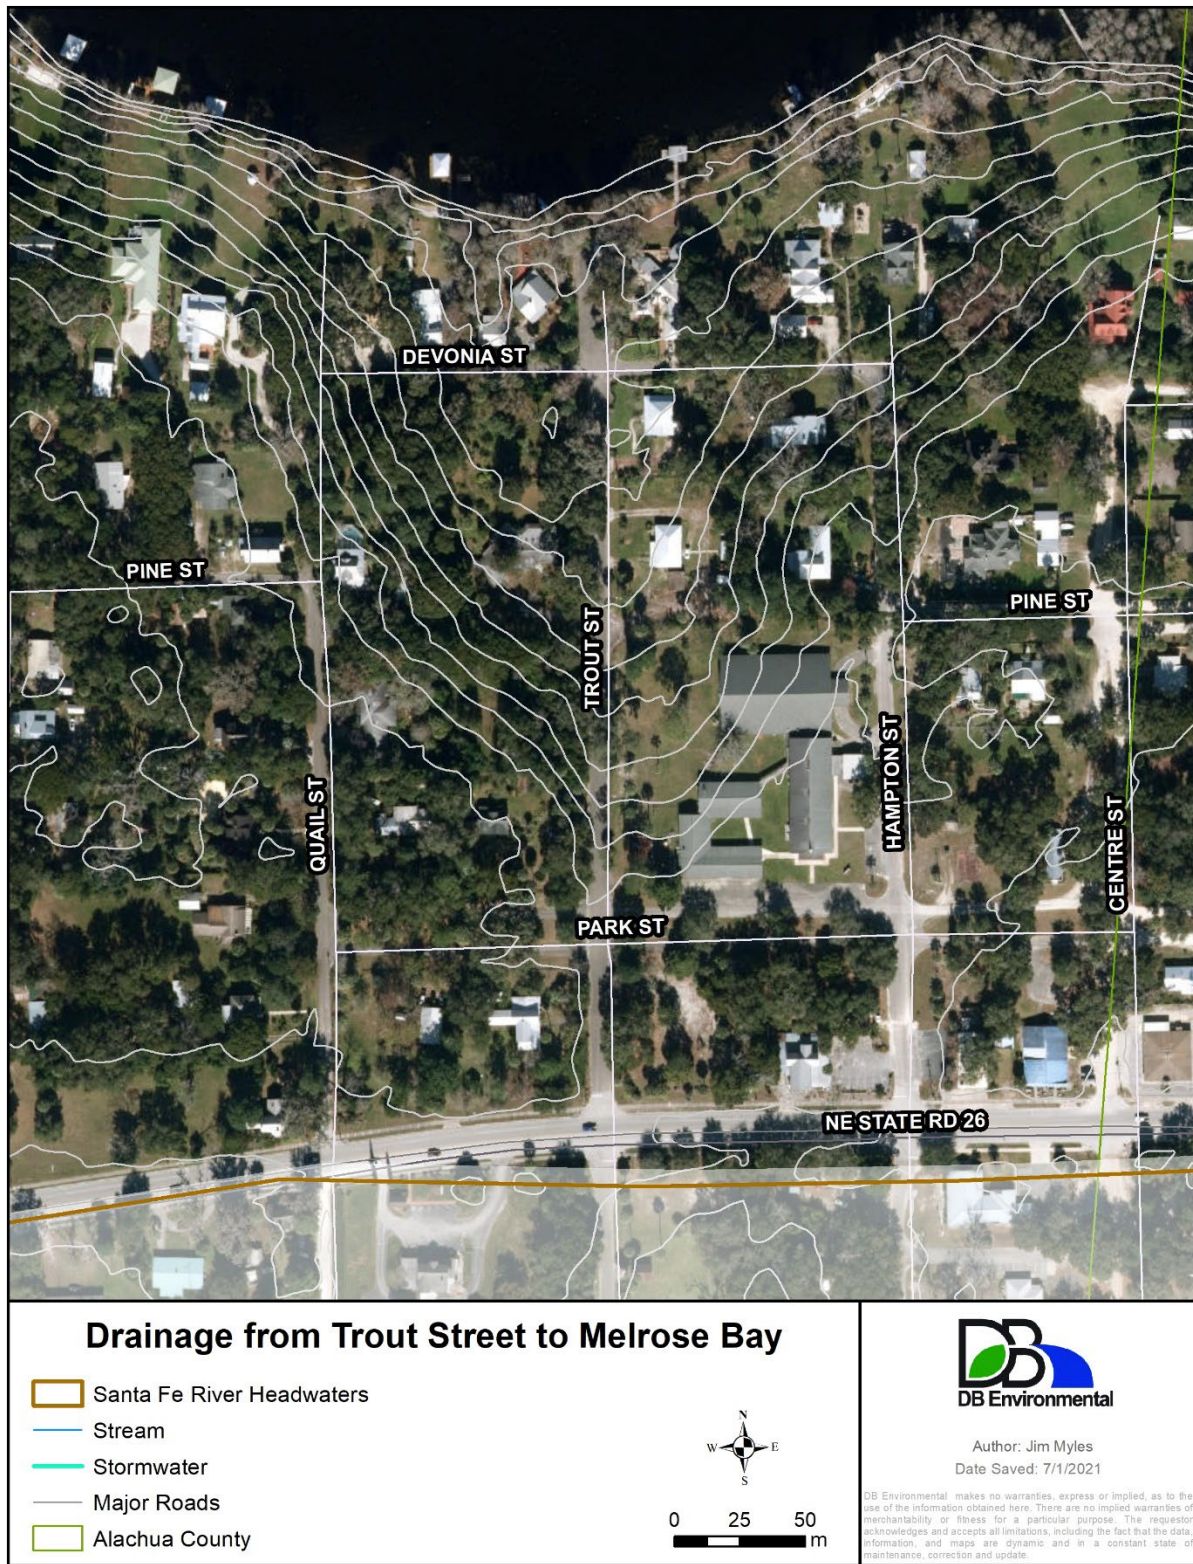
**Figure 55.** Stormwater runoff from Trout Street to Melrose Bay near the boat ramp.

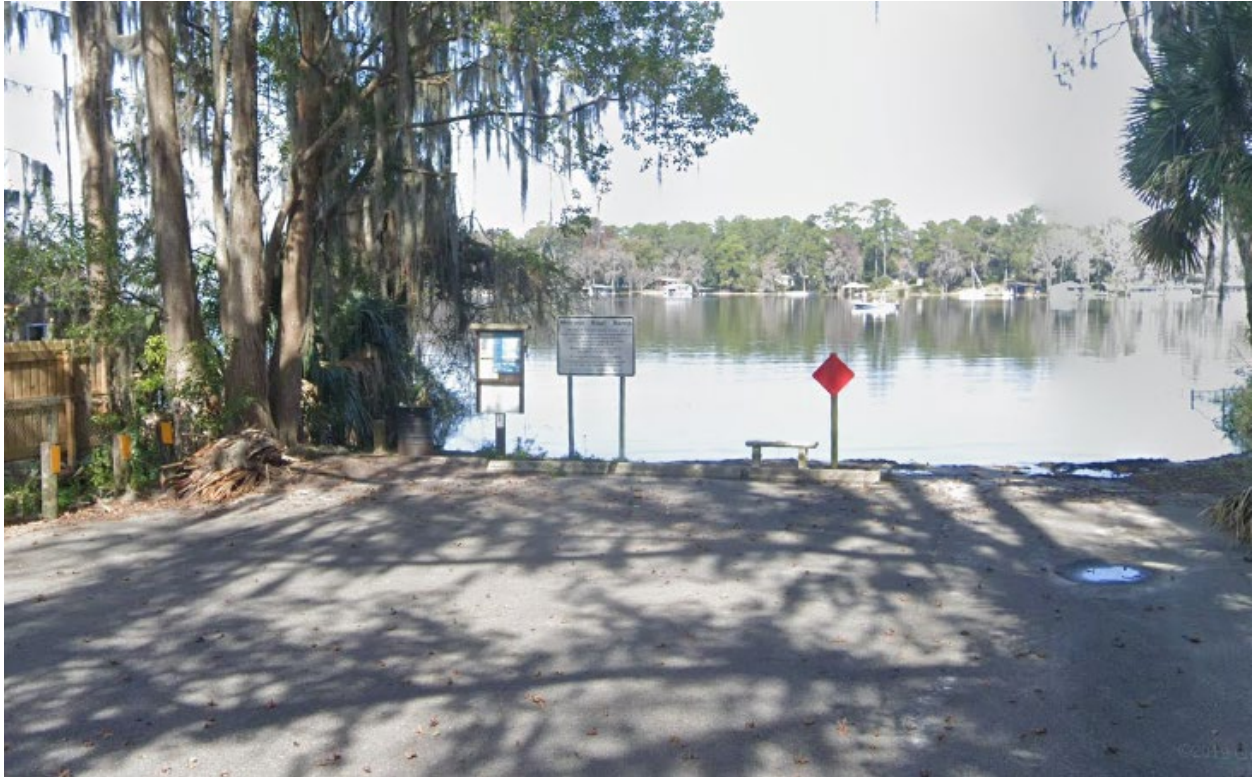
**Figure 56.** Trout Street boat ramp on Melrose Bay. Image is from Google Street View.

The neighborhood surrounding Trout Street and the boat ramp located on Melrose Bay contribute untreated stormwater runoff to the lake (Figure 55) through a stormwater collection system and road runoff that discharges near the boat ramp (Figure 56). This collection system appears to drain several blocks of residential properties between SR 26 and the boat ramp (Figure 55). While curb inlets, drop inlets, and concrete swales are evident in Google Street View (Figure 57) this stormwater infrastructure is not captured in the geodatabase provided by Alachua County Public Works (Figure 55). There are also drop inlets along SR 26 and the fate of that stormwater is unknown.

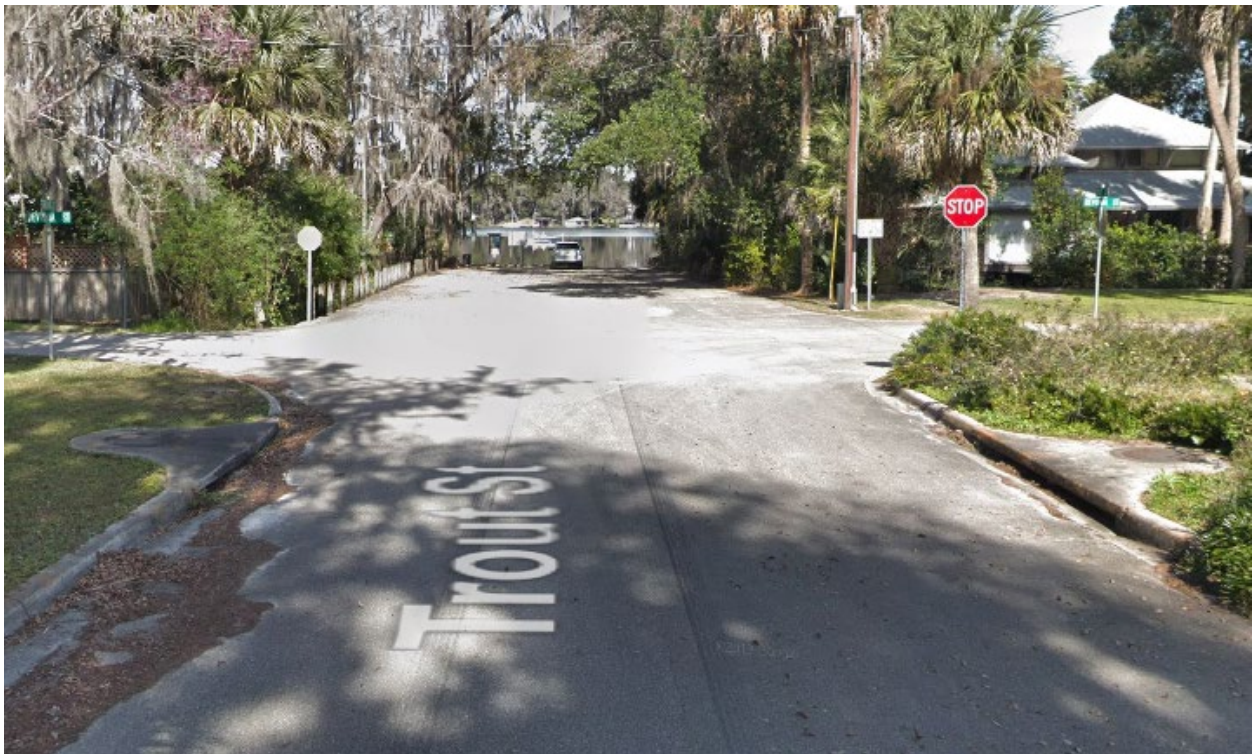
**Figure 57.** Stormwater drainage on Trout Street in Melrose, FL. Image is from Google Street View.
