# Evaluation of Nutrient Sources and Potential Nutrient Reduction Projects for Santa Fe Lake

September 30, 2023

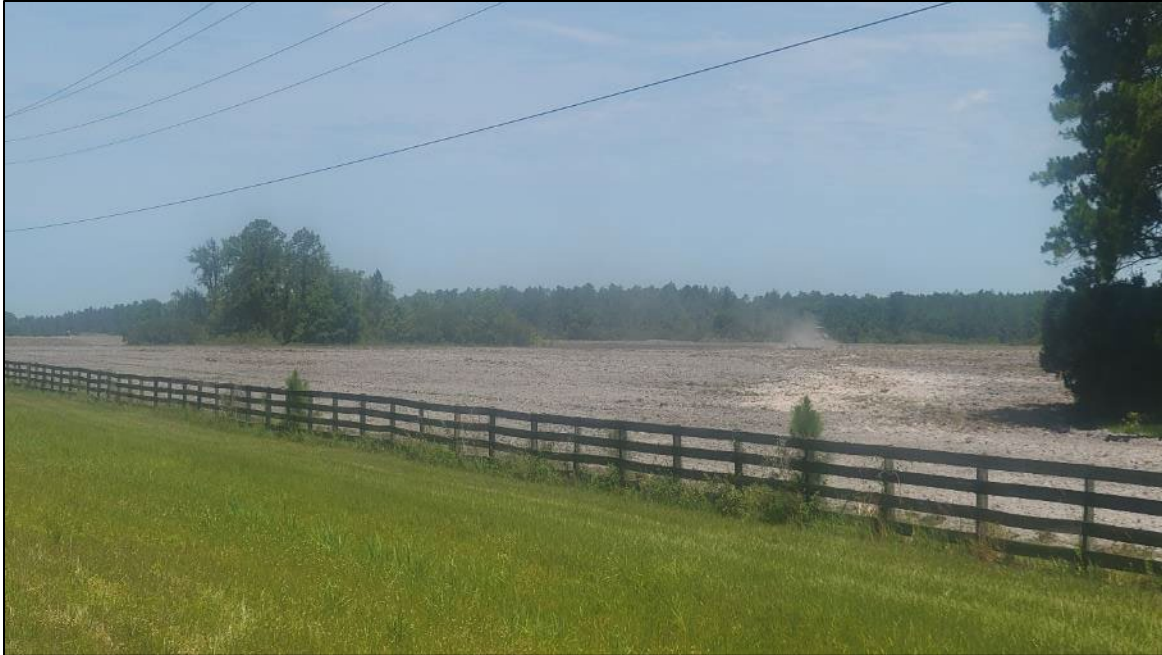
Figure 10. Grovin Farms after the sod was cut and the land was tilled.

and trees were cleared and burned, and the area tilled (Figure 10). To address this stormwater runoff, both the quantity and quality of the water entering Santa Fe Lake from this drainage area needs to be determined. Several key pieces of information are required to estimate these loads, including the contributing areas, surface water flow paths, discharges, and water quality. To gather the necessary information, the stormwater infrastructure was located and then the flow path and drainage area was modeled. To estimate nutrient loading, a stream gauging station was installed, and water quality monitoring was initiated.

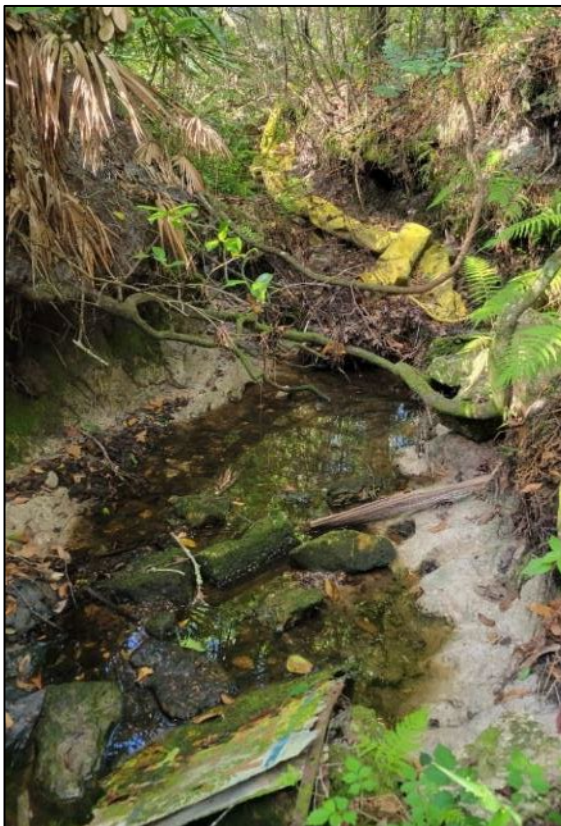
Figure 11. Garbage and turbidity barrier in channel east of NE 221<sup>st</sup> Street.

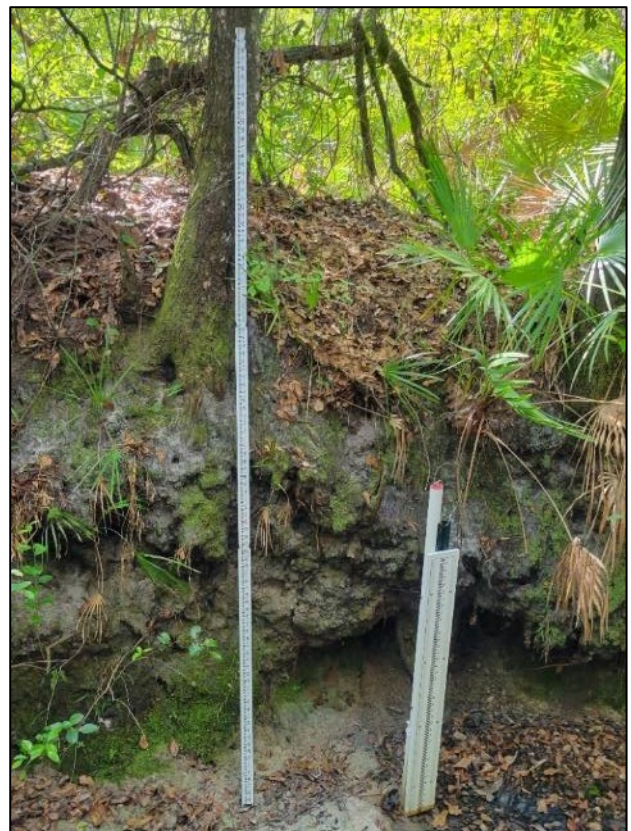
Figure 12. Incised channel near the staff gauge downstream of the southern culvert on NE 221<sup>st</sup> Street.

To determine the hydroperiod of this ephemeral stream, a staff gauge and water level recorder were installed in the southern channel on May 27, 2022 (Figure 12). The early part of summer 2022 was relatively dry and several trips to sample water quality in these culverts after rain events found the streams dry or disconnected. The pressure transducer data was downloaded regularly, and the mean daily stage of the stream was calculated (Figure 13). The mean daily stream stage does not accurately represent how flashy the flow is within these stream channels and how high the peak flows can be (Figure 13). The data collected by the pressure transducers on a 10-minute interval shows stage increases of up to 3 feet in less than an hour which quickly subsides within hours of the peak rainfall (Figure 14 through Figure 18). This has made it difficult to collect samples and flow measurements during the peak stormwater flows.

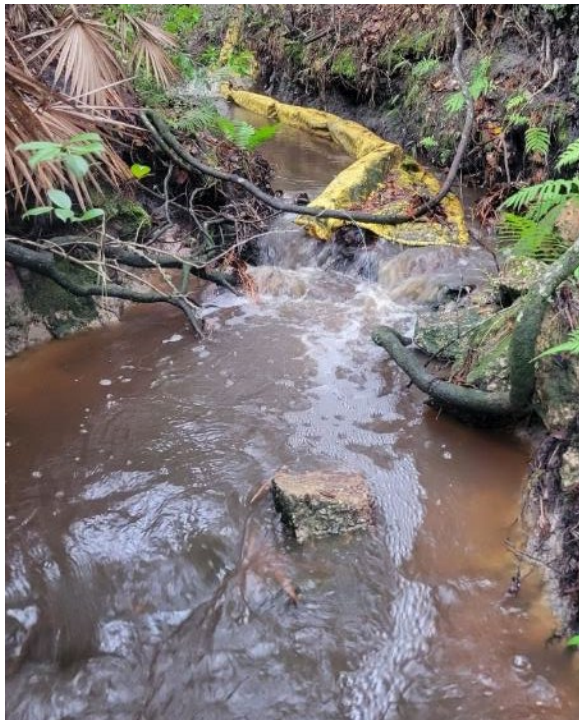
Figure 19. Flow in the southern culvert at NE 221<sup>st</sup> Street.

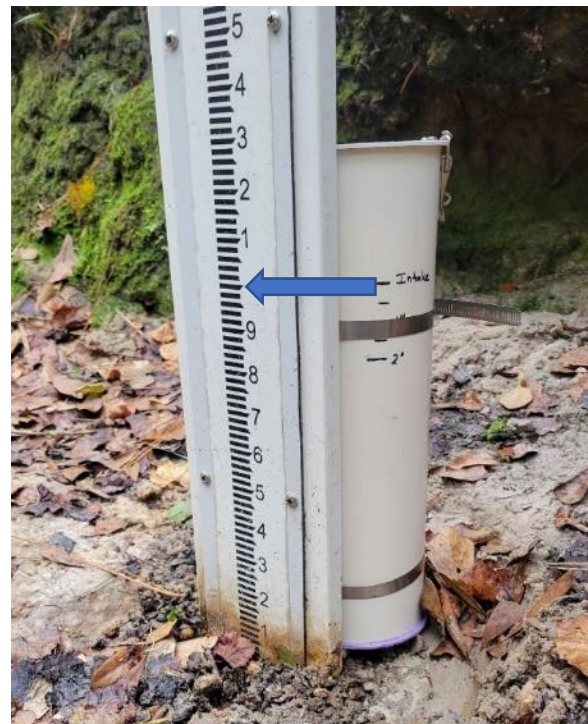
Figure 20. First flush sampler installed at the staff gauge in the southern culvert at NE 221<sup>st</sup> Street.

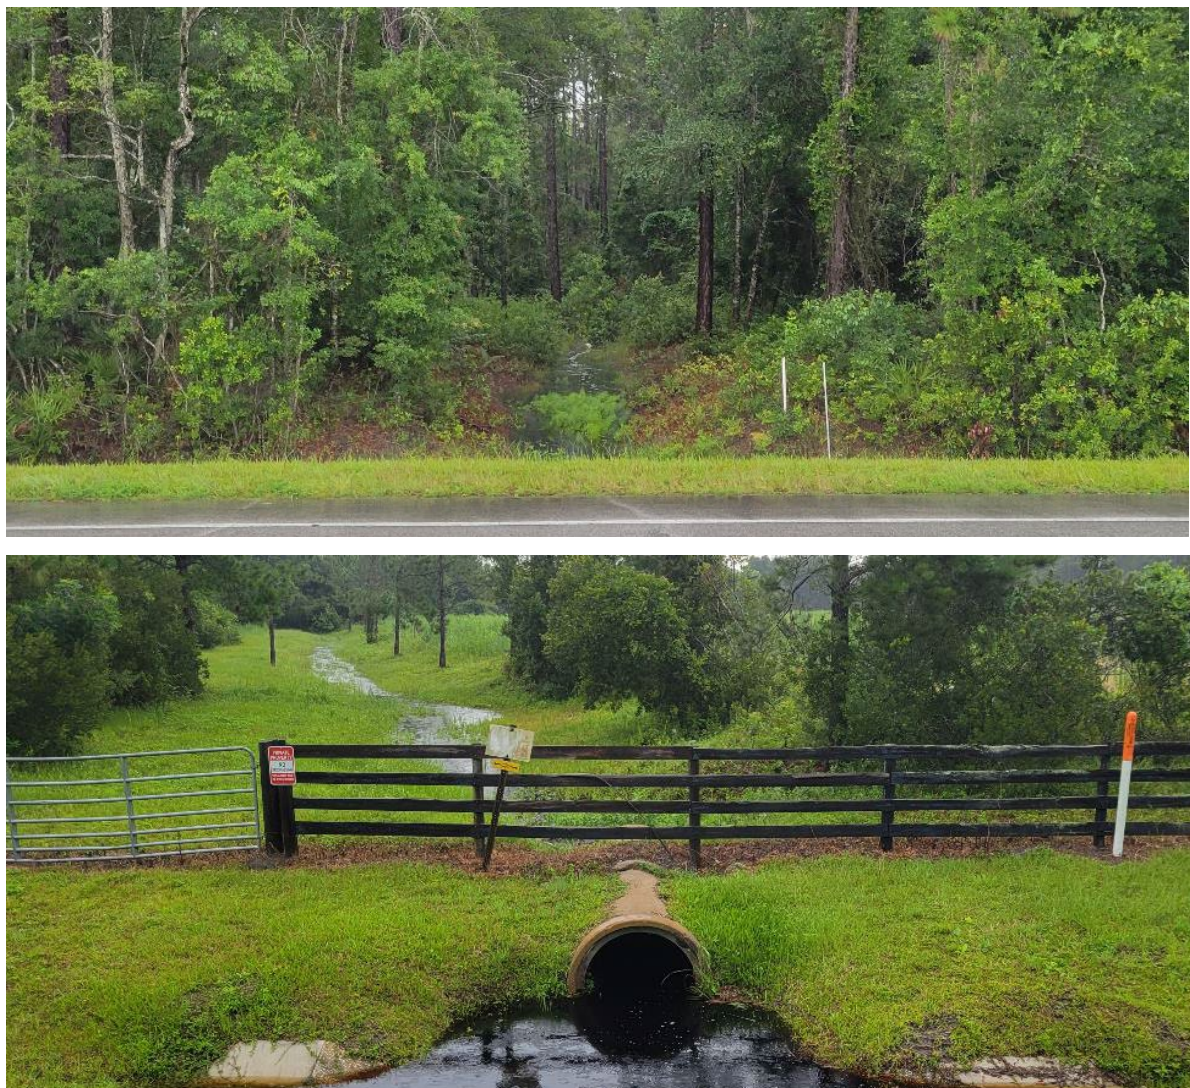
Figure 23. Water flowing from the forested parcel south of SR 26 (top picture) onto the agricultural parcel north of the highway (bottom picture). Water was also flowing from the roadside ditches on either side of SR 26.

The area south of SR 26 appears to be a closed basin which only discharges to the channel and lake under high water conditions, which was observed on June 22, 2023 (Figure 23). The hydrologic connection is made through the culvert under SR 26, to the ditches draining the sod farm. This drainage basin has 44 acres of silviculture and 10 acres of forested wetlands (Figure 9), which have relatively low nutrient loading rates. The upland pine forest lies on Pomona sand in HSG A/D, with a cover type of Woods in good condition the runoff curve number was 77. The forested wetlands had the same soil type, cover, and runoff curve number of 77. This model run resulted in an estimated annual runoff volume of 21 acre-feet of water transporting approximately 90 pounds of nitrogen and 8 pounds of phosphorus (Table 6) which is significantly less than the agricultural basins to the north.

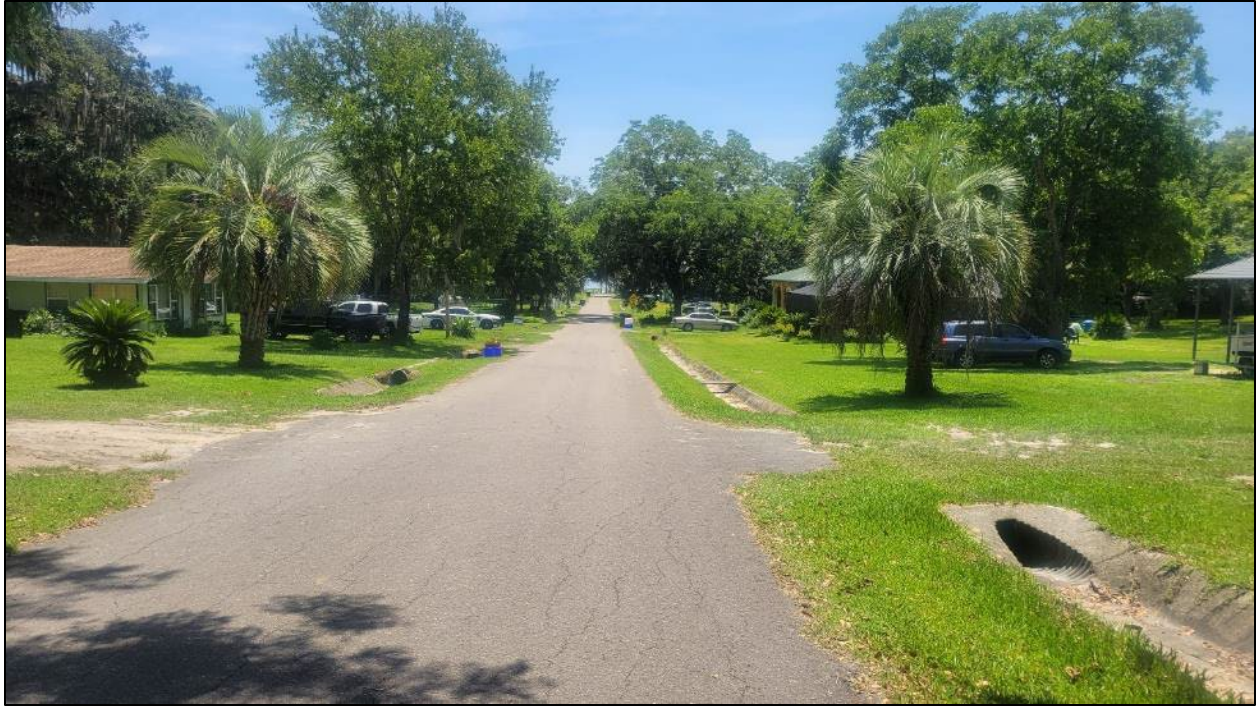
Figure 25. Stormwater collection system along NE 100<sup>th</sup> Avenue.

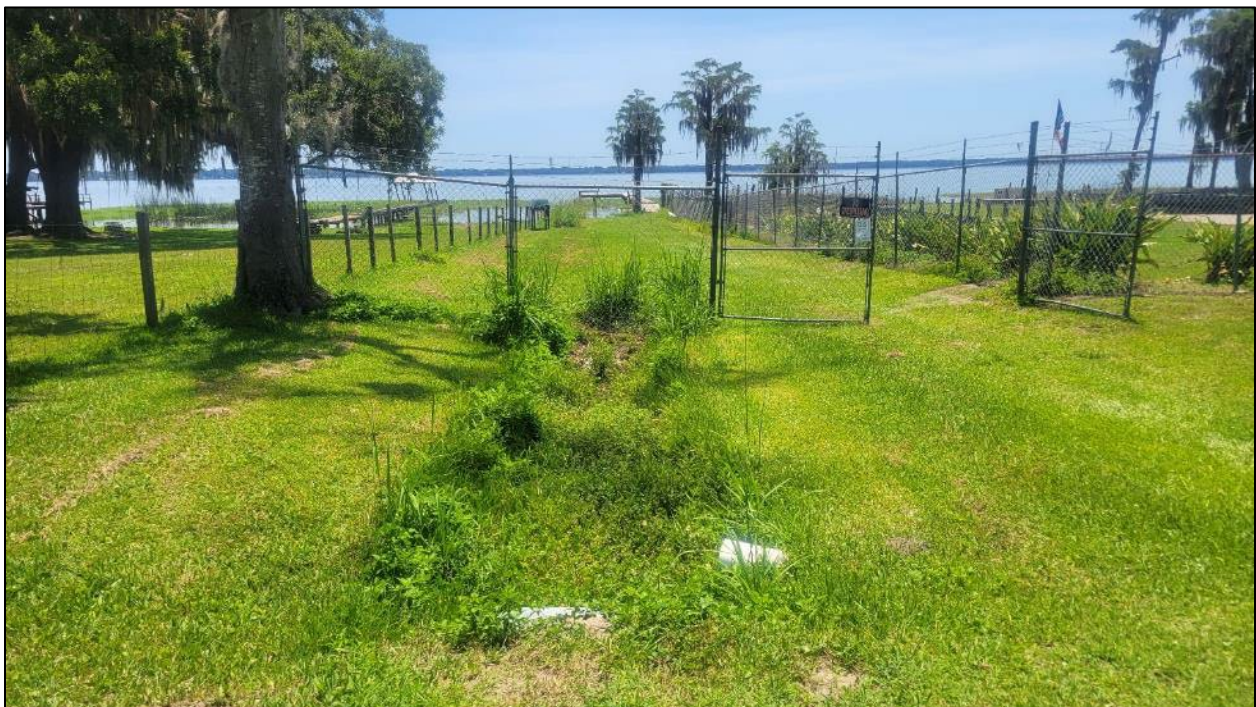
Figure 26. Outfall from the stormwater collection system along NE 100<sup>th</sup> Avenue that discharges into a grass swale before reaching Santa Fe Lake.

While reviewing the stormwater geodatabase, a collector pipe was observed near the corner of CR 1469 and NE 100<sup>th</sup> Avenue. The stormwater infrastructure downstream of this area was surveyed and appended to the Alachua County stormwater geodatabase (Figure 24). Stormwater runoff from CR 1469 and NE 100<sup>th</sup> Avenue (CR NE 28-D) and the surrounding residences flows east into Santa Fe Lake. On either side of the road there are concrete-lined swales with culverts at each residential driveway collecting and quickly transporting runoff toward the lake (Figure 25). At the end of the concrete channel there is a small parcel where the stormwater discharges into a grass swale that extends approximately 220 ft before reaching the lake (Figure 26). The parcel is maintained for private access to the lake.

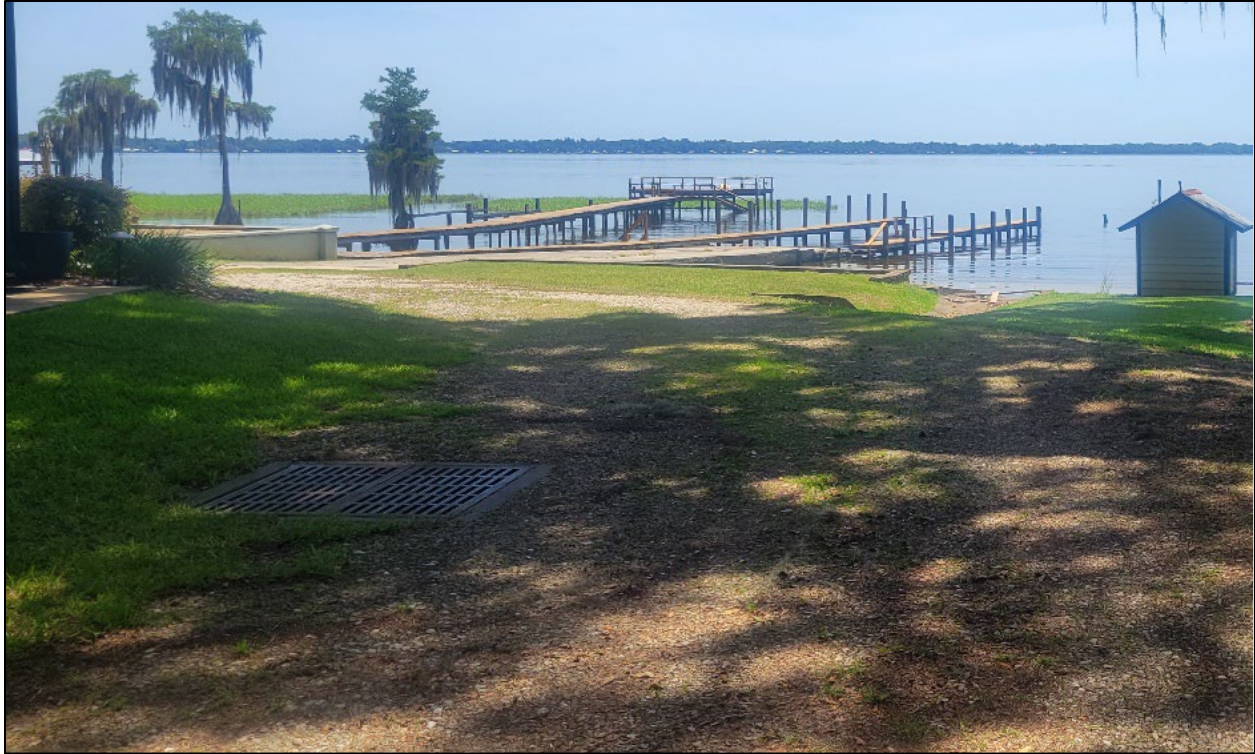
Figure 27. Outfall from the stormwater collection system along NE 101<sup>st</sup> Avenue that discharges into Santa Fe Lake.

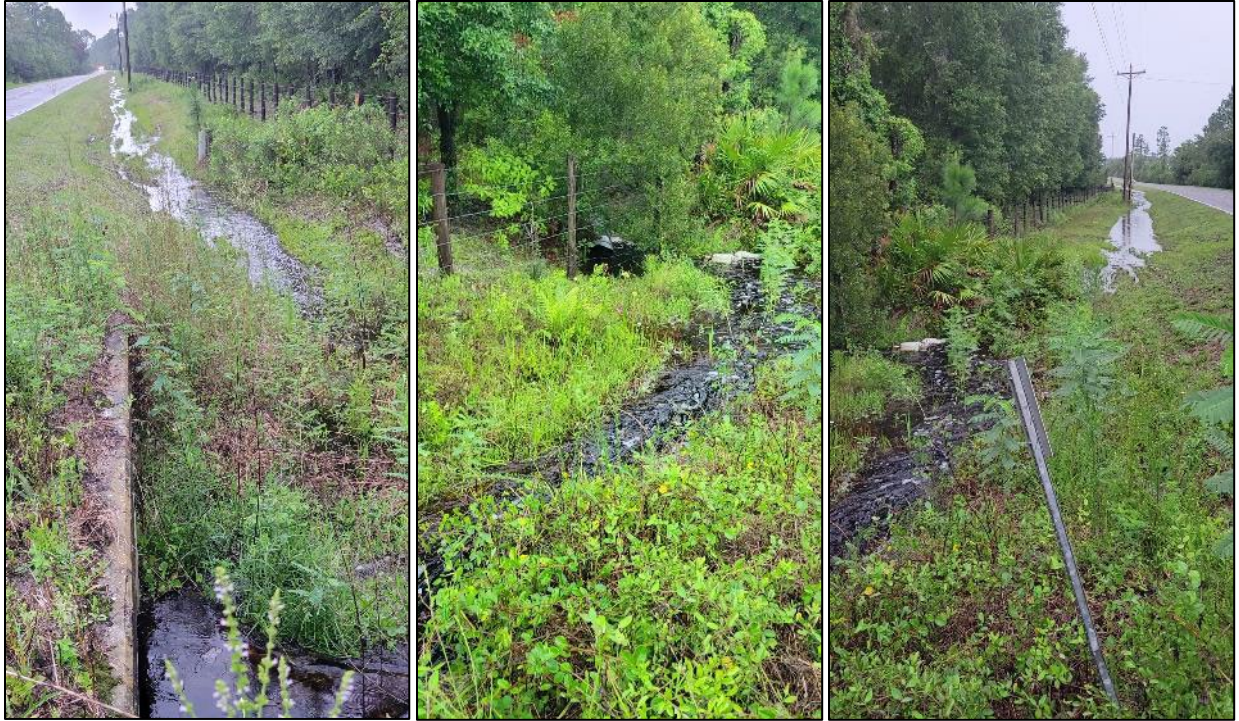
Figure 33. Runoff in the roadside ditch along the east side of NE County Road 1469 (June 22, 2023).

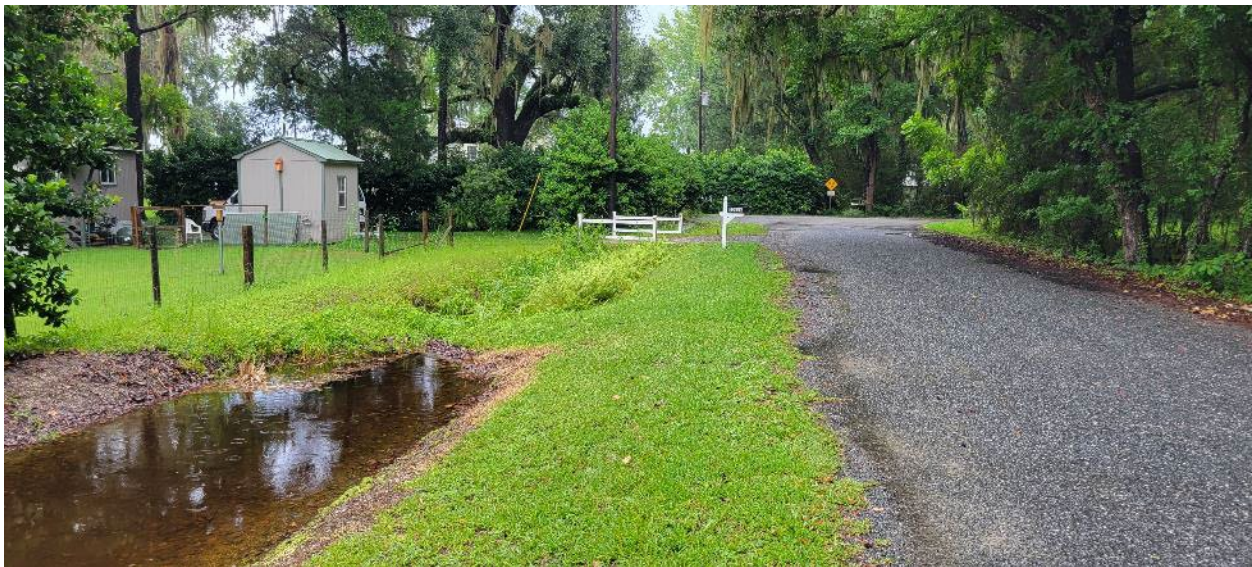
Figure 37. Ditch along NE 132<sup>nd</sup> Avenue. Picture taken facing east toward the outfall and Little Santa Fe Lake.

The eastern half mile of NE 132<sup>nd</sup> Ave drains into a ditch along the northern side of the road (Figure 37) which discharges into Santa Fe Lake through private property (Figure 38). There are also two outfalls on the south side of NE 132<sup>nd</sup> Ave that discharge into pine flatwoods that drain into the littoral wetlands of Santa Fe Lake (Figure 38). Additional outfalls were identified along NE 203<sup>rd</sup> Ter which discharges road runoff into a canal on Santa Fe Lake (Figure 38). Together these outfalls drain approximately 51 acres of which 39 acres are pecan groves, 7.5 acres are upland forest and 5 acres of low-density residential land uses (Figure 38). This 51-acre drainage basin is part of a larger (131 acres) sub-basin that was modeled for the MFL which included an estimate of annual runoff volumes. This larger sub-basin consists of 54 acres of agricultural land uses, 31 acres of urban development, 23 acres of flatwoods, 16 acres of wetlands and 5 acres of rangeland. We estimated the annual nutrient load from the larger sub-basin to be 154 lbs of TN and 14 lbs of TP.
