Lake Forest Creek

Fact Sheet

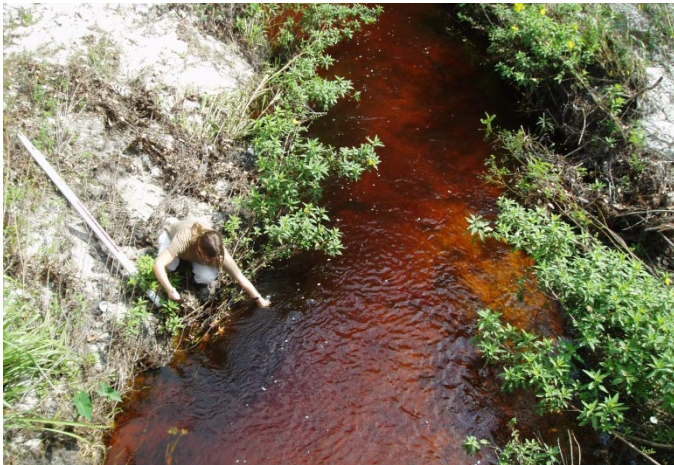
Photos of Lake Forest Creek including sampling (left).
