4.1 Introduction

4.2 Watershed Description

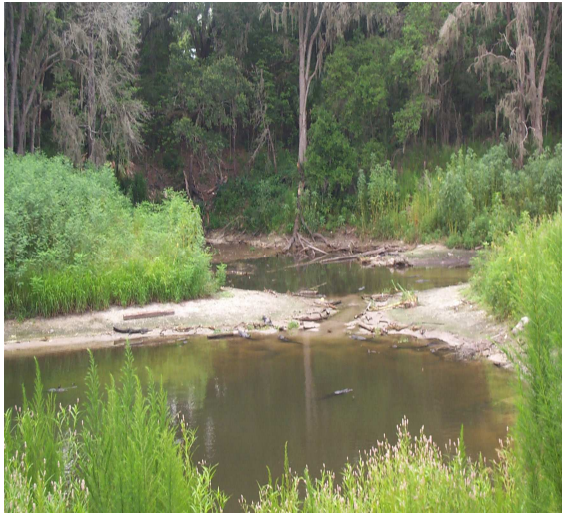
was dredged in the 1930's by the Camp family, owners of Paynes Prairie at the time, in order to contain the flow of Sweetwater Branch and drain the area for agriculture (Weimer 2002). Sweetwater Branch Canal empties into Alachua Lake where it discharges to the Floridan aquifer via Alachua Sink.

Alachua Sink at Paynes Prairie during a period of low water

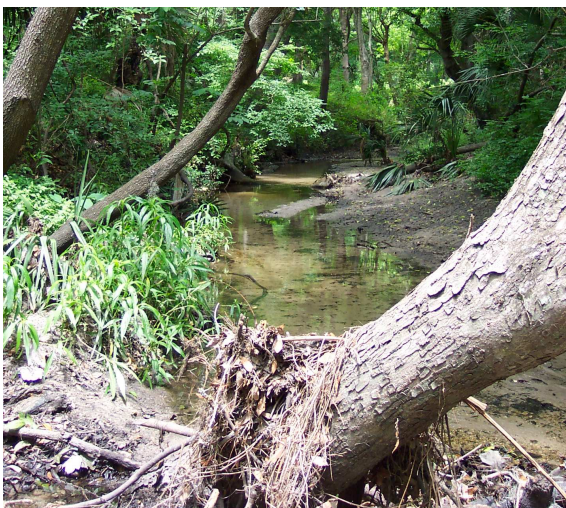
Sweetwater Branch upstream of SE 4th Street

From the GRU Kelly plant to SE 4th Street, exposed clayey sand and sandy clay along the streambed and banks indicate the severity of streambed erosion that occurs during stormflow conditions. The stream channel is further eroded downstream of the confluence with GRU's Main Street WRF reclaimed water discharge. The banks in this area are very steep with exposed tree root systems, bare soil, and evidence of bank erosion.
