# Santa Fe Lake

## Water Quality

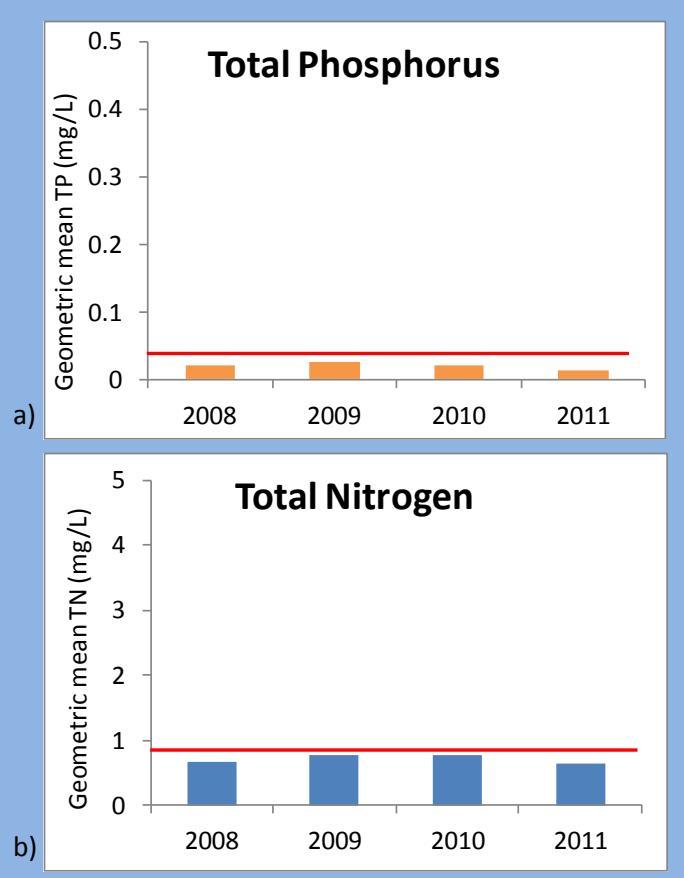
**Figure 4.** Graph of annual geometric mean of a) total phosphorus (TP) data and b) total nitrogen data (TN) collected by Lake Watch and ACEPD. Nutrient standards for clear low alkalinity are represented by the red line a) TP of 0.03 mg/L and b) TN of 0.93 mg/L.

**Nutrients:** The proposed FDEP water quality nutrient standards will be effective in 2012. When these standards are effective, Santa Fe Lake will be considered a clear, low alkalinity lake based on data from Lake watch, despite its tannic nature. Santa Fe Lake is not impaired for either TP or TN.

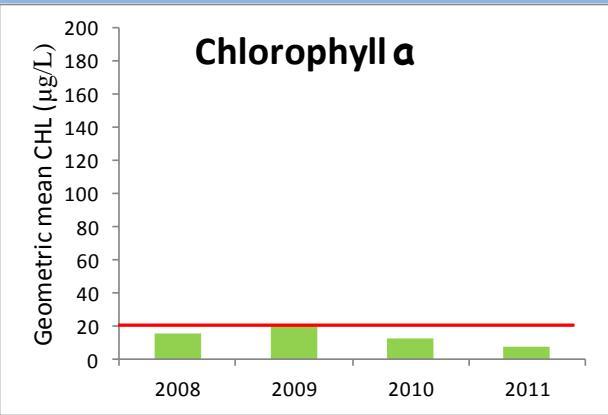
**Figure 5.** Graph of annual geometric mean of Chlorophyll **a** collected by Lake Watch and ACEPD. Nutrient standards for lakes with color <40 Platinum Cobalt Units and alkalinity  $\leq$  20 mg/L CaCO<sub>3</sub> are represented by the red line 6 µg/L.

**Chlorophyll a:** When the proposed FDEP standard come into effect Lake Santa Fe will not be considered impaired for Chlorophyll a. Chlorophyll a is a measure of the algae in the water column. High chlorophyll a can indicate a nutrient imbalance.

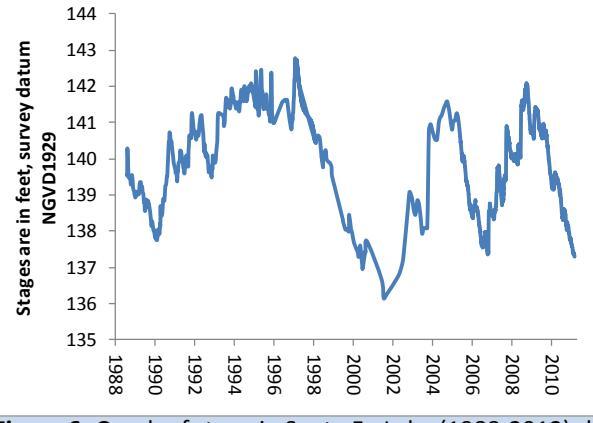
Figure 6. Graph of stage in Santa Fe Lake (1988-2012) data collected by SRWMD.

**Lake Level:** Surface water elevation of Santa Fe Lake is monitored by the Suwannee River Water Management District and fluctuates dramatically with rainfall. The graph below is the recorded stage (water level) from March 1988 to Feb 2012.
